CONSTRUCTION WITHOUT OVERSIGHT

Douglas H. Evans, P.E., FSFPE
DHE FPE LLC
Las Vegas, NV

In 2008, Clark County Building Department instituted a rigorous inspections program to uncover unreported building code violations in the existing resorts on the world-famous Las Vegas Strip. The violations discovered were primarily due to substantial work conducted without permits or inspections and inadequate or improper maintenance. An overview of the various types of violations and their extent will be discussed.

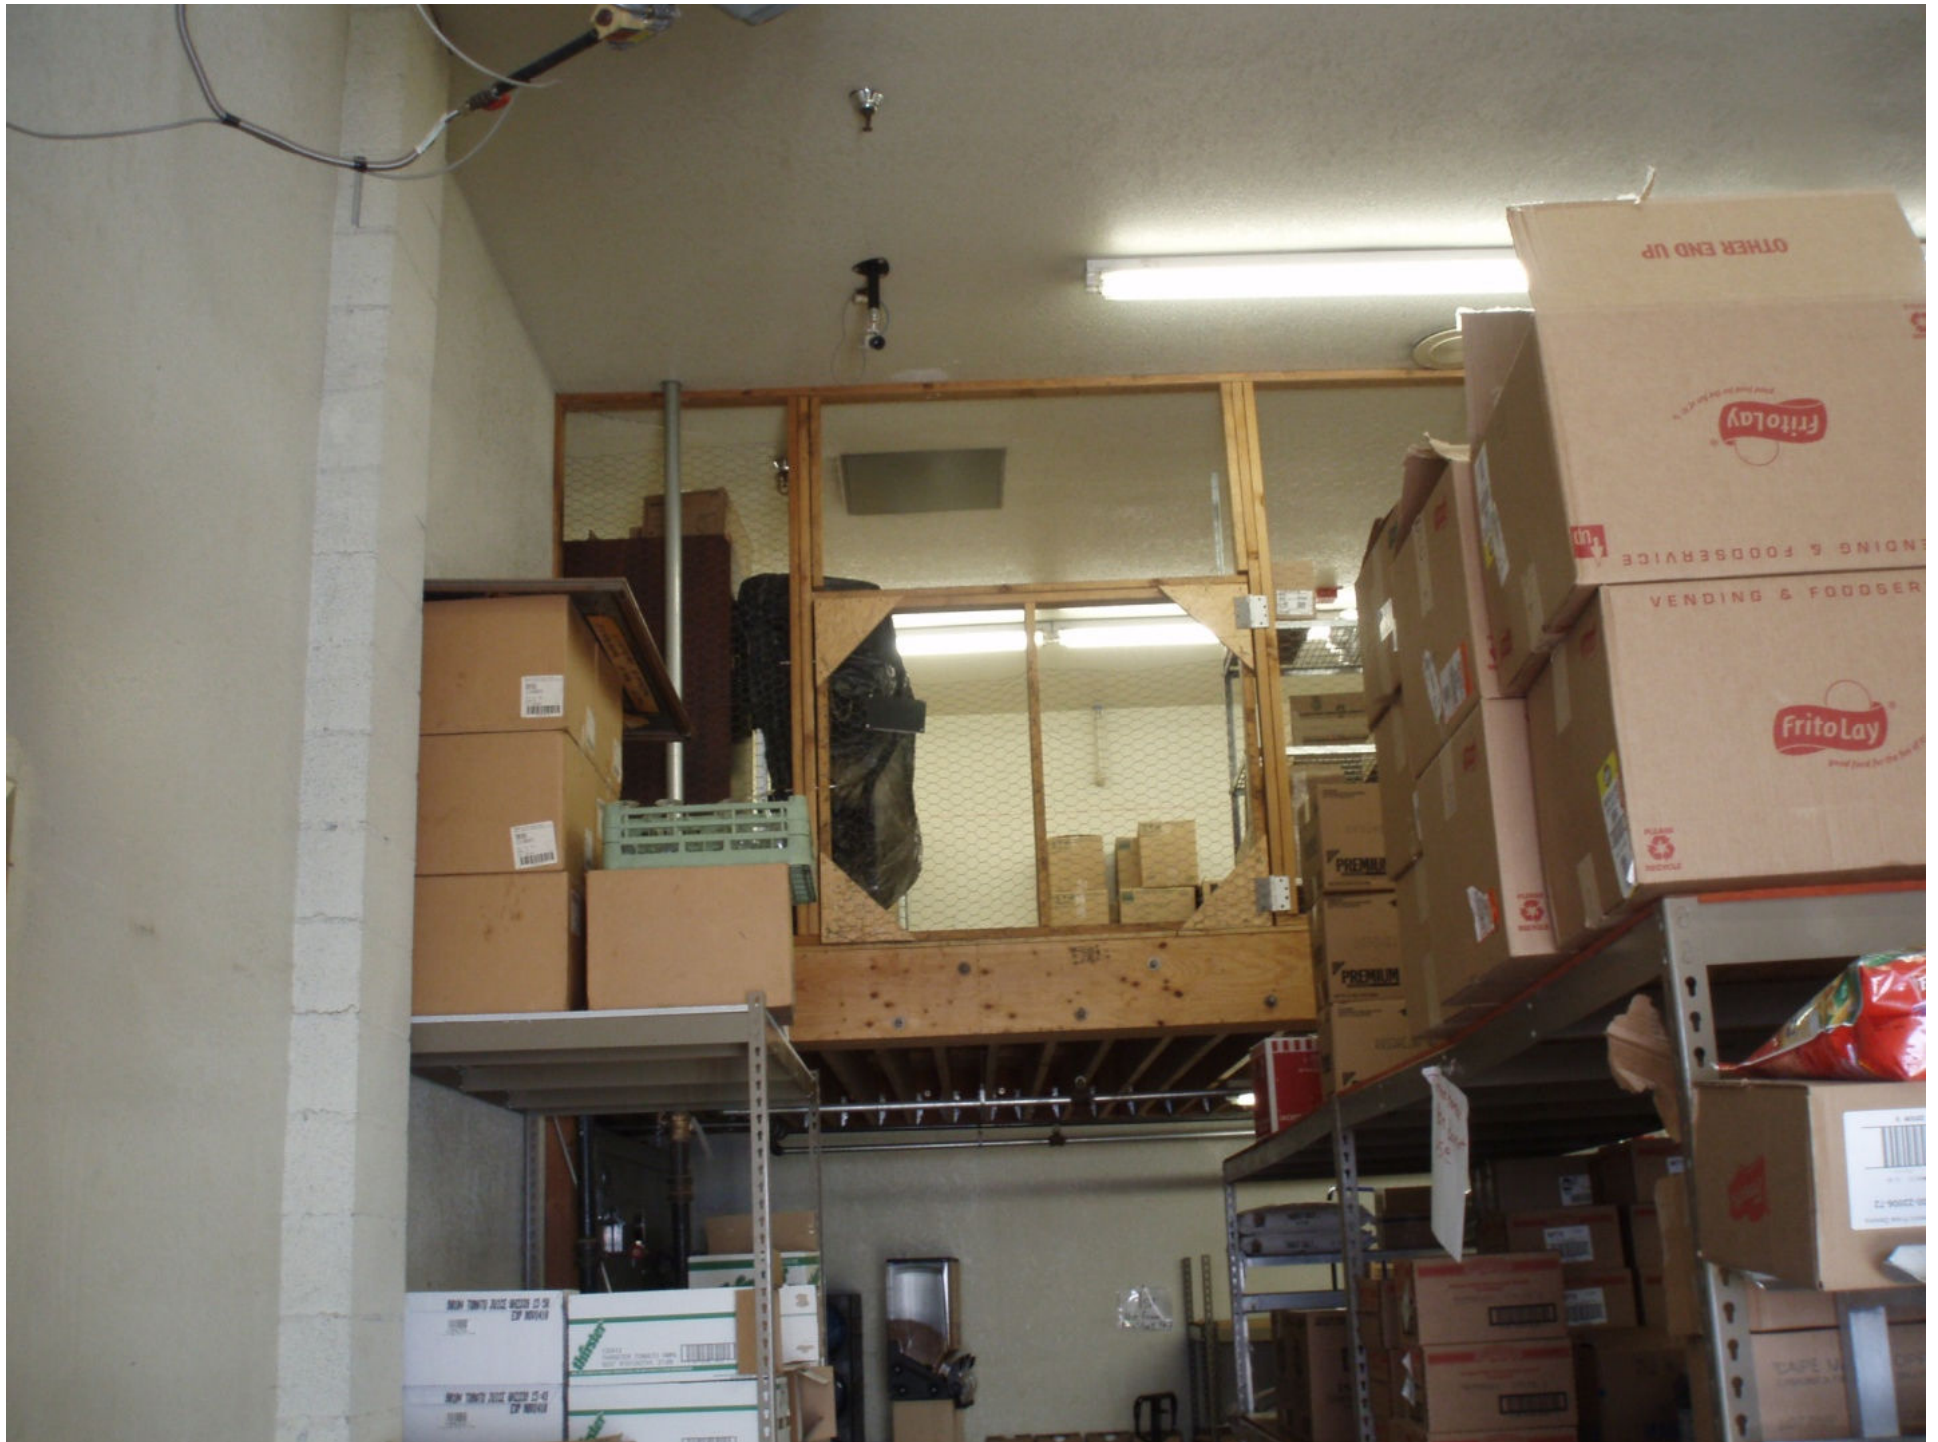
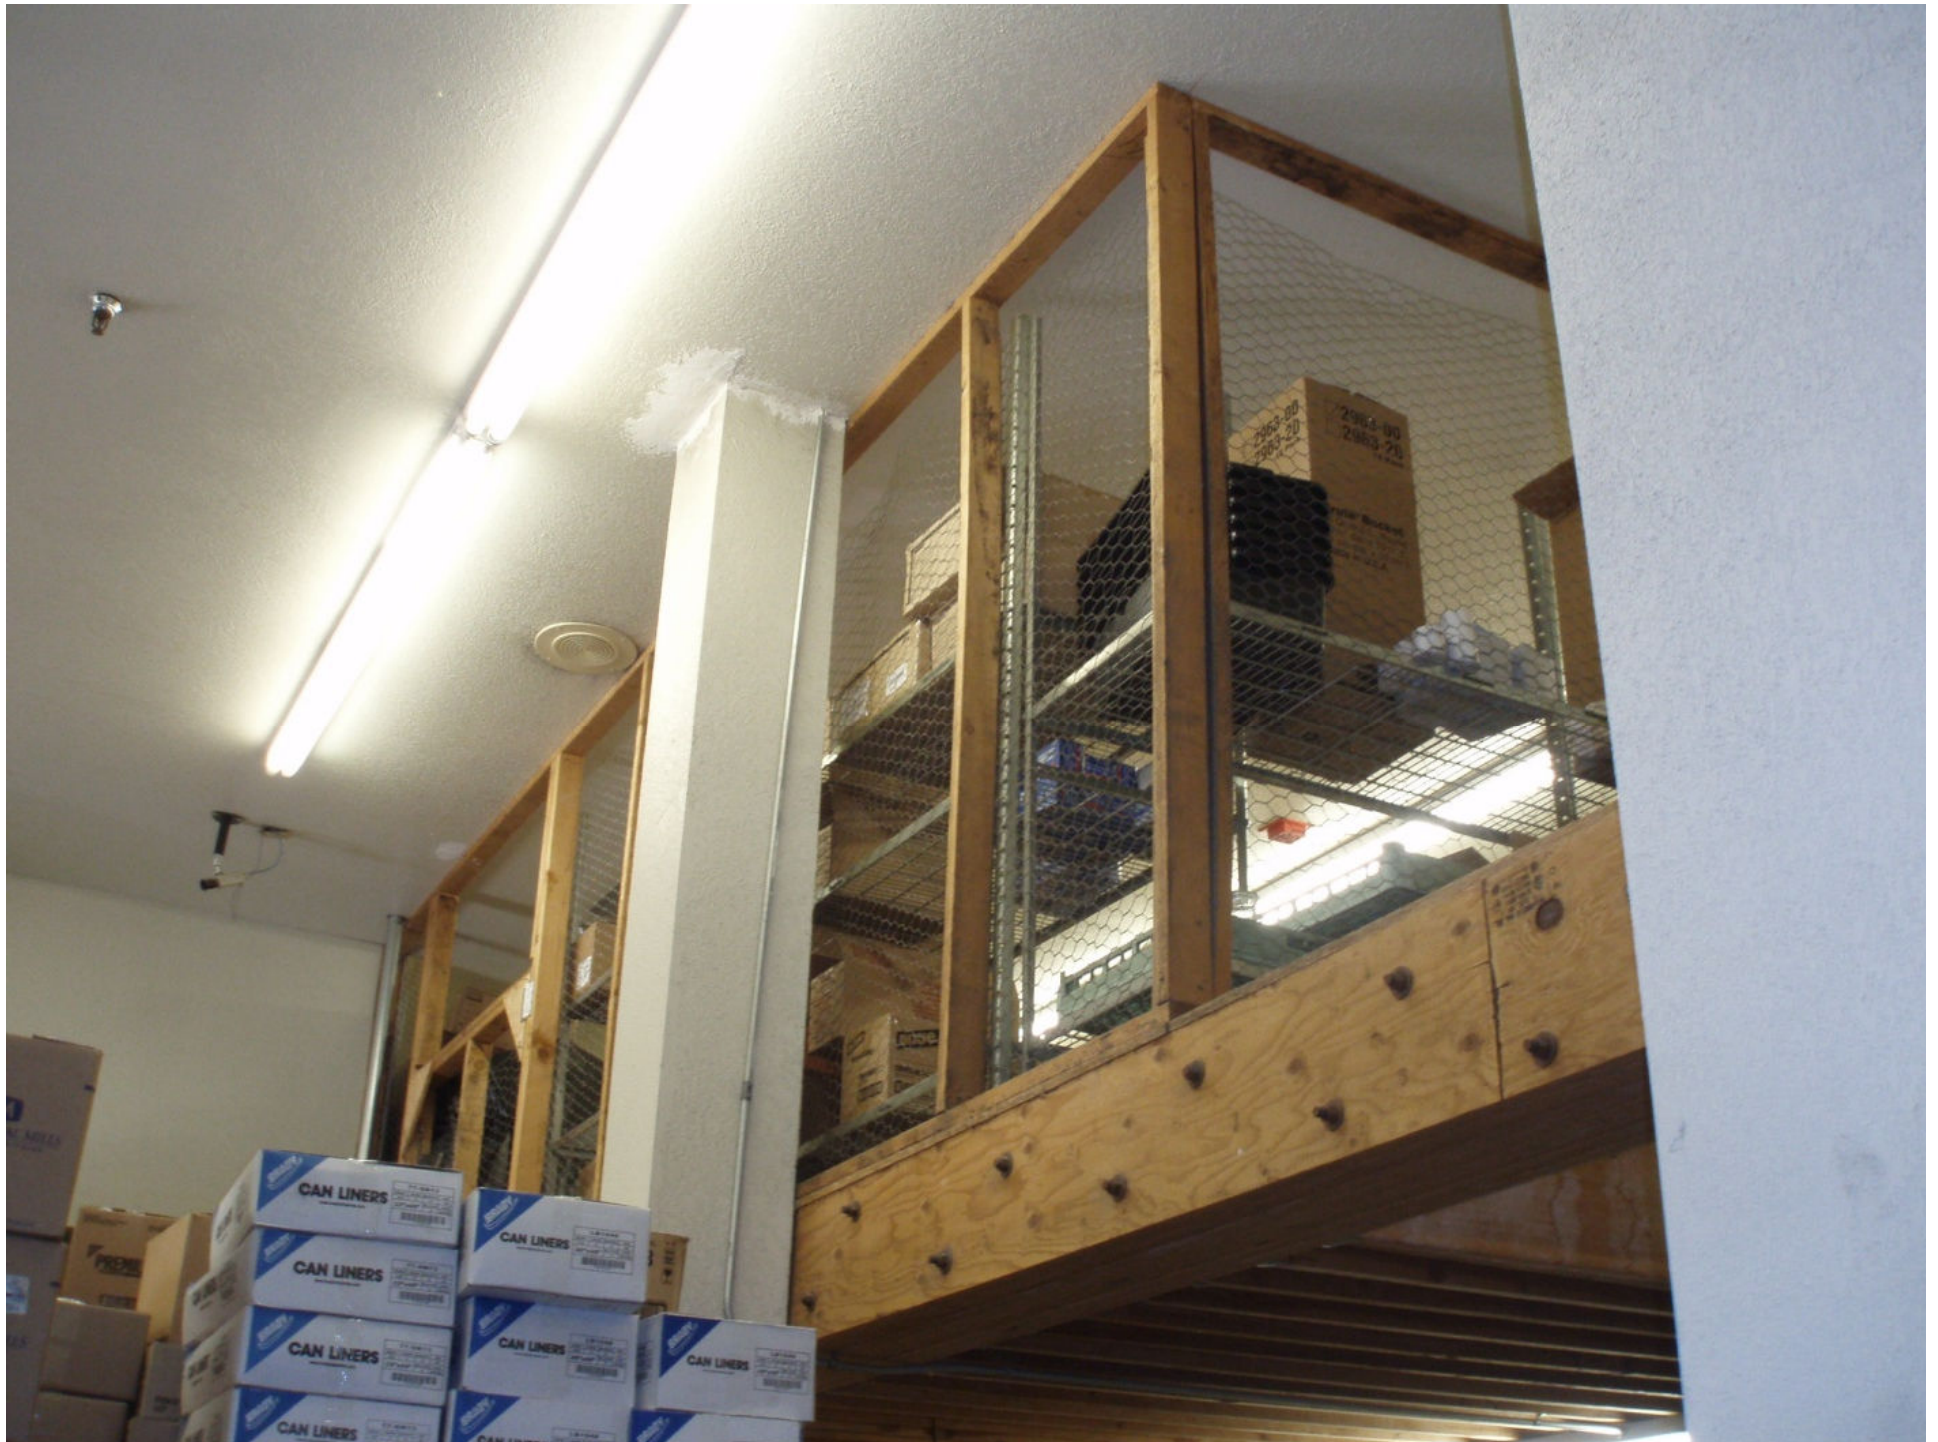
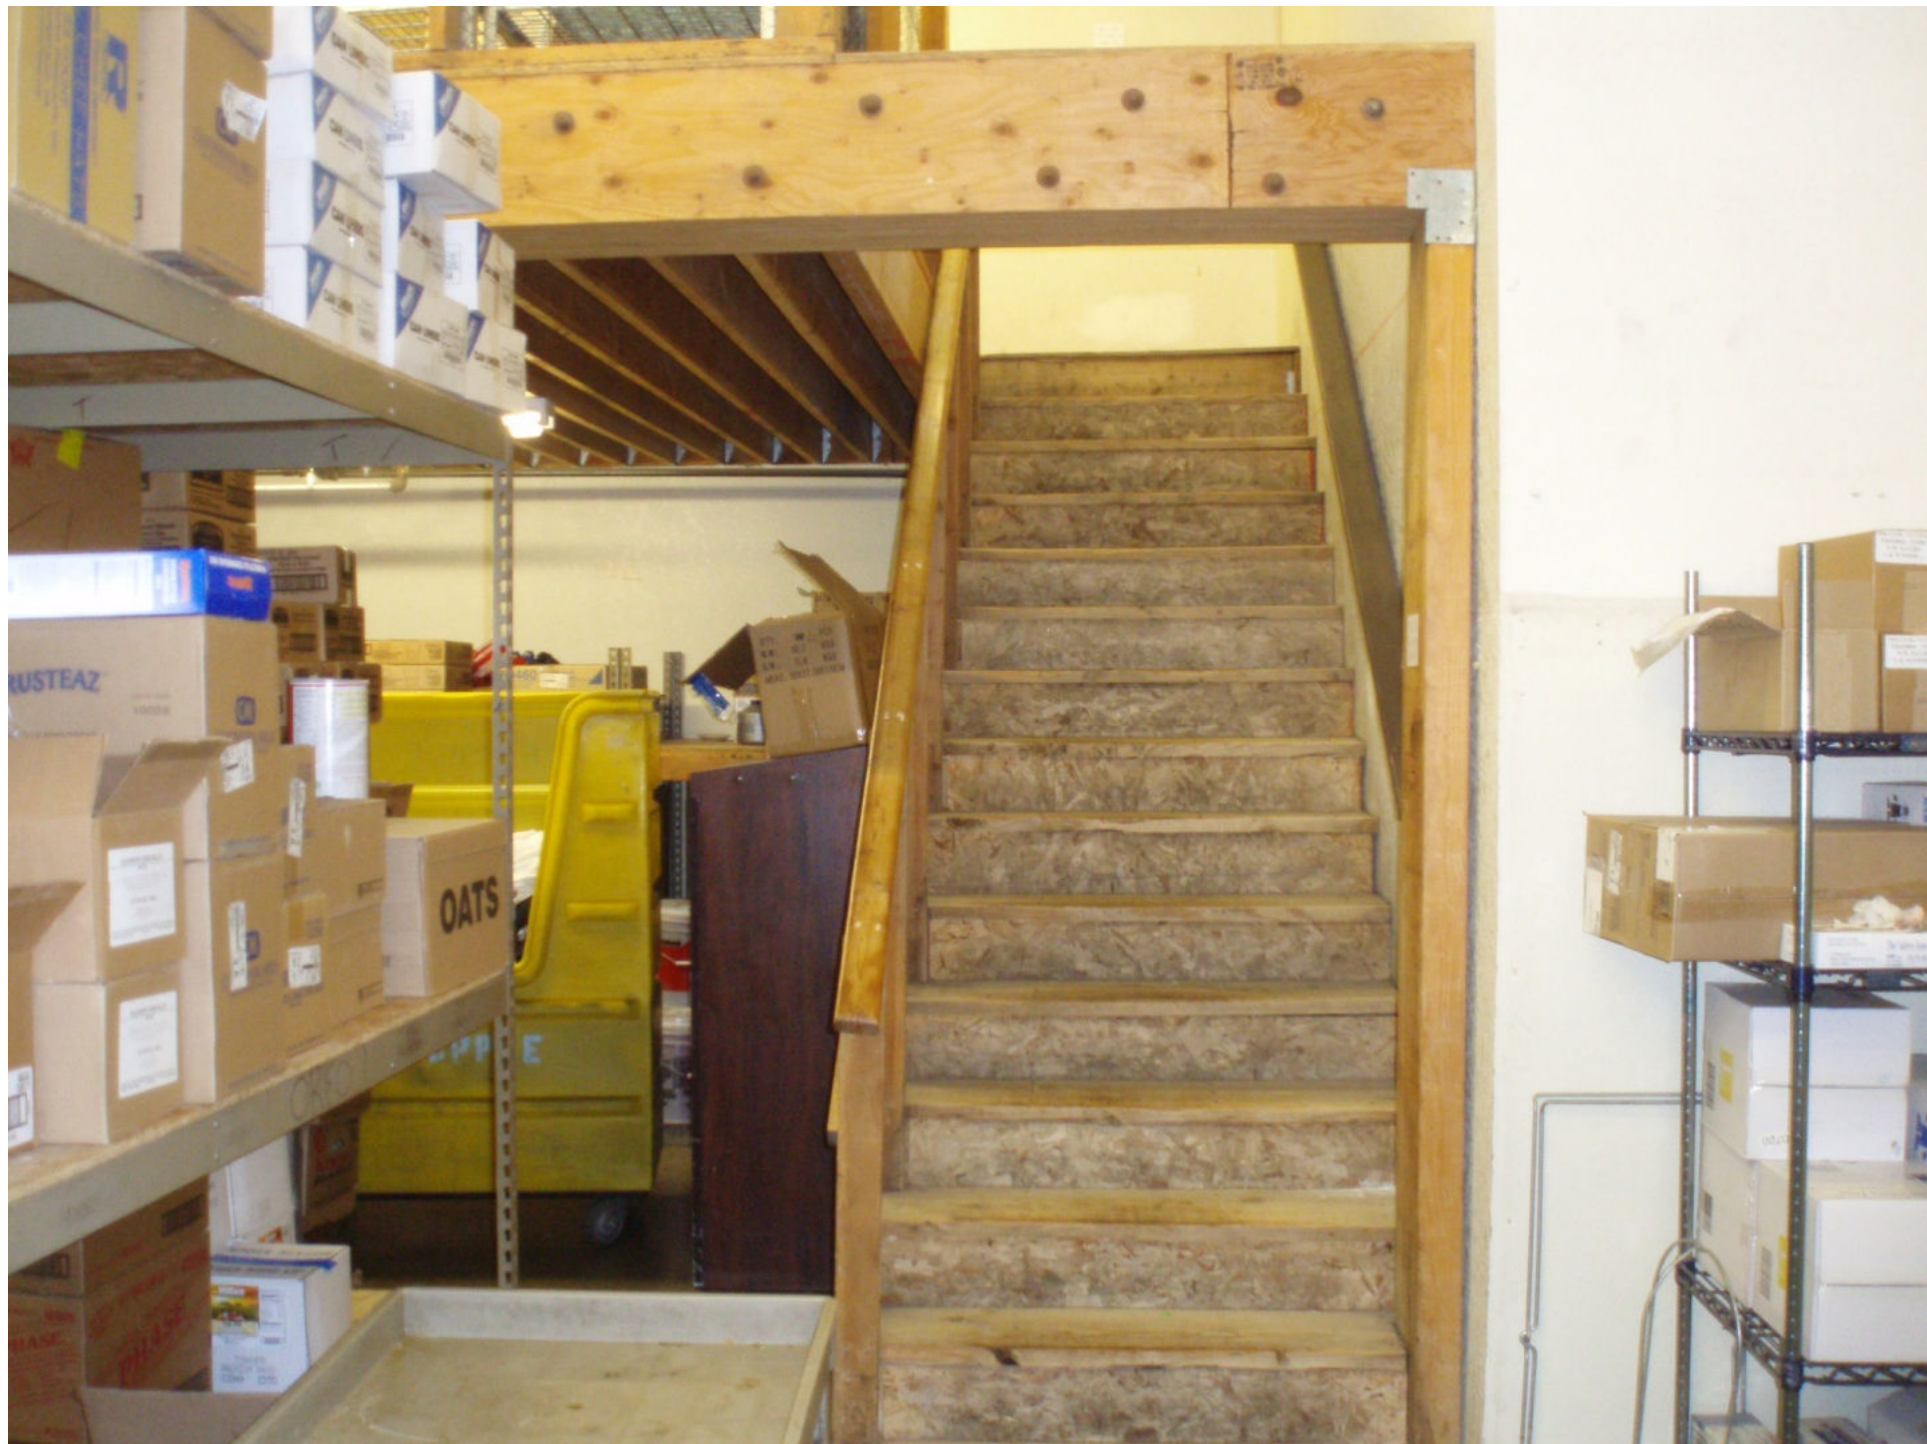
Combustible Construction in Non-Combustible Buildings

Wood room constructed for comm
equipment w/o permits. Basement
HK storage area.
