CONSTRUCTION WITHOUT OVERSIGHT

Douglas H. Evans, P.E., FSFPE
DHE FPE LLC
Las Vegas, NV

In 2008, Clark County Building Department instituted a rigorous inspections program to uncover unreported building code violations in the existing resorts on the world-famous Las Vegas Strip. The violations discovered were primarily due to substantial work conducted without permits or inspections and inadequate or improper maintenance. An overview of the various types of violations and their extent will be discussed.

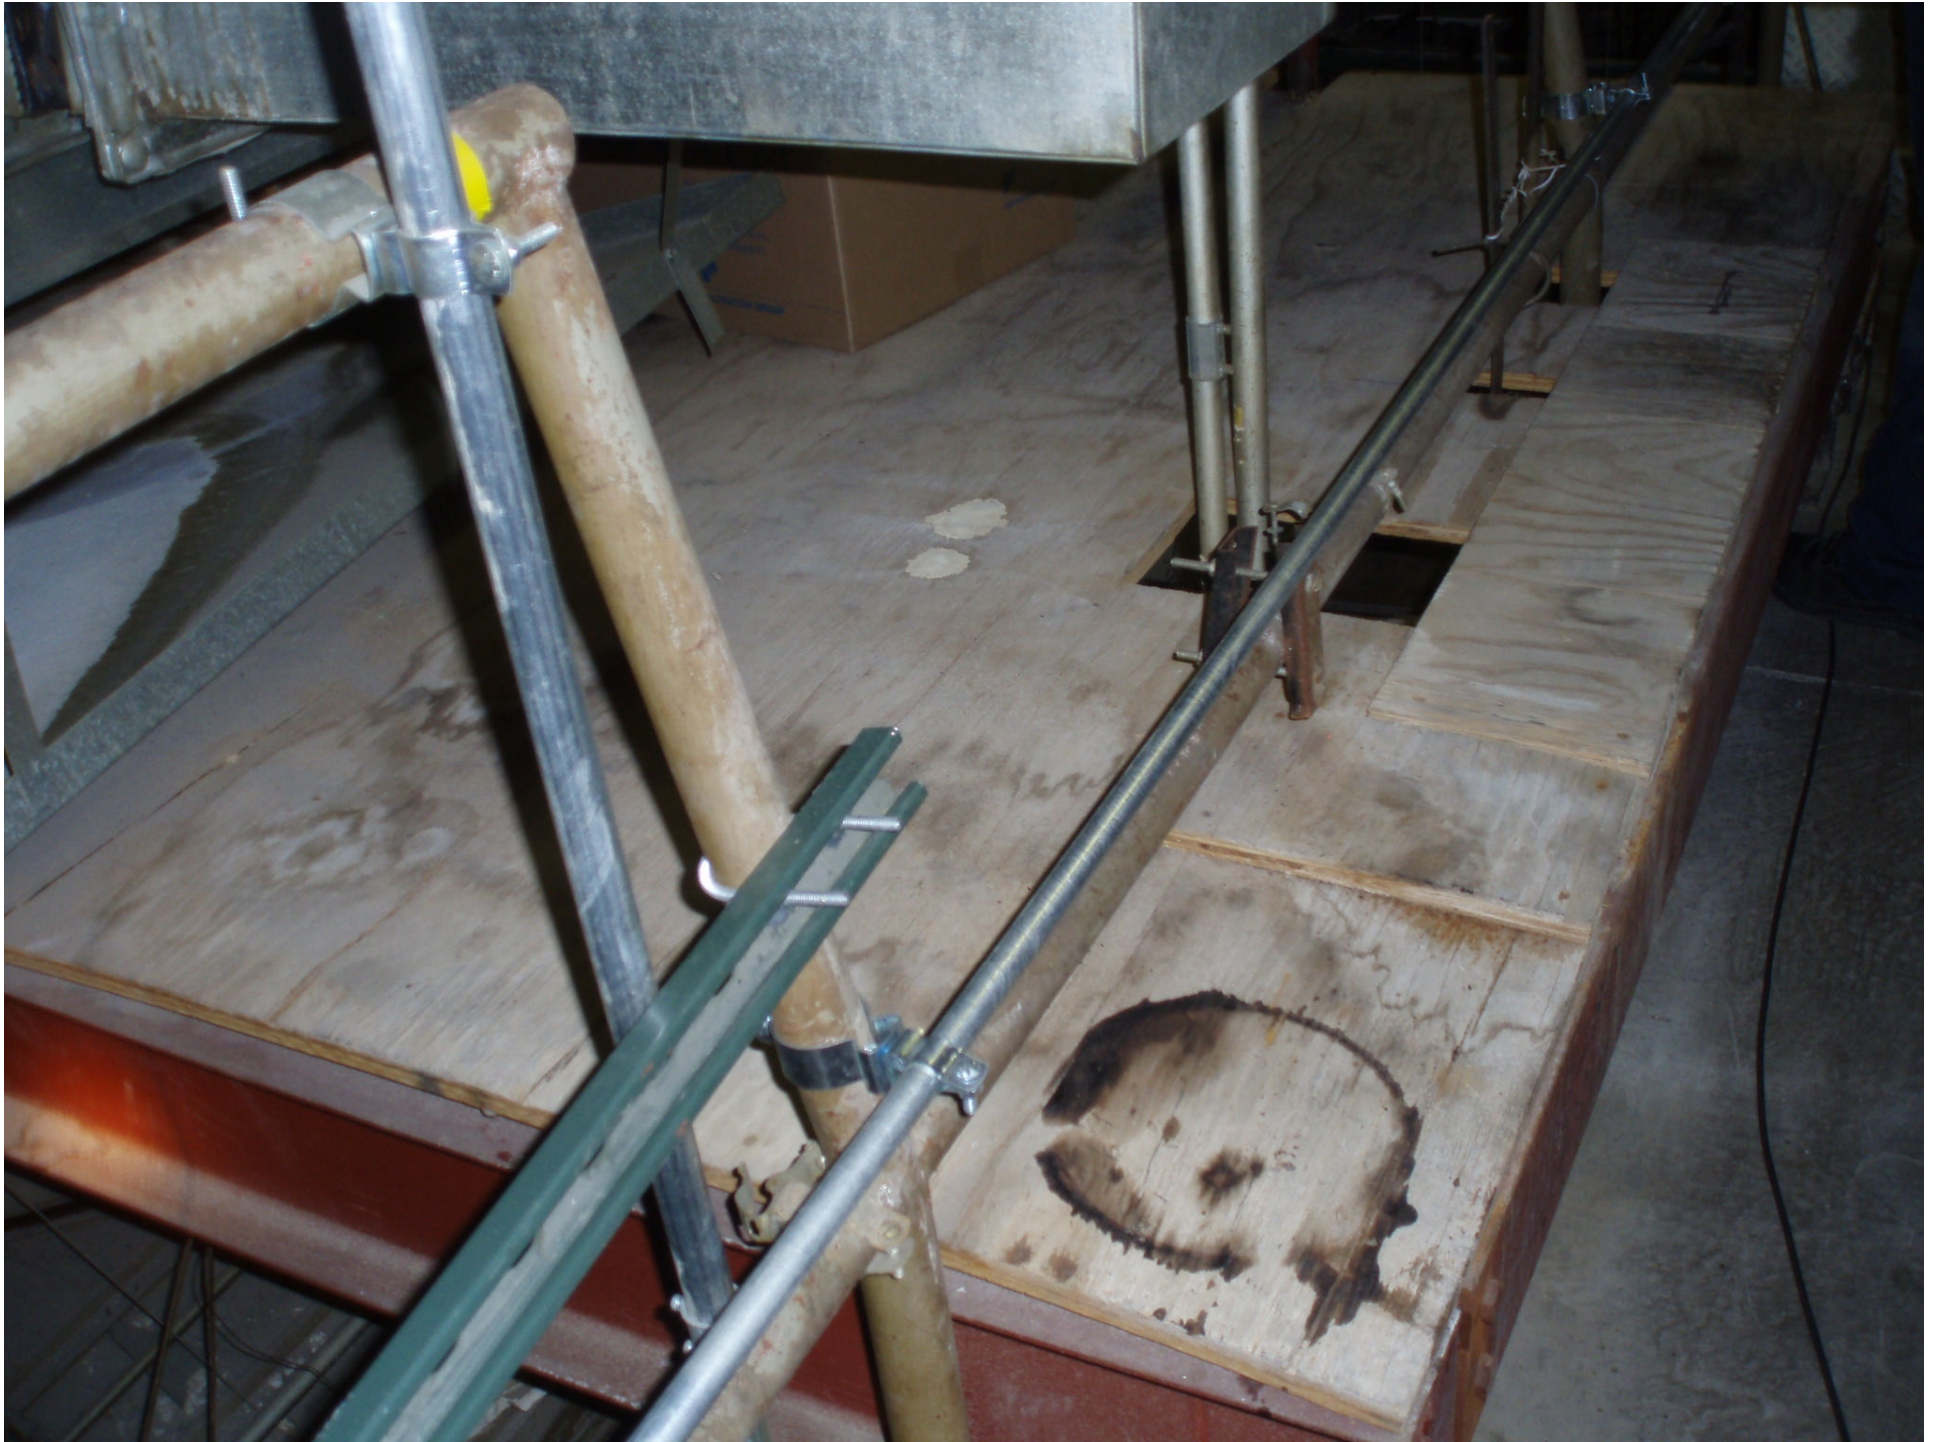
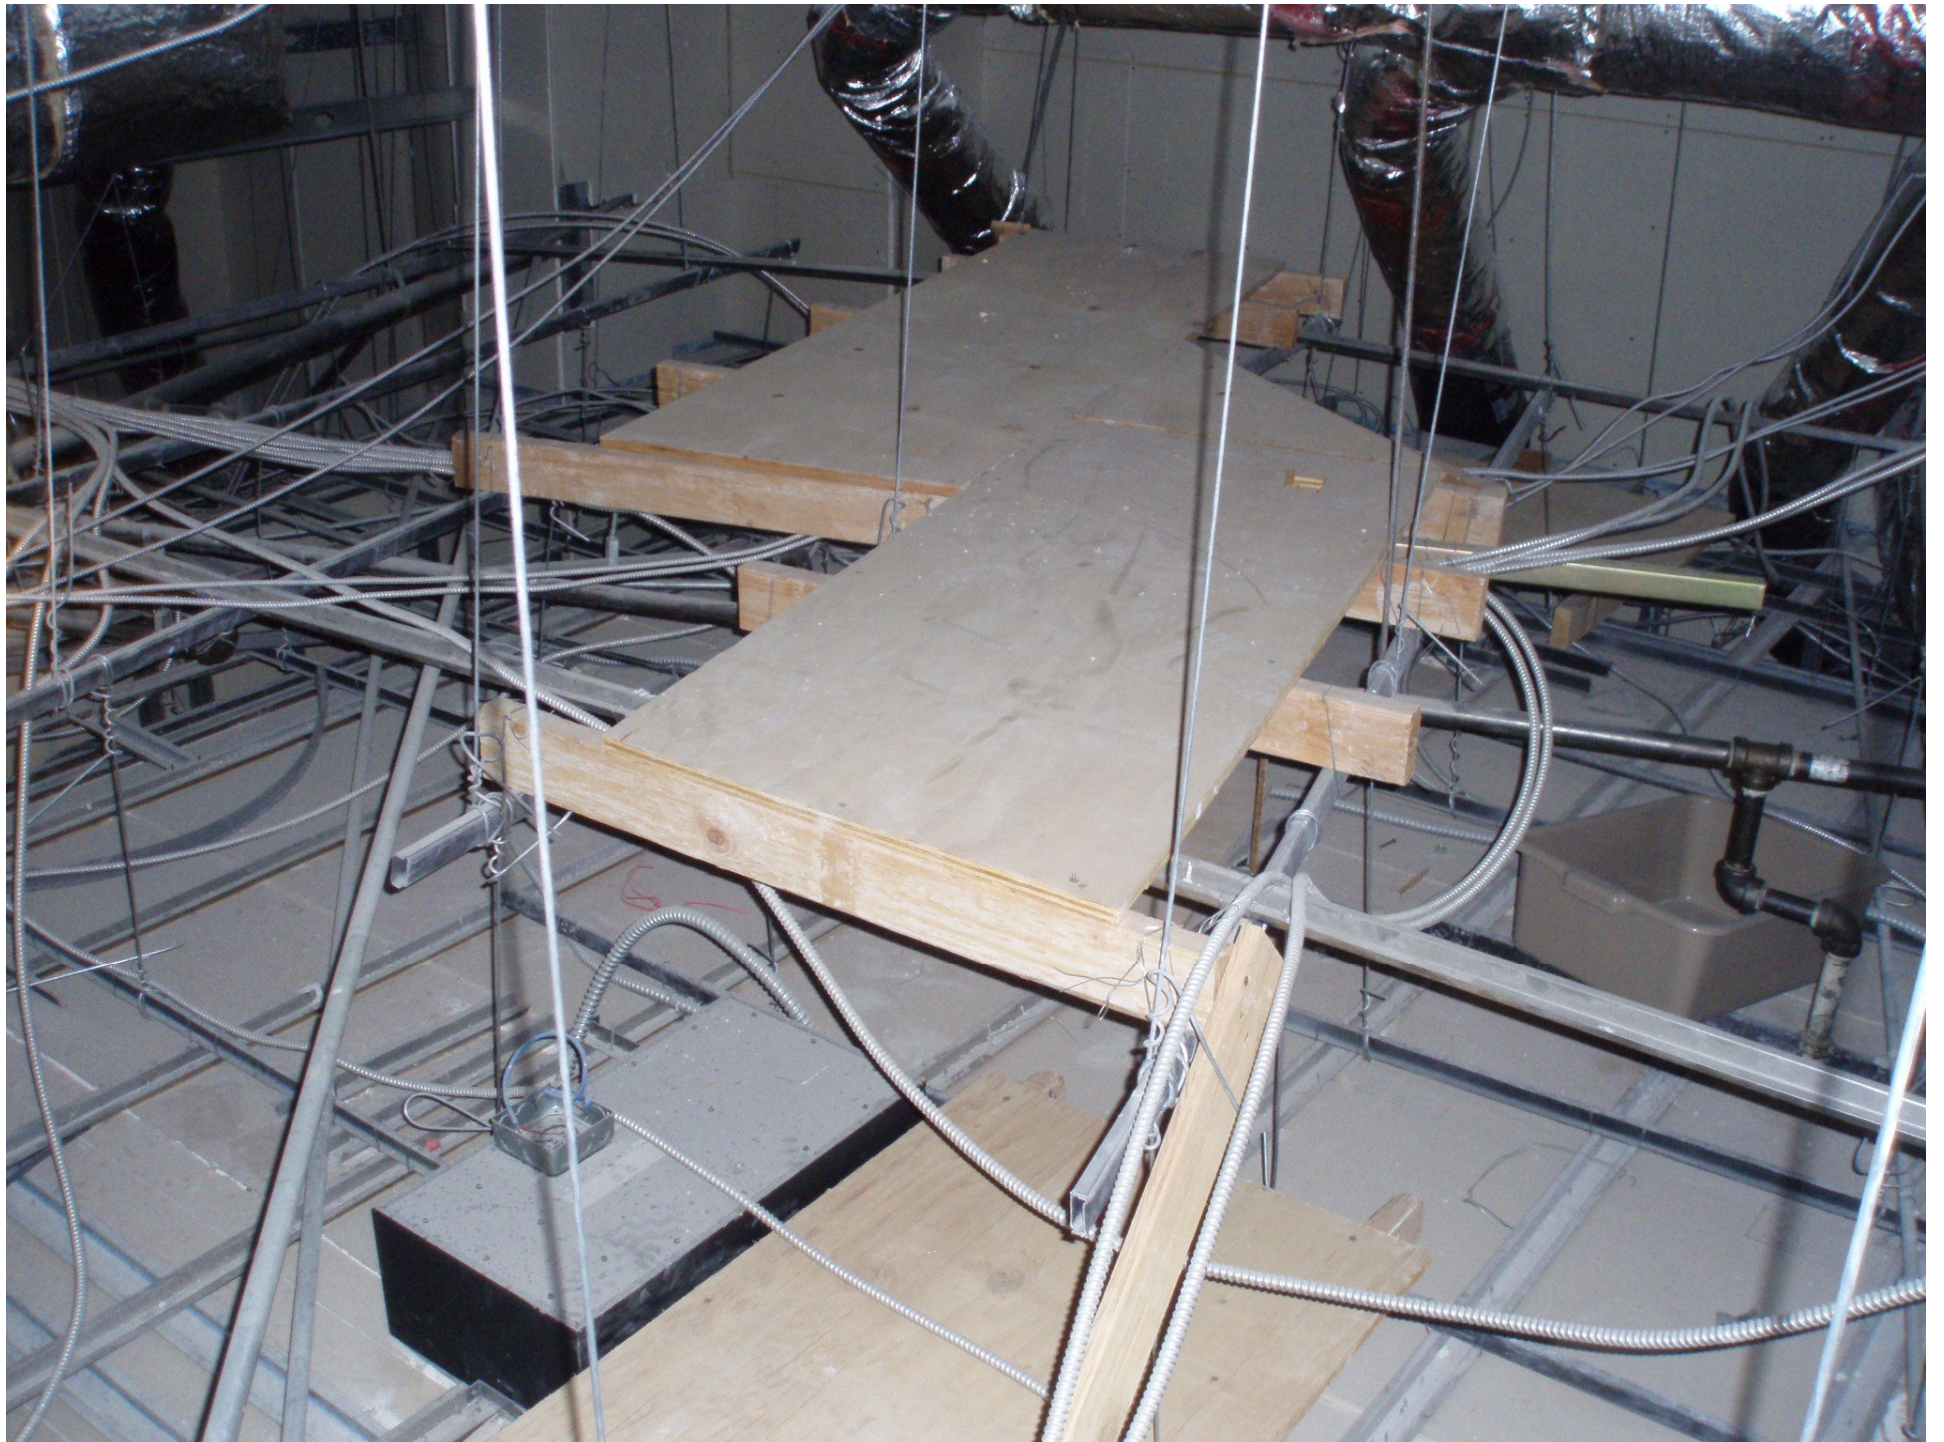
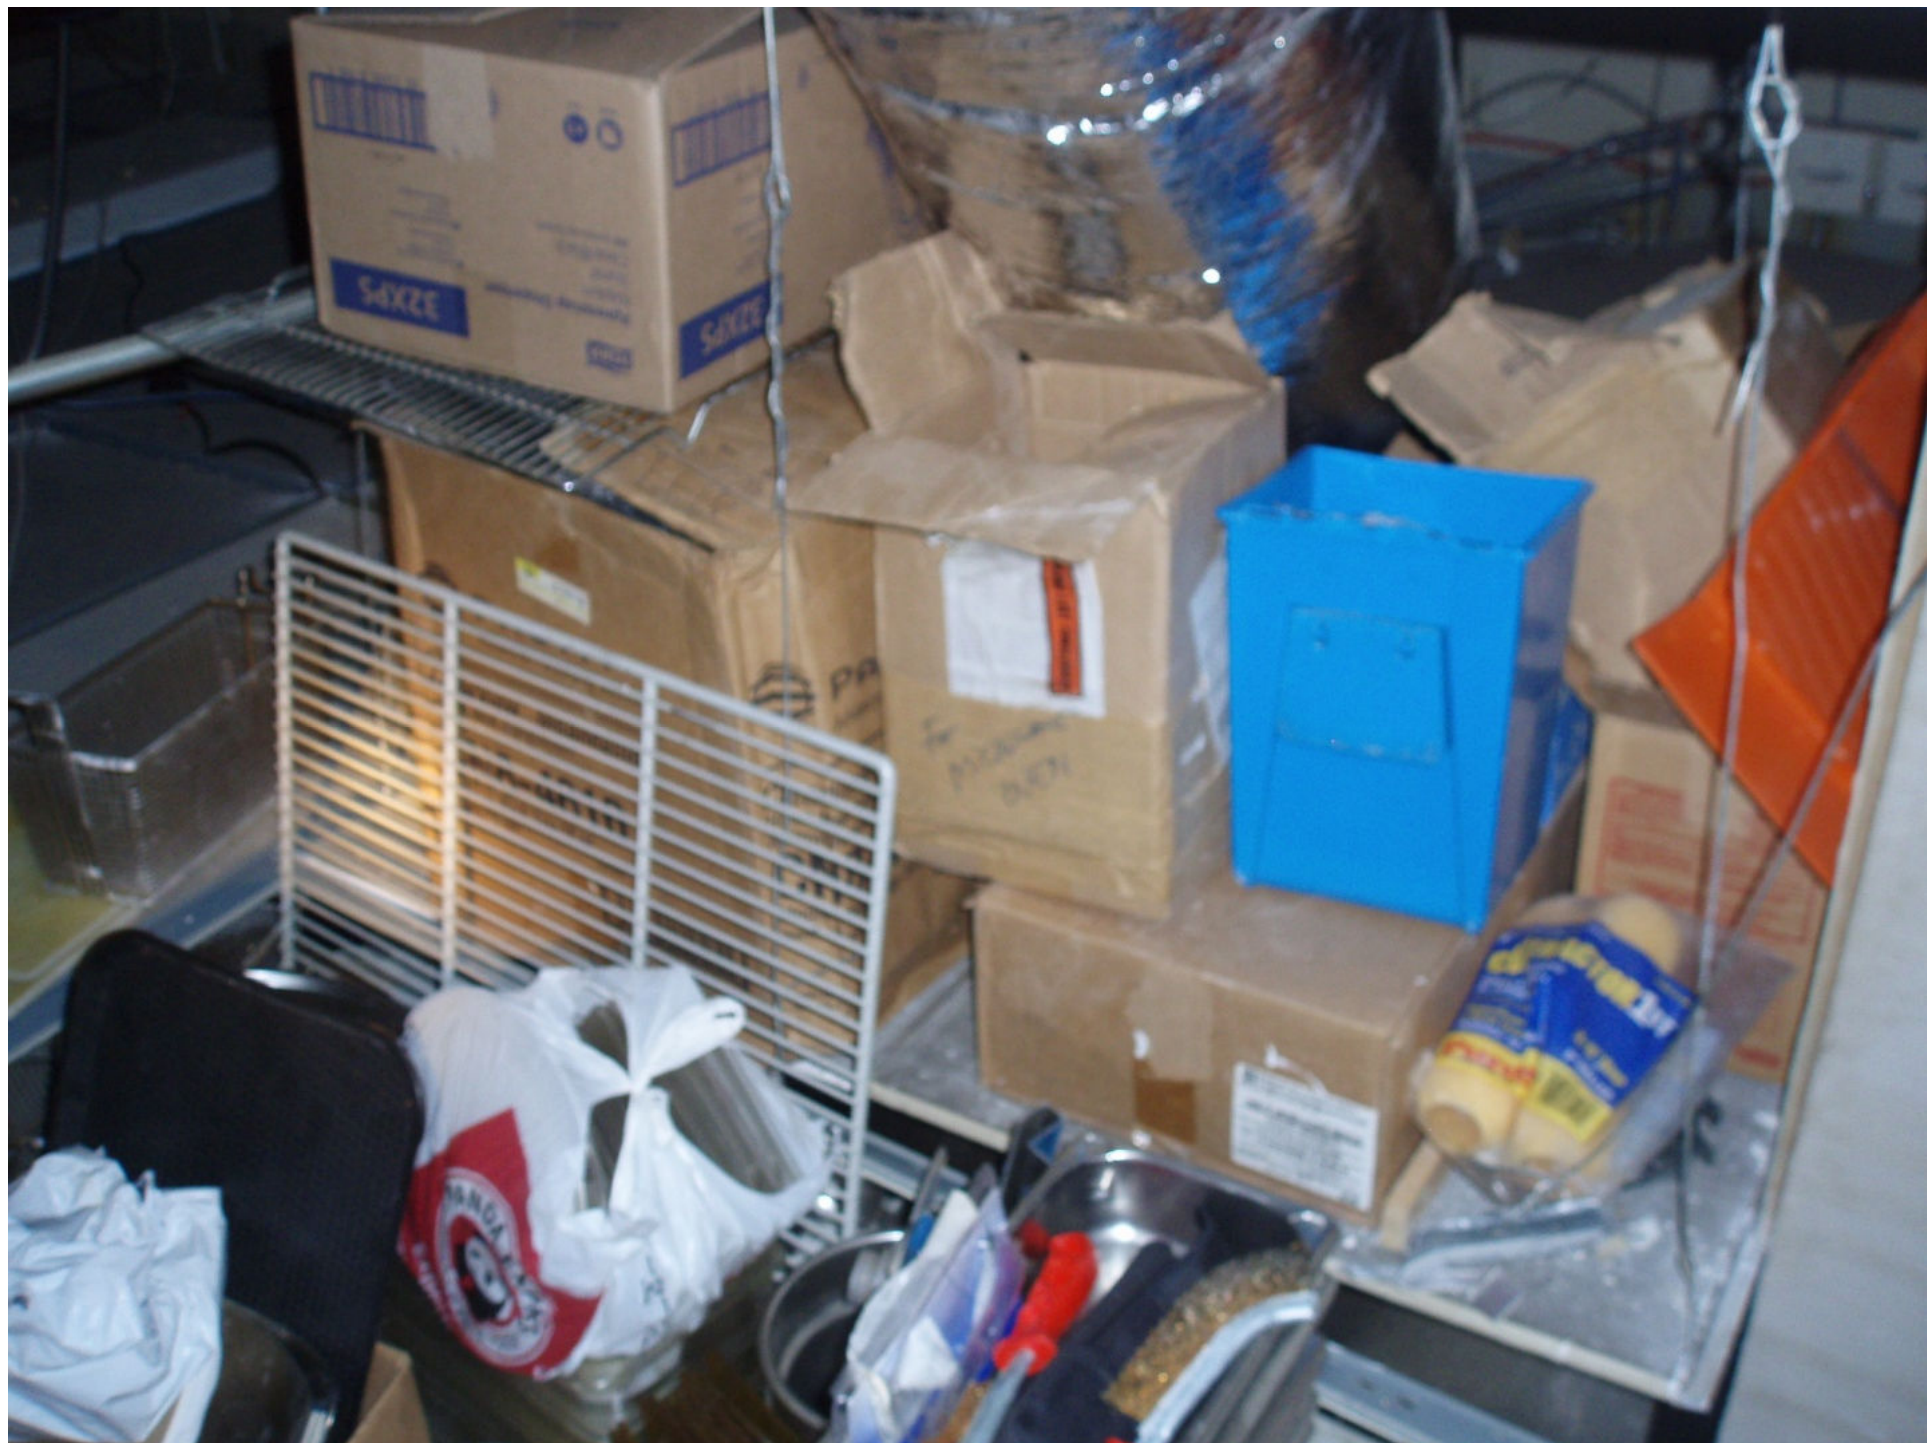
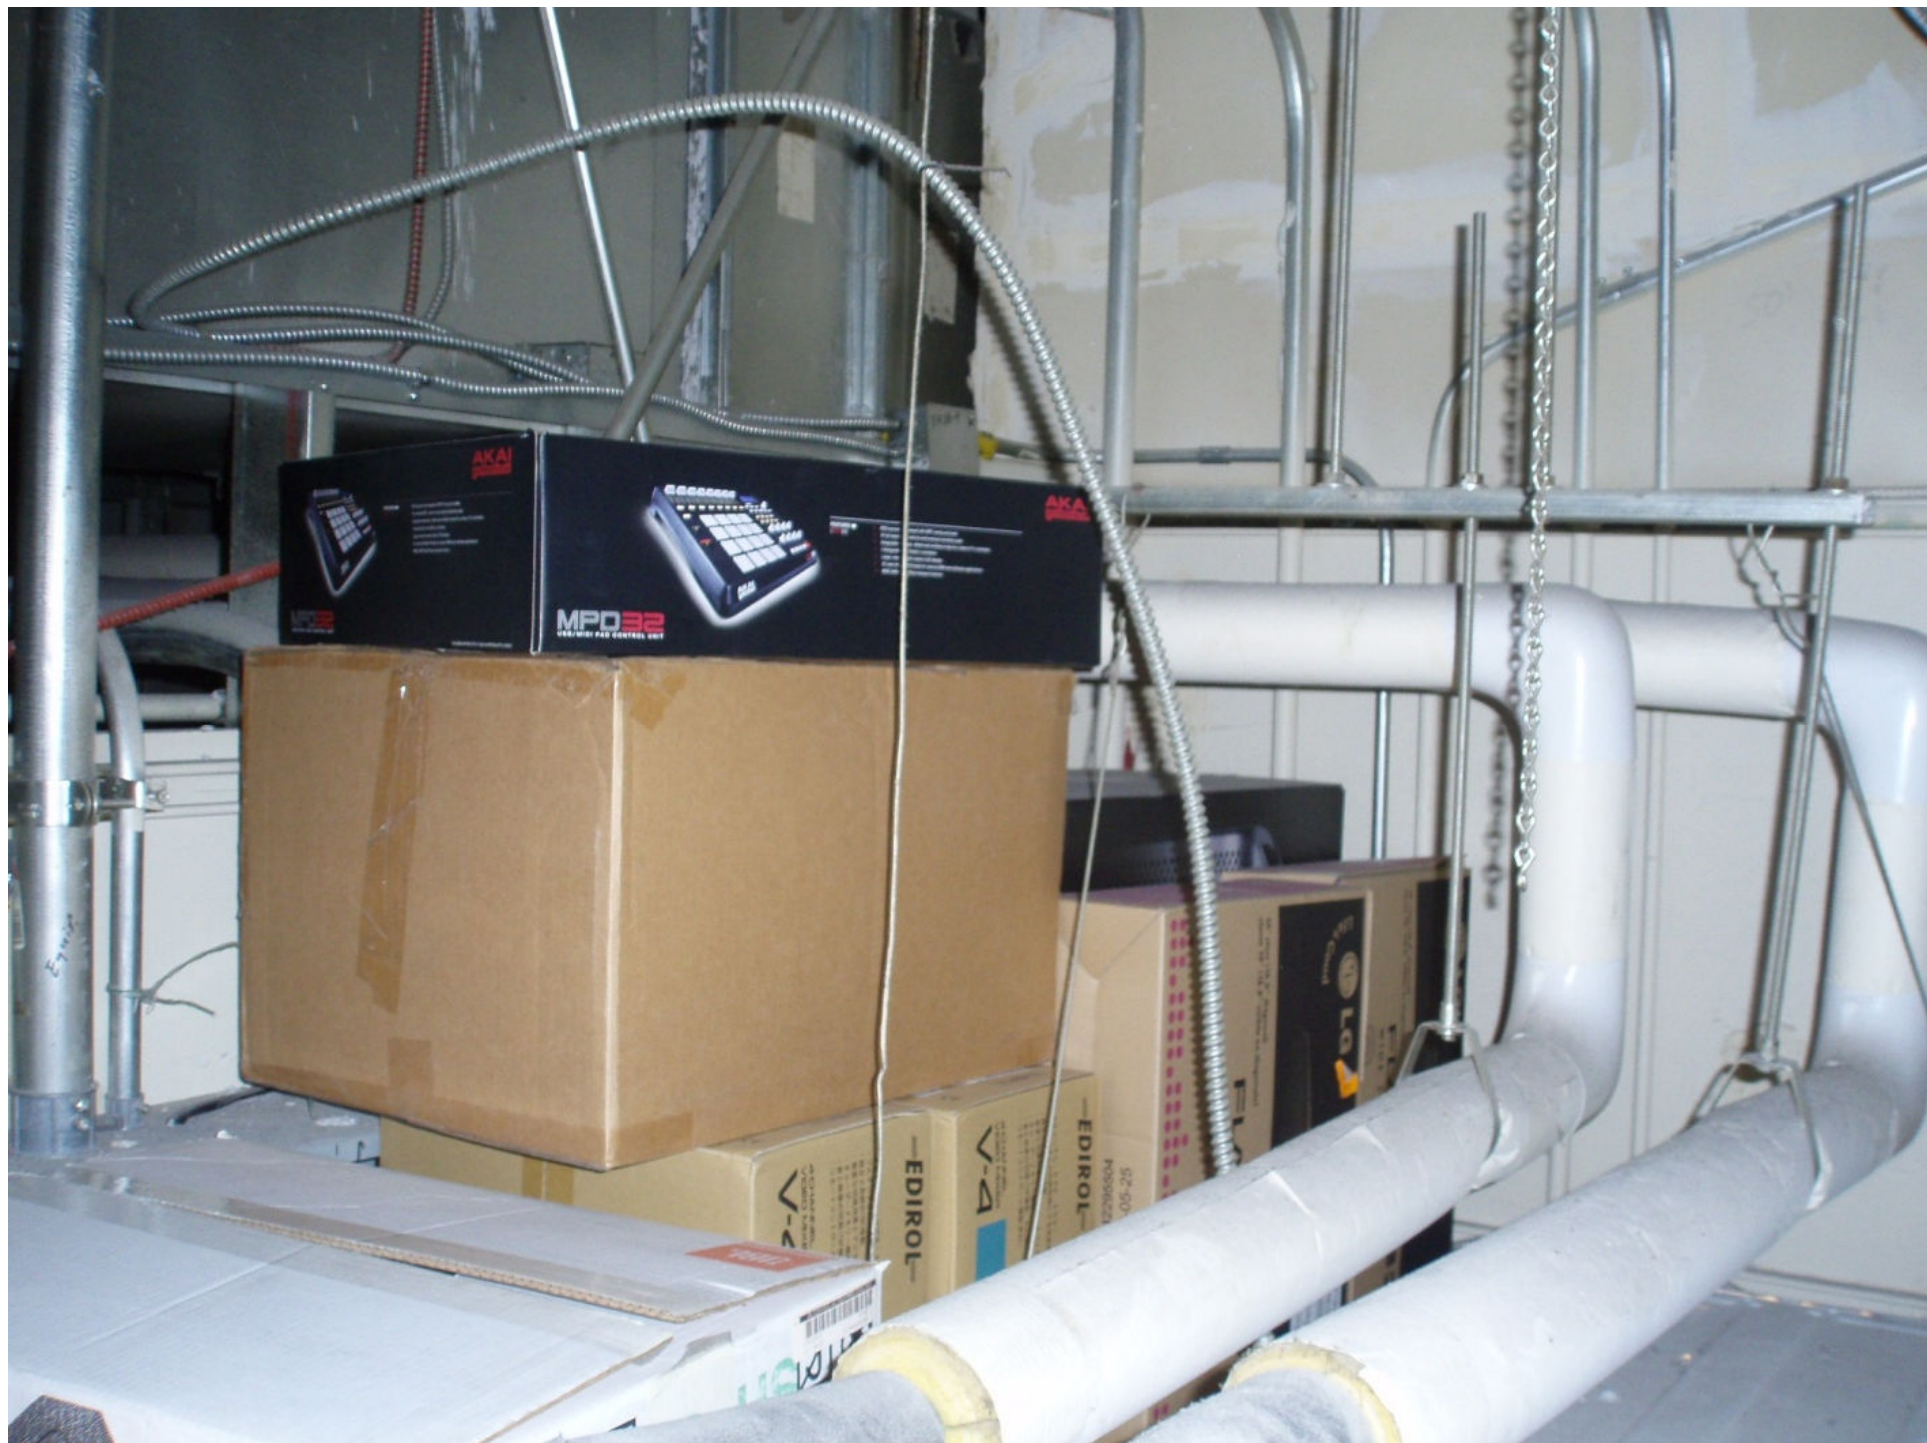
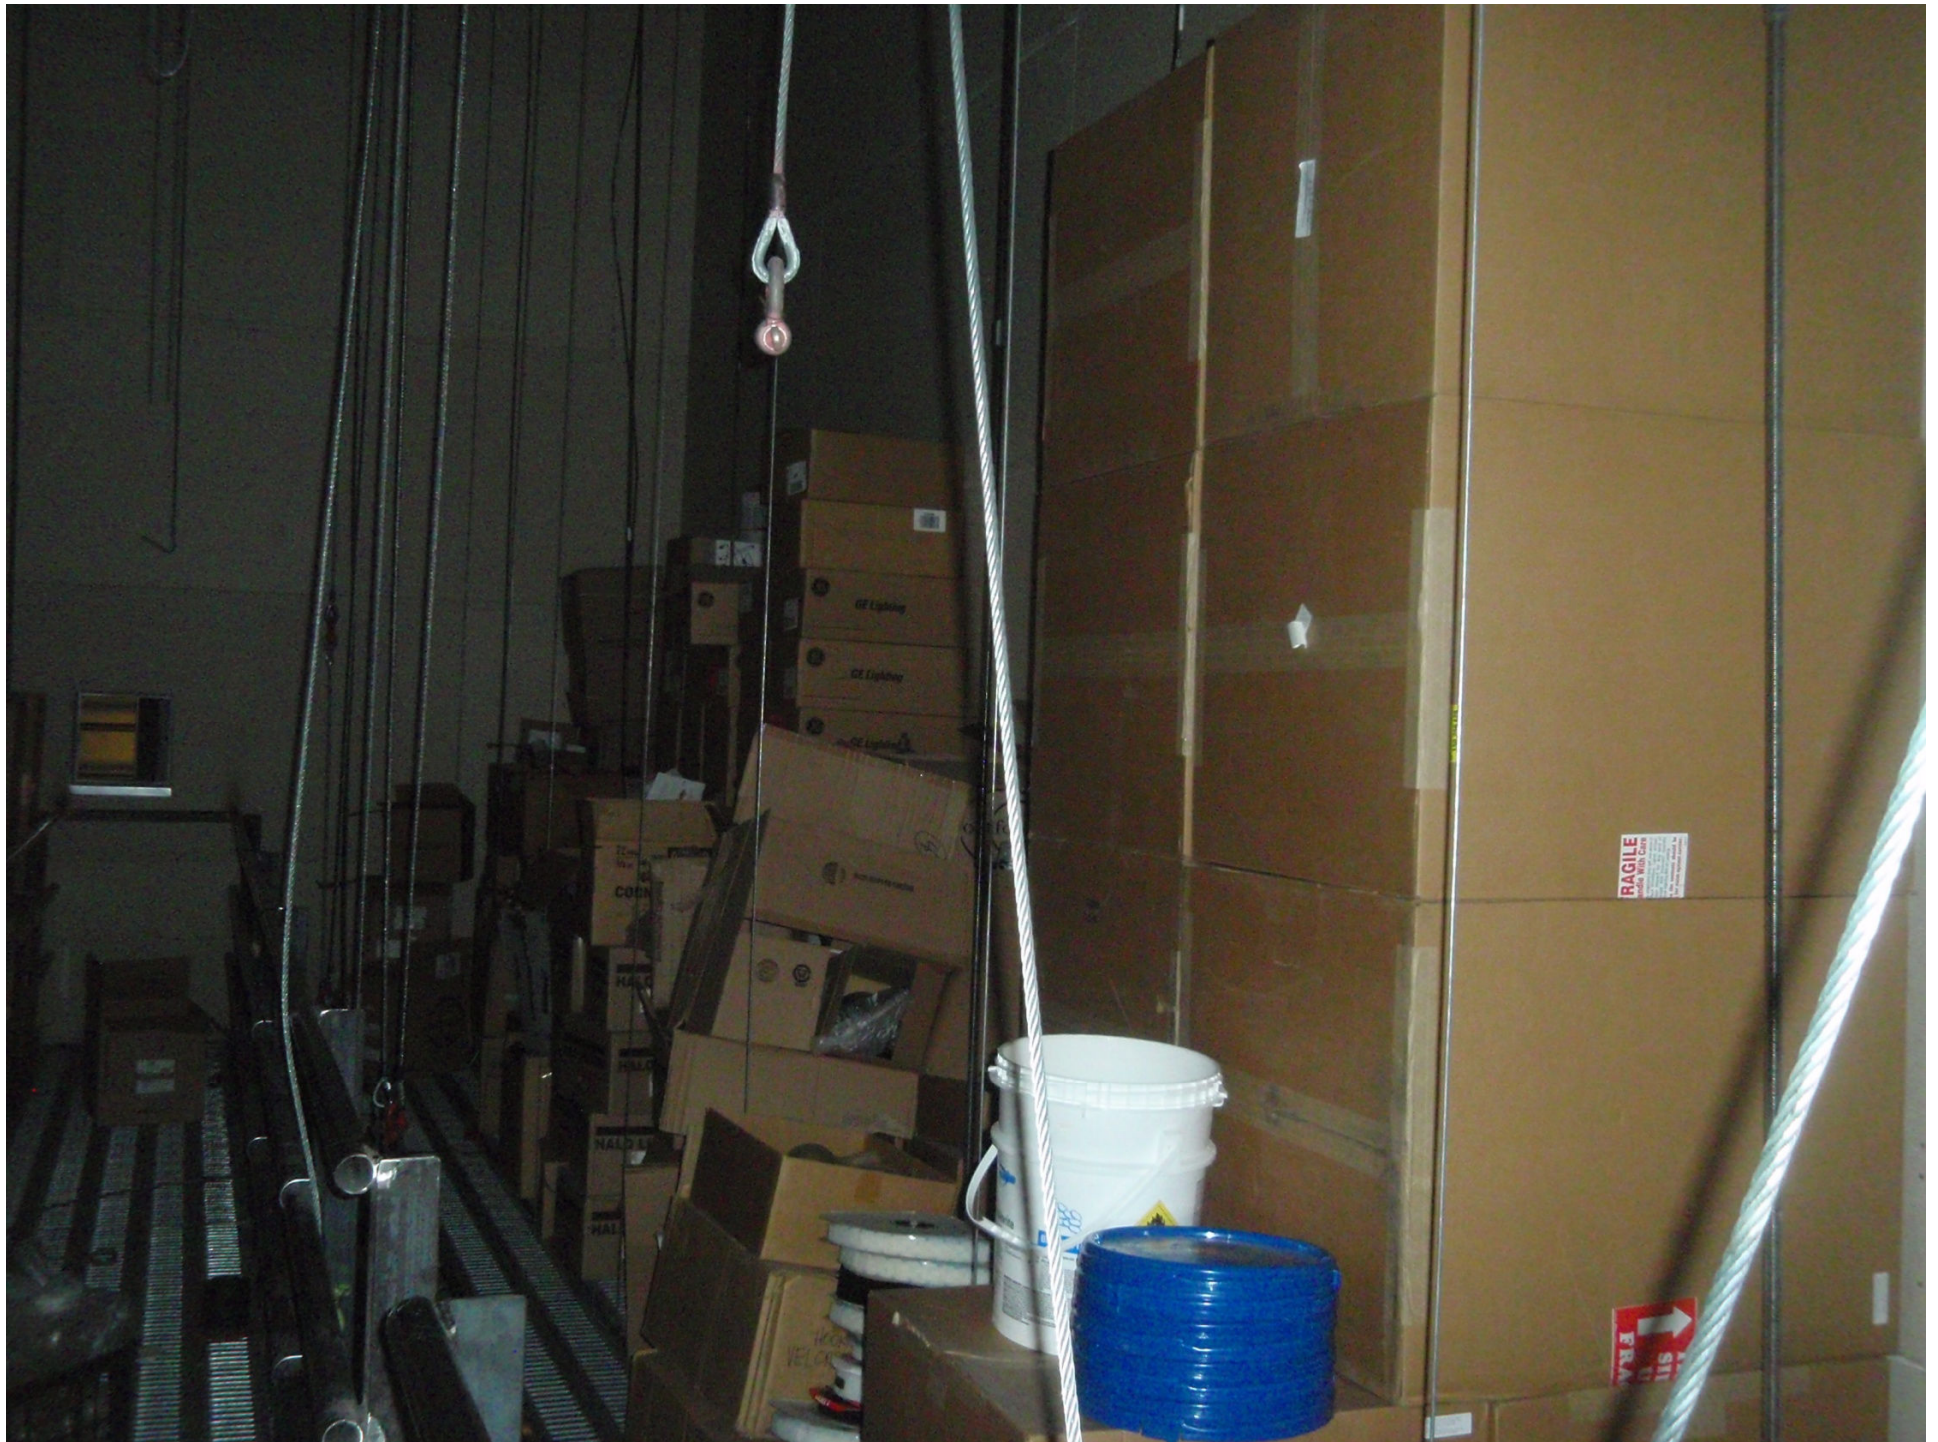
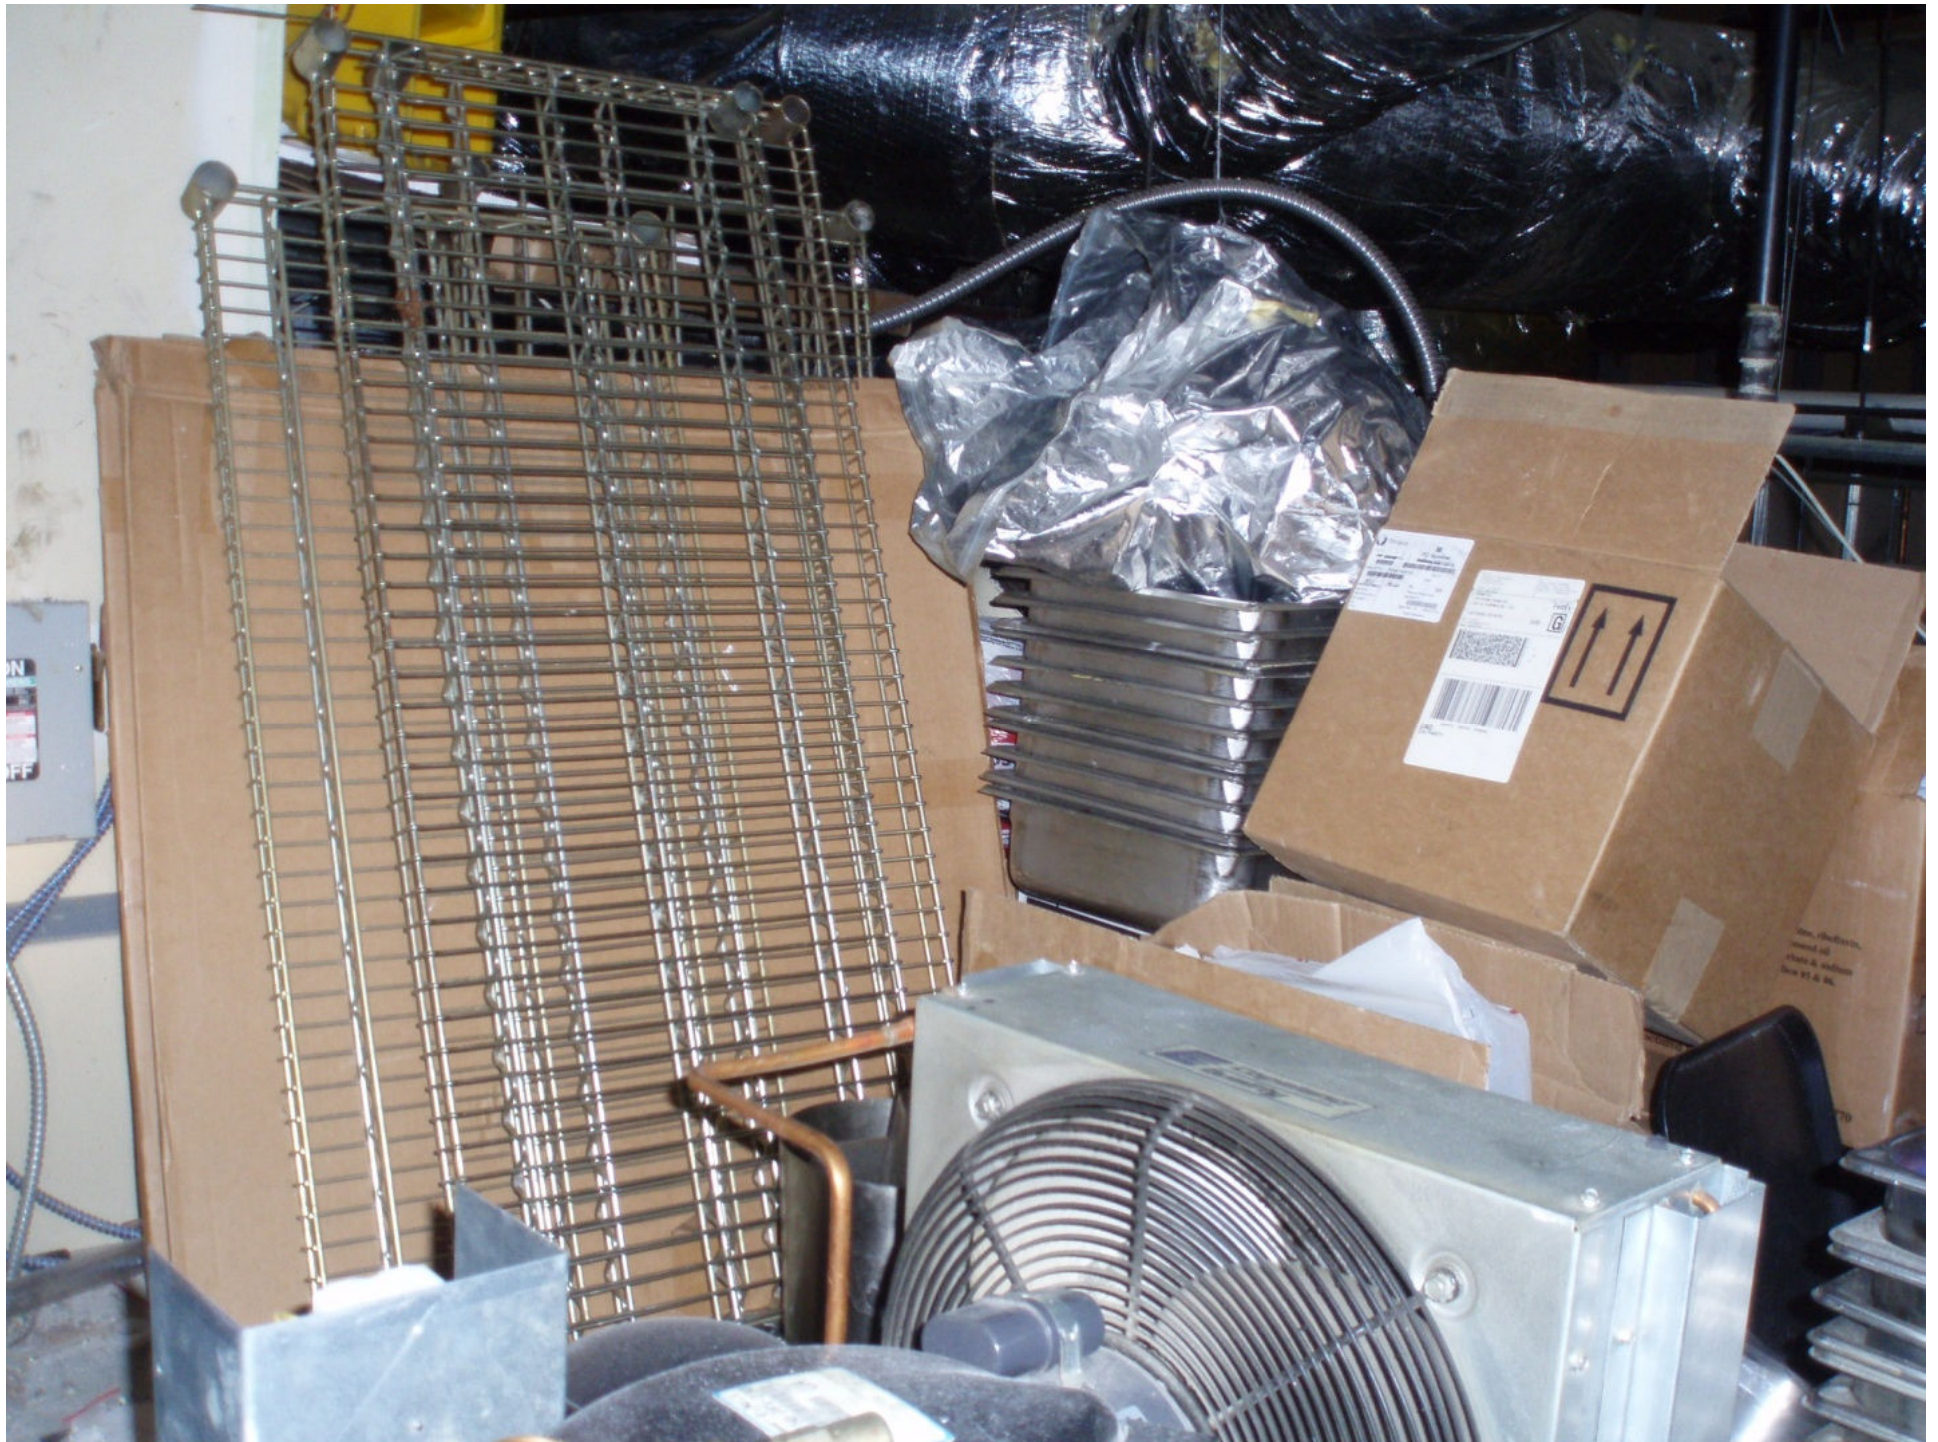
Combustibles in Plenums
