CONSTRUCTION WITHOUT OVERSIGHT

Douglas H. Evans, P.E., FSFPE
DHE FPE LLC
Las Vegas, NV

In 2008, Clark County Building Department instituted a rigorous inspections program to uncover unreported building code violations in the existing resorts on the world-famous Las Vegas Strip. The violations discovered were primarily due to substantial work conducted without permits or inspections and inadequate or improper maintenance. An overview of the various types of violations and their extent will be discussed.

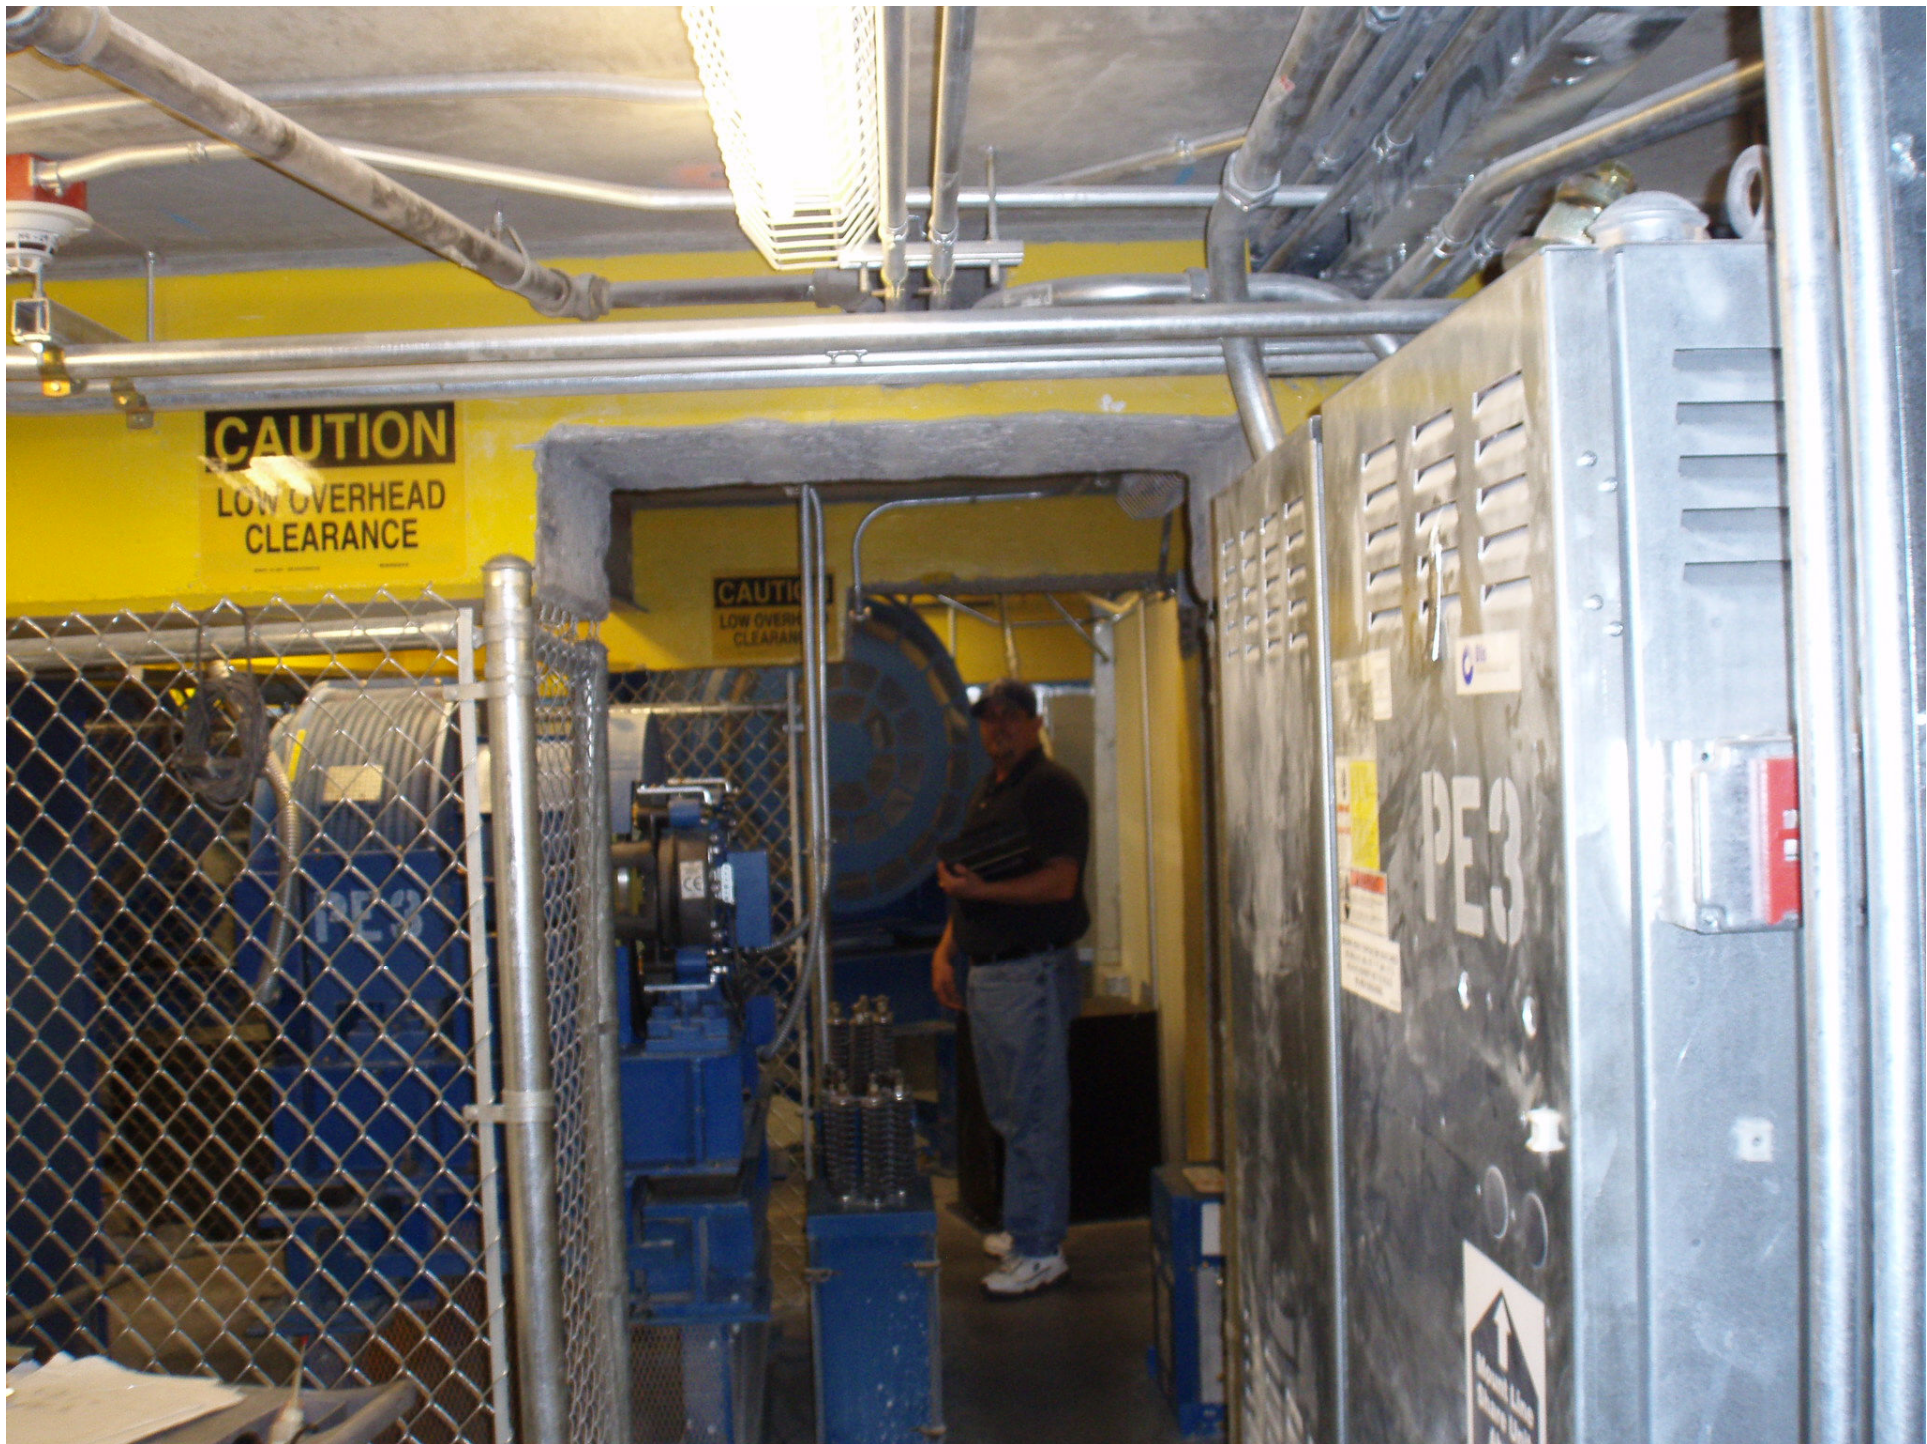
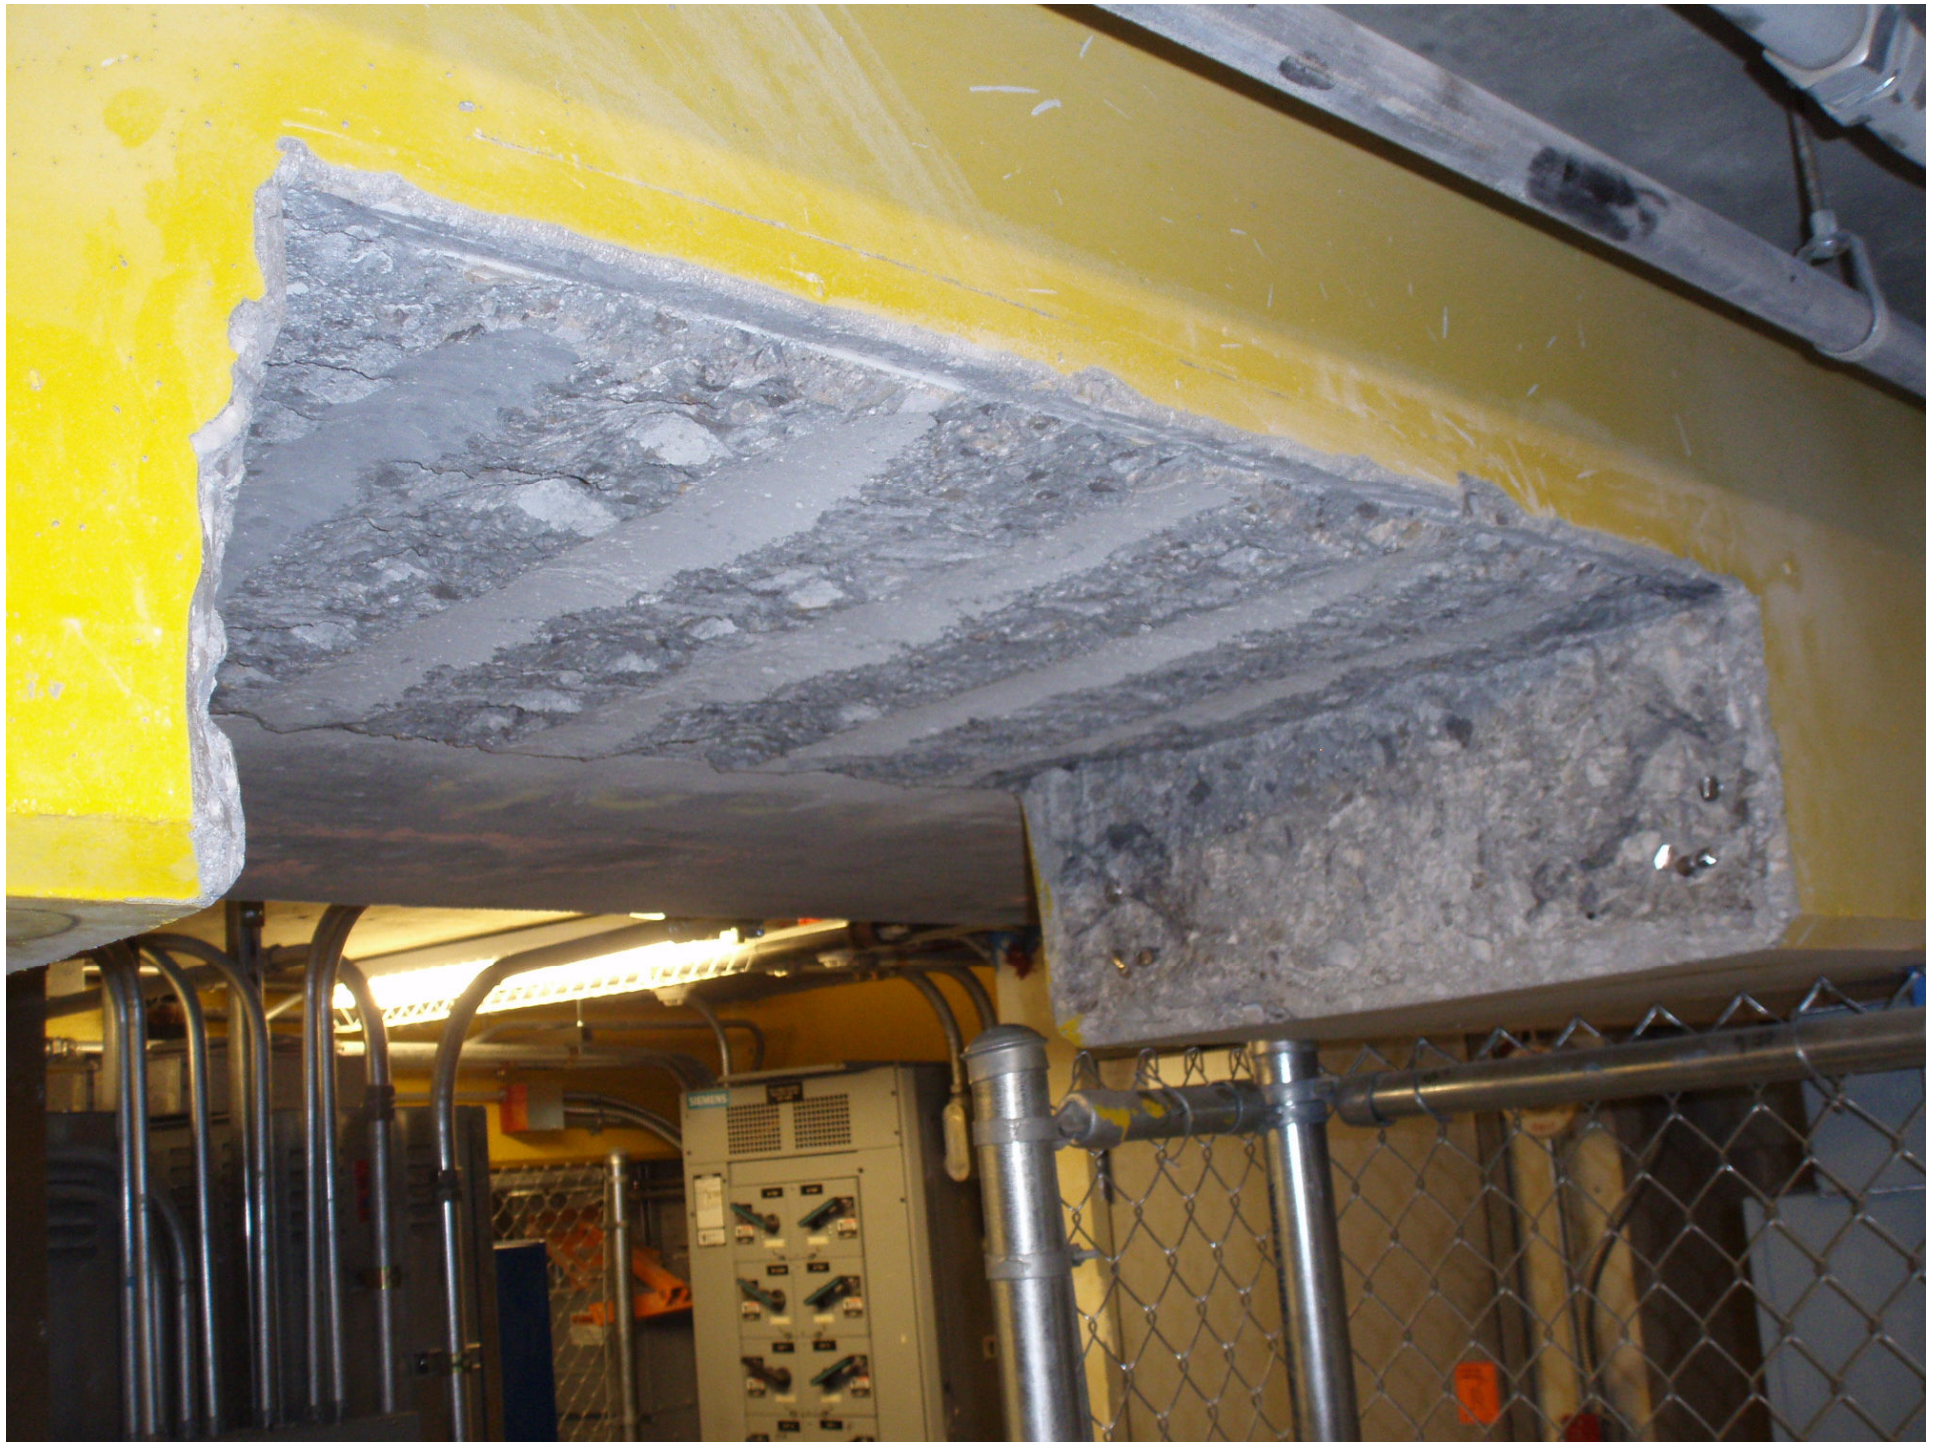
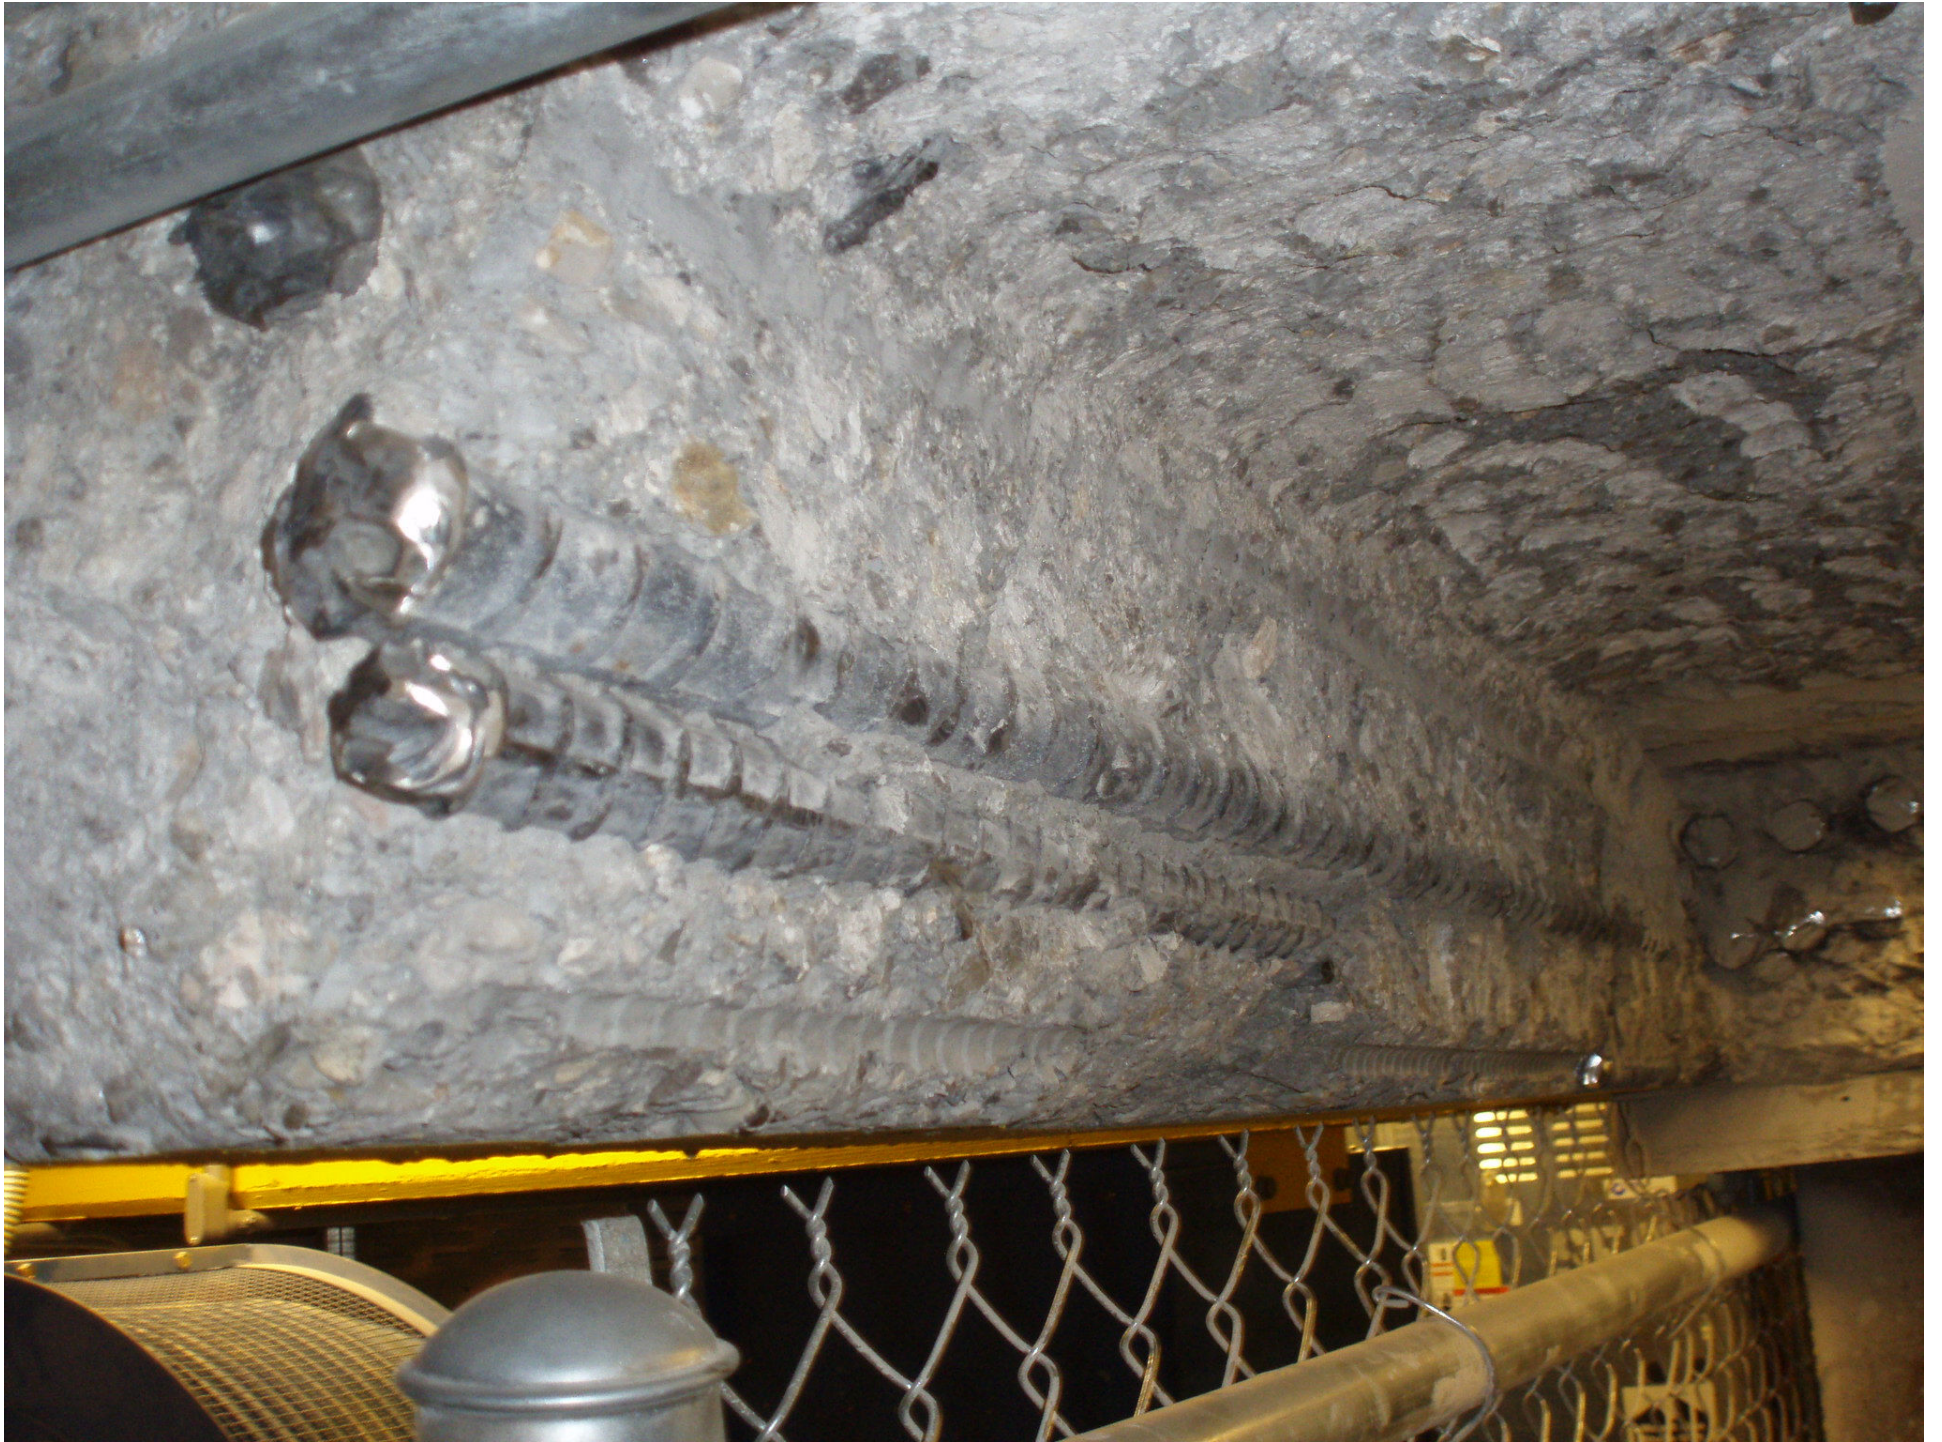
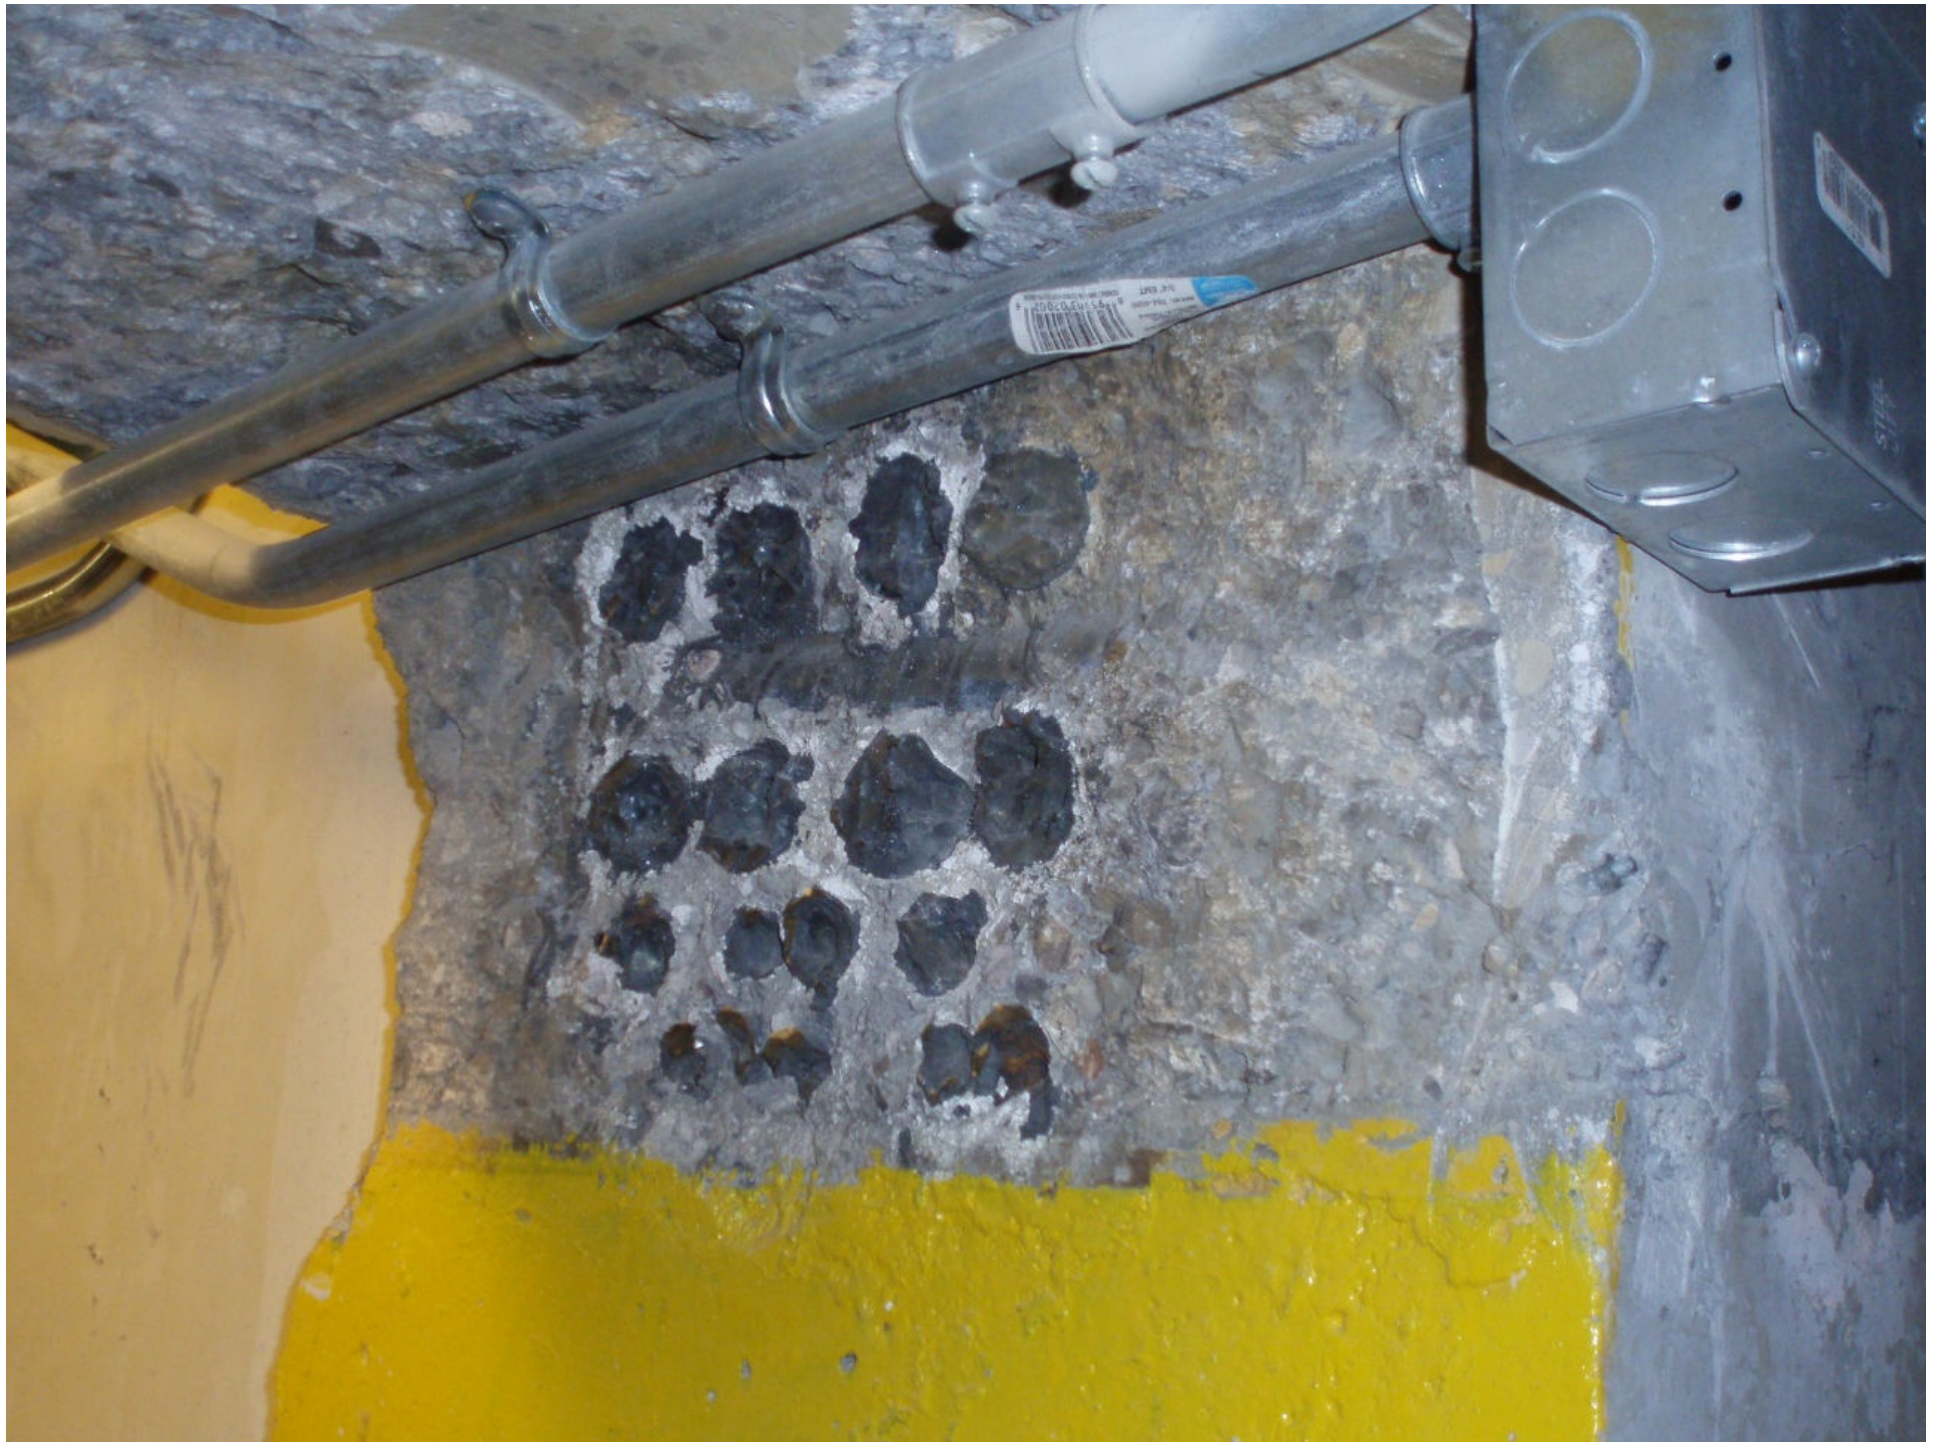
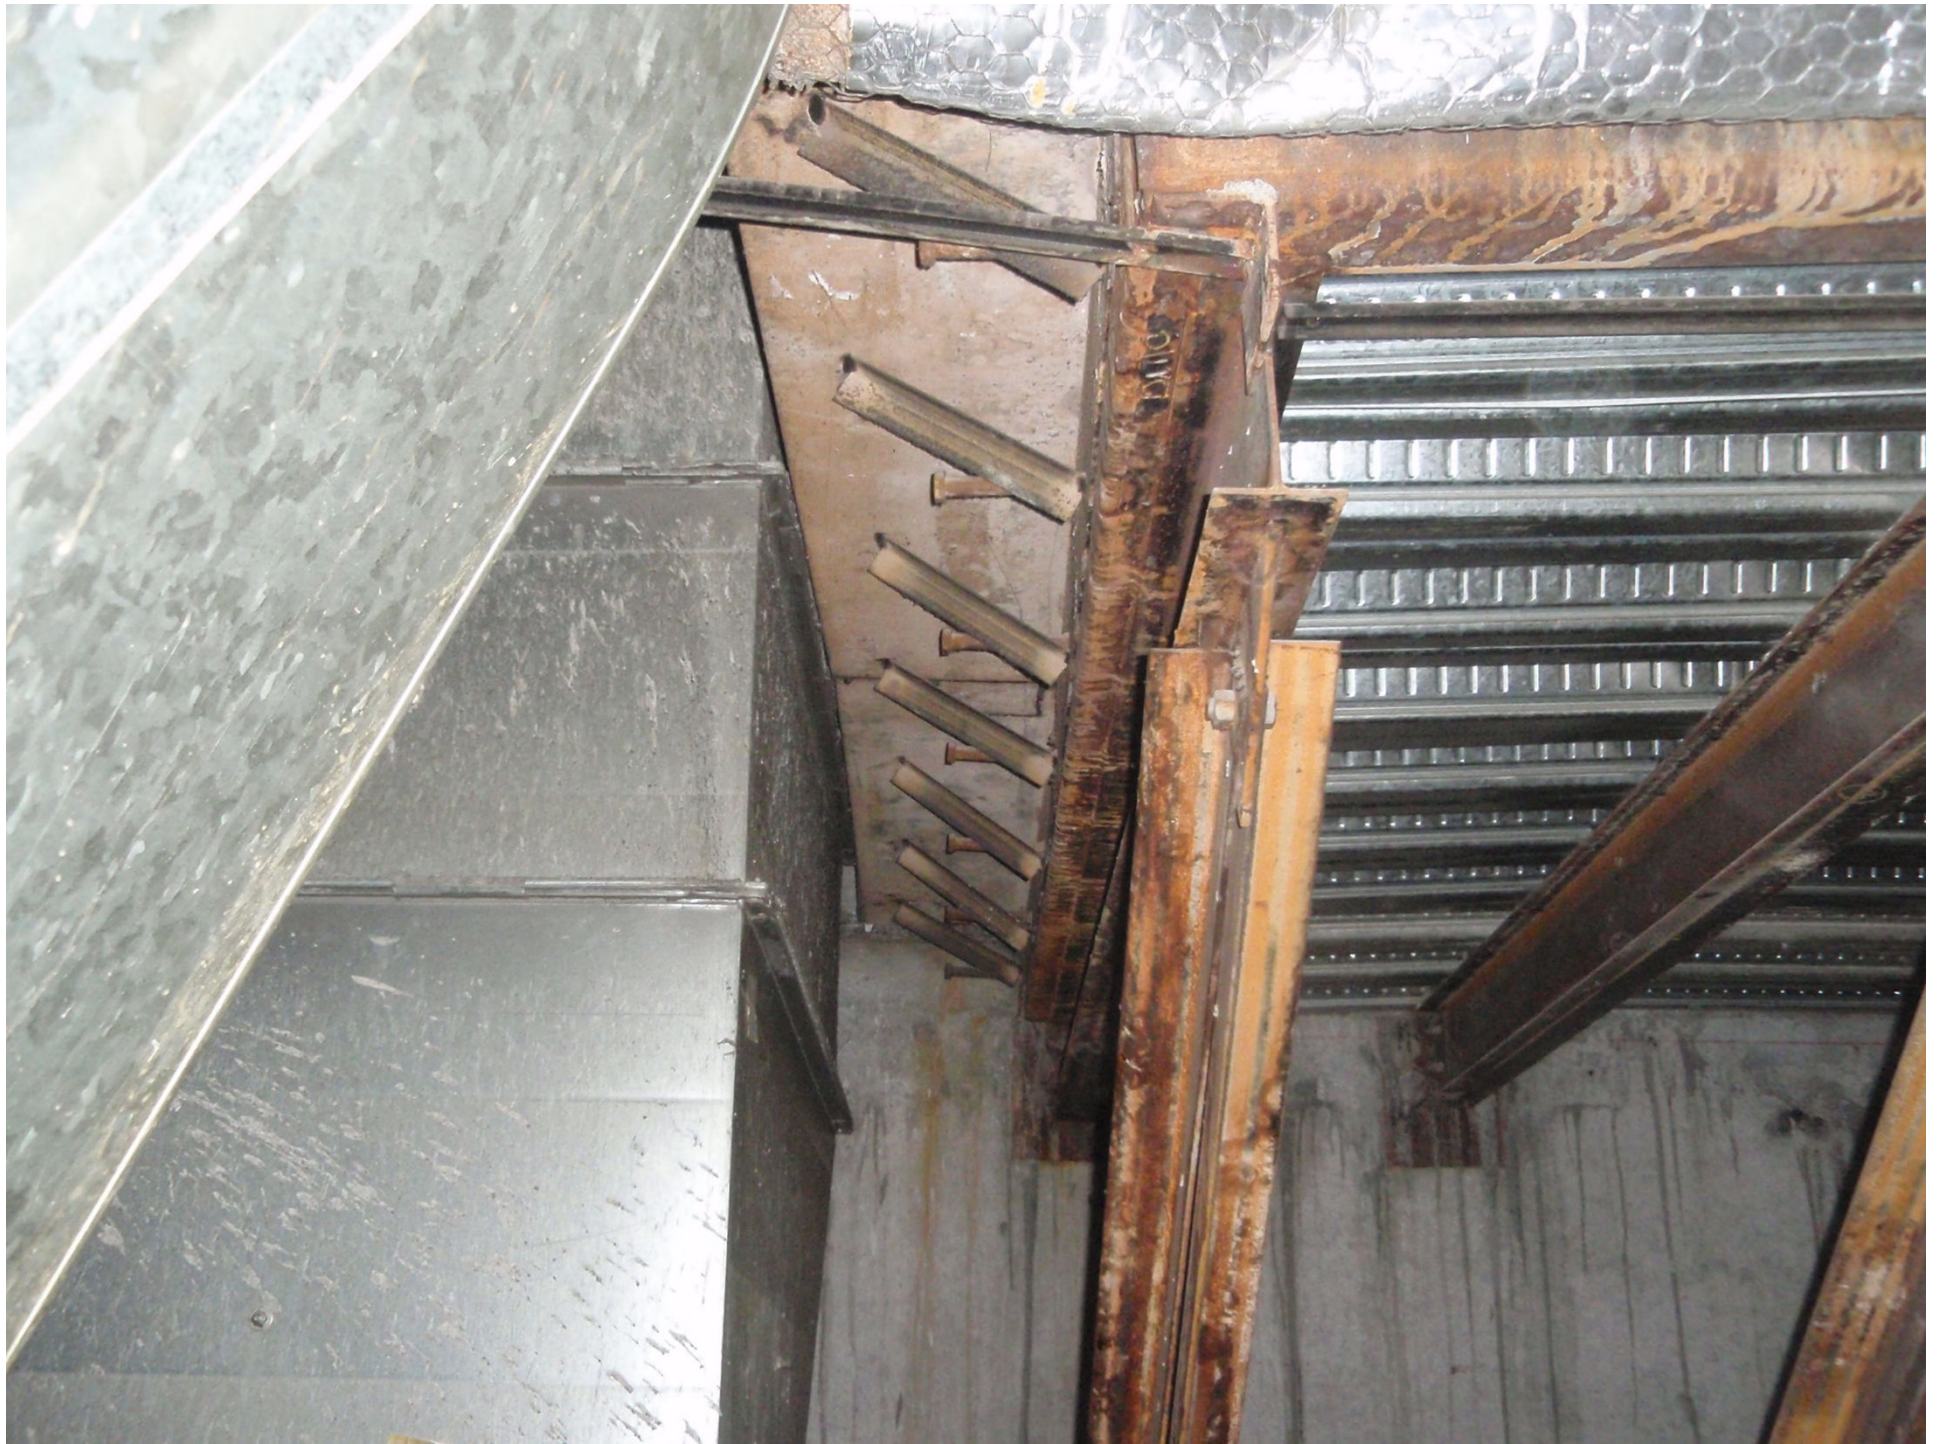
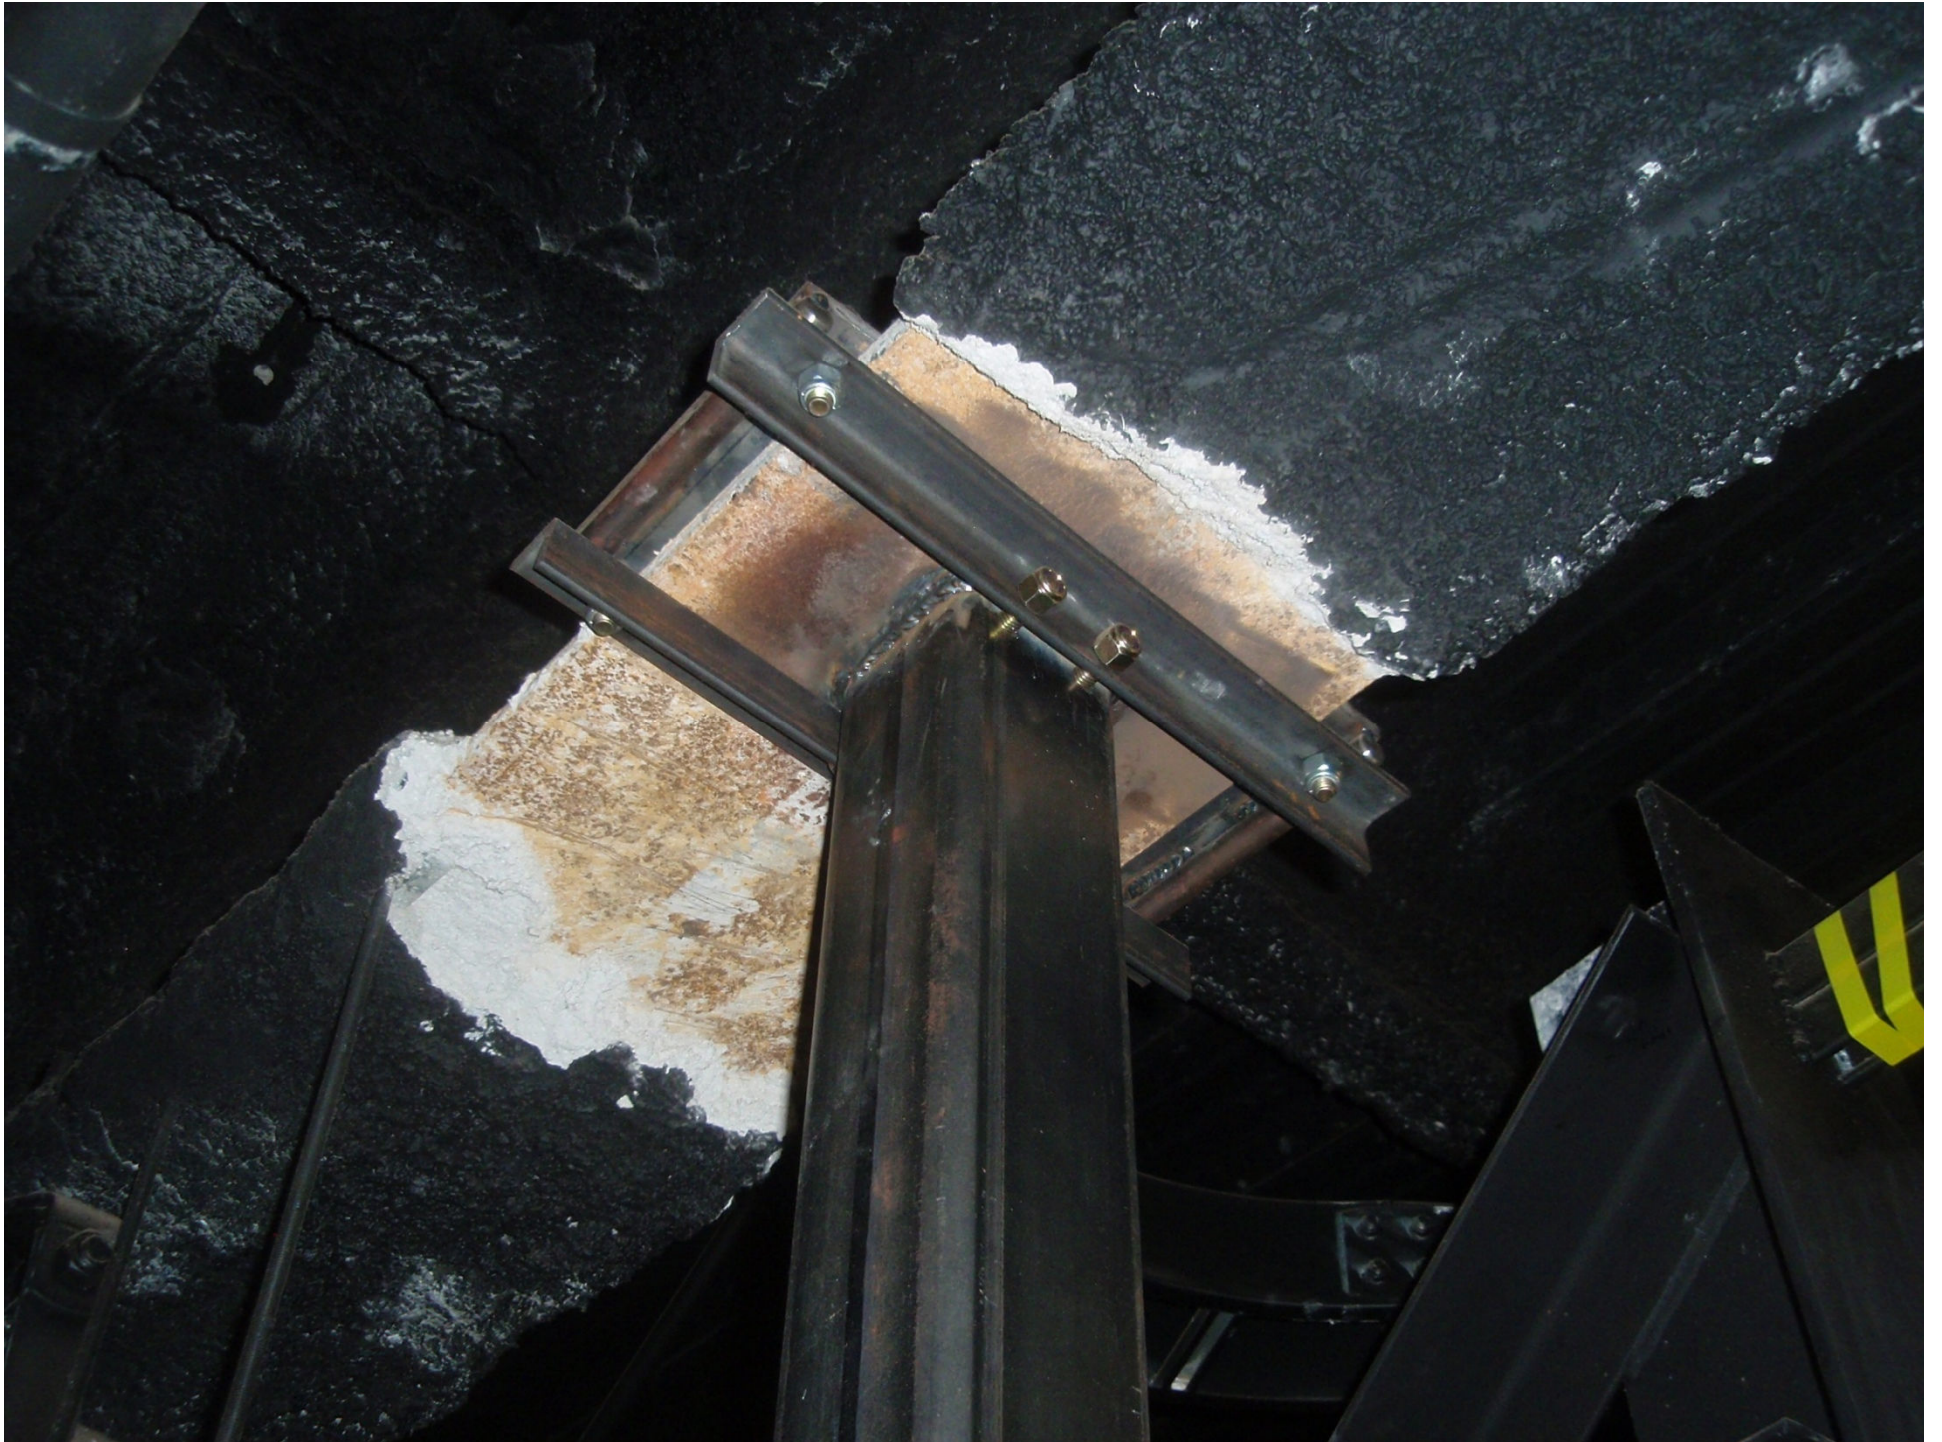
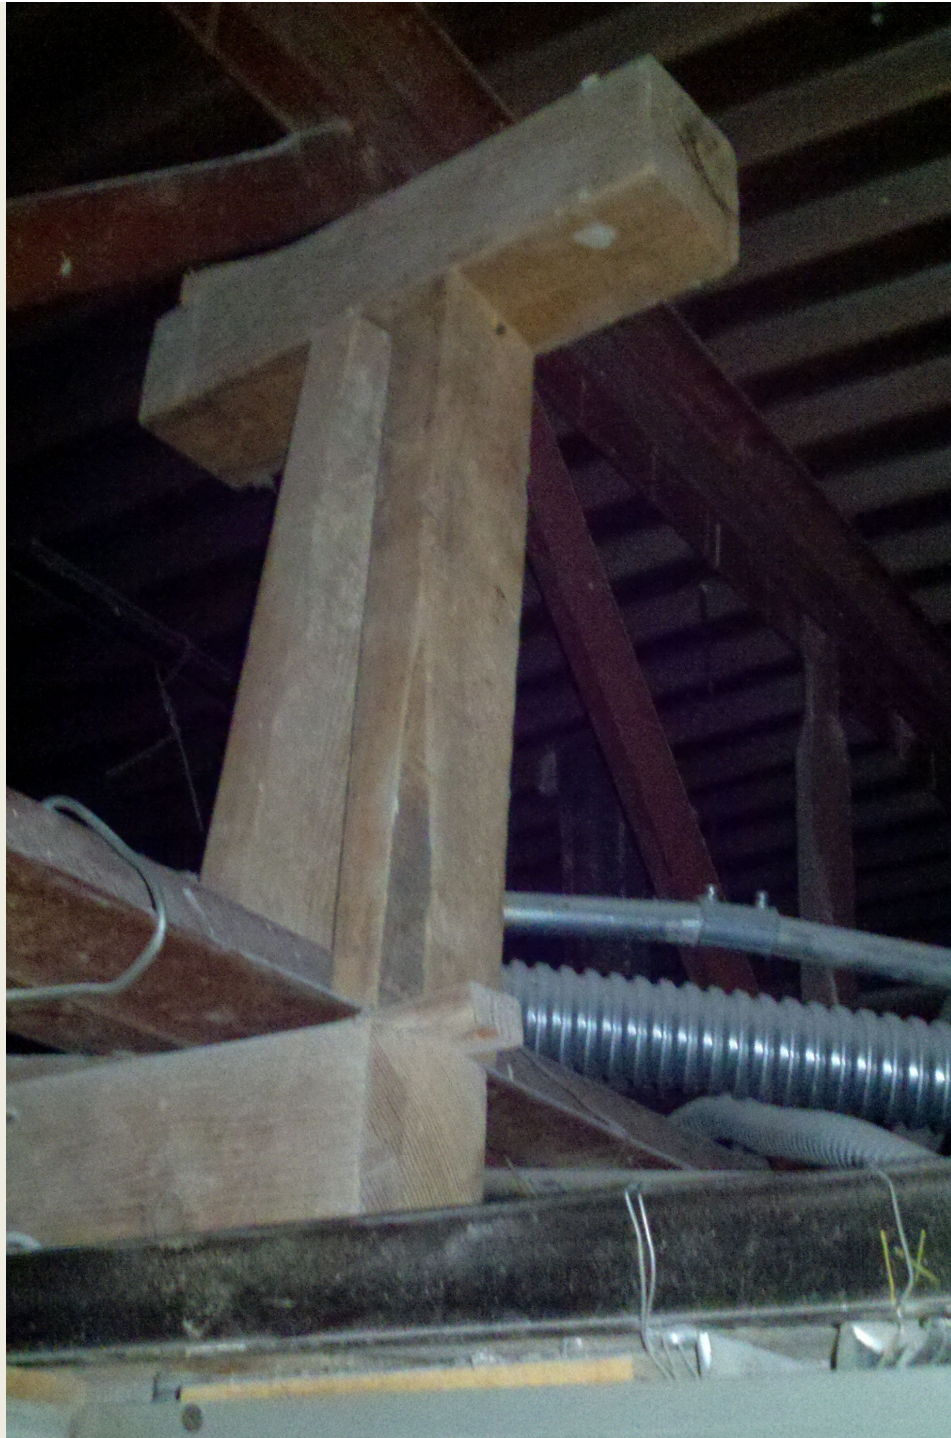
STRUCTURAL MODIFICATIONS
