CONSTRUCTION WITHOUT OVERSIGHT

Douglas H. Evans, P.E., FSFPE
DHE FPE LLC
Las Vegas, NV

In 2008, Clark County Building Department instituted a rigorous inspections program to uncover unreported building code violations in the existing resorts on the world-famous Las Vegas Strip. The violations discovered were primarily due to substantial work conducted without permits or inspections and inadequate or improper maintenance. An overview of the various types of violations and their extent will be discussed.

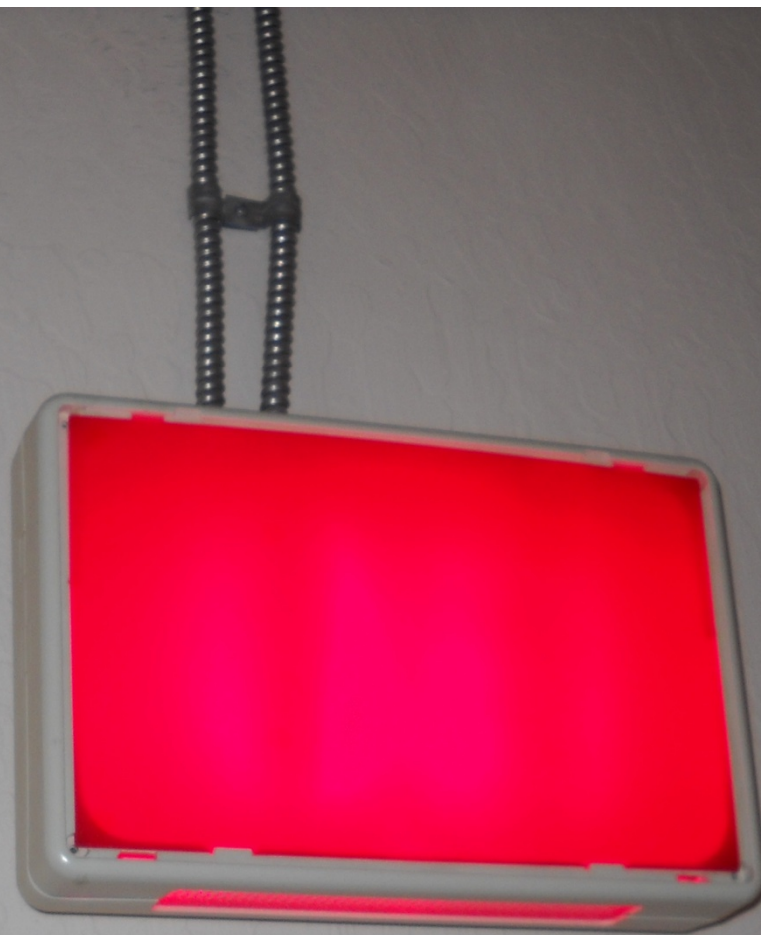
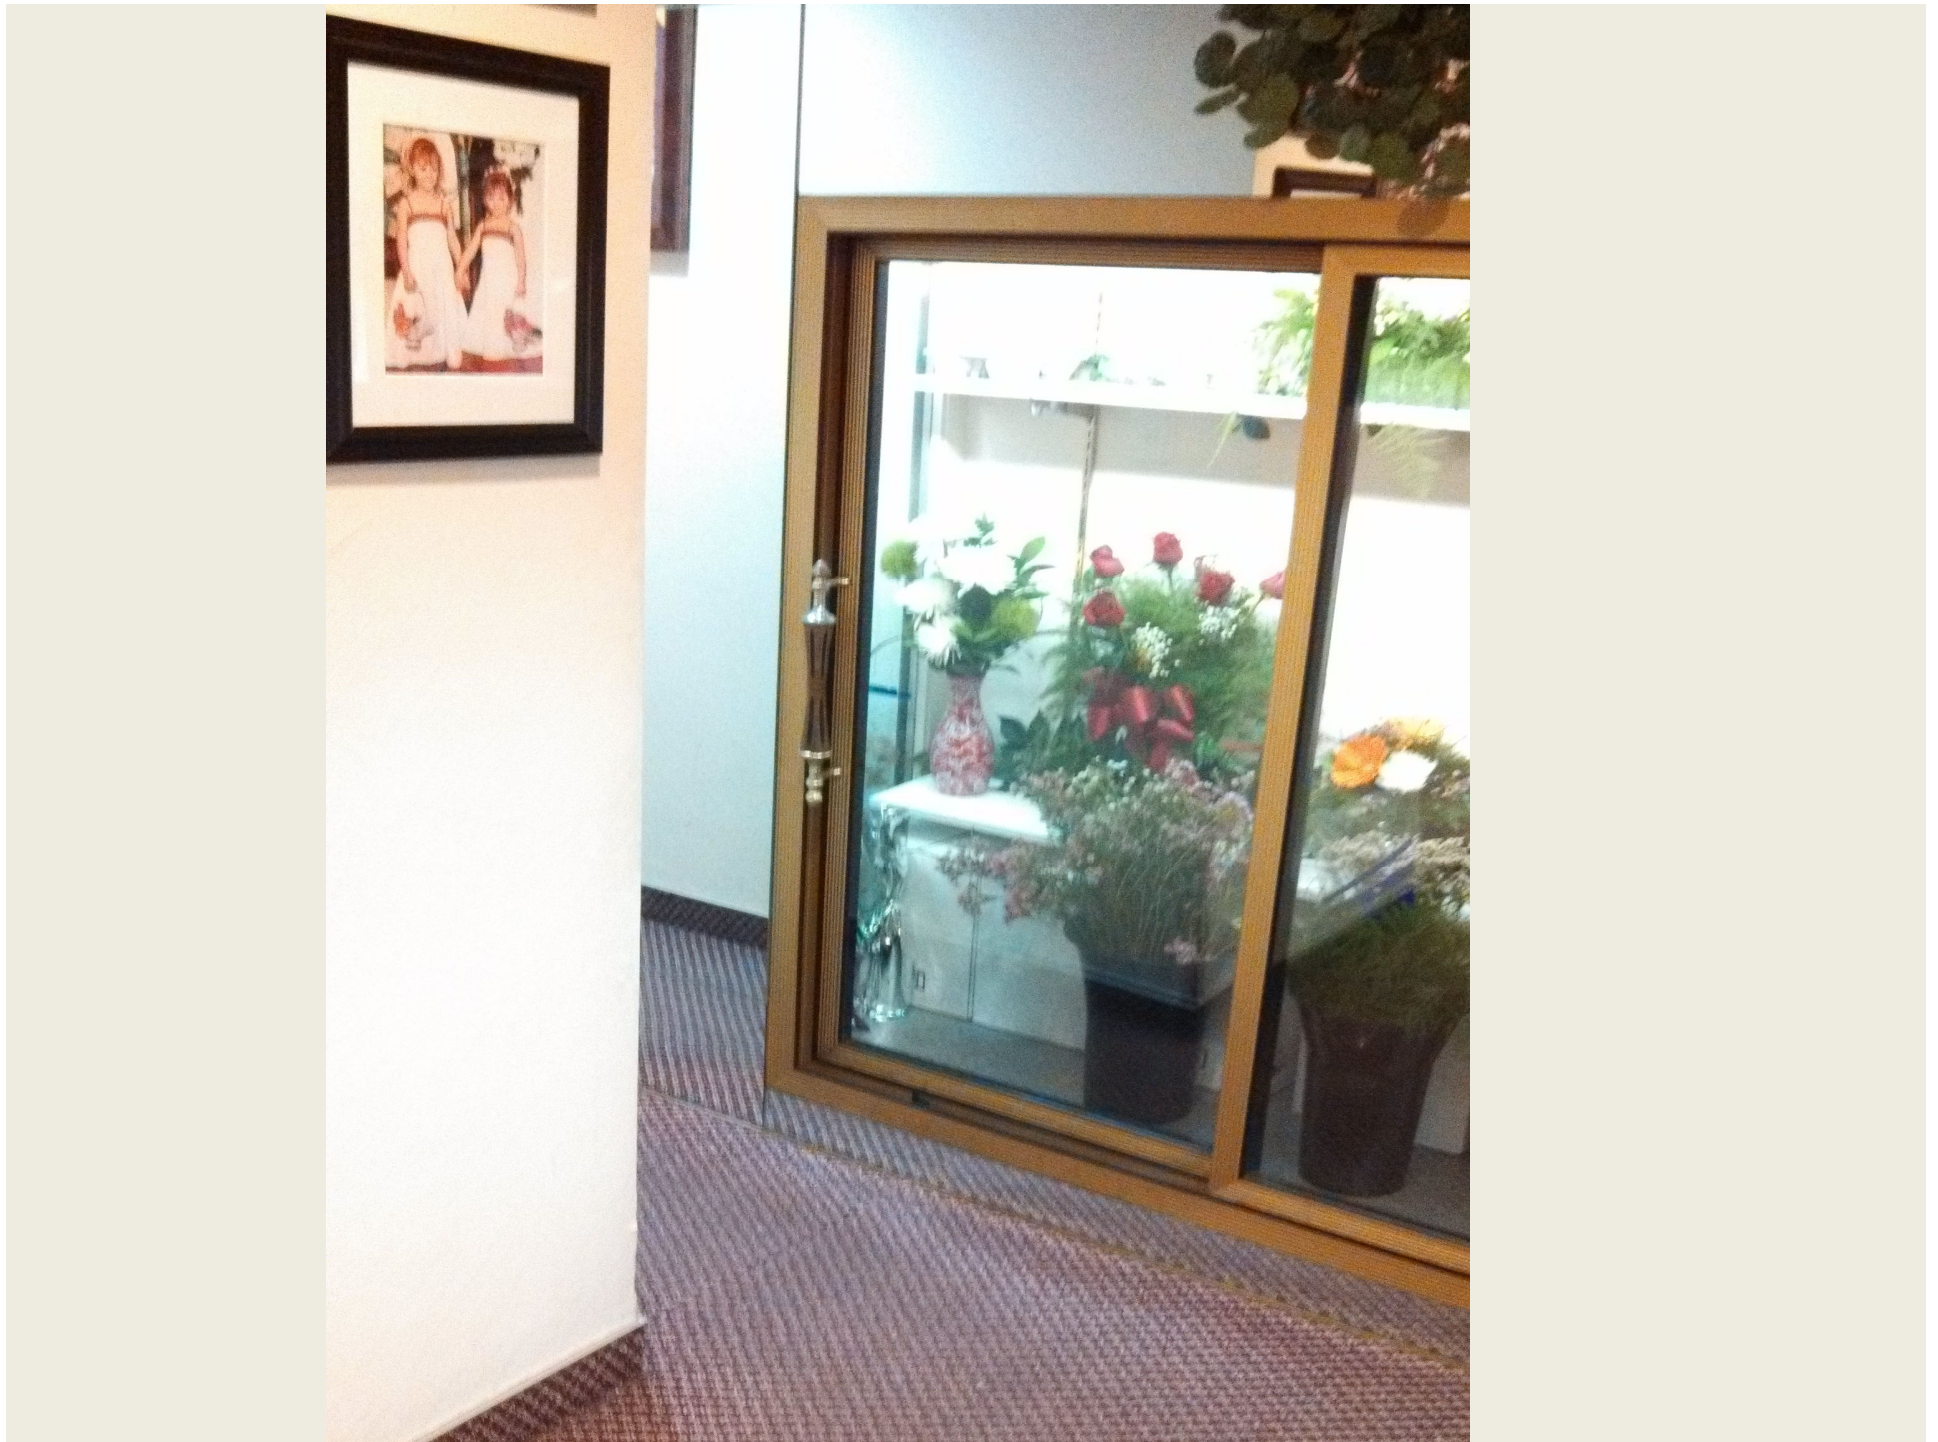
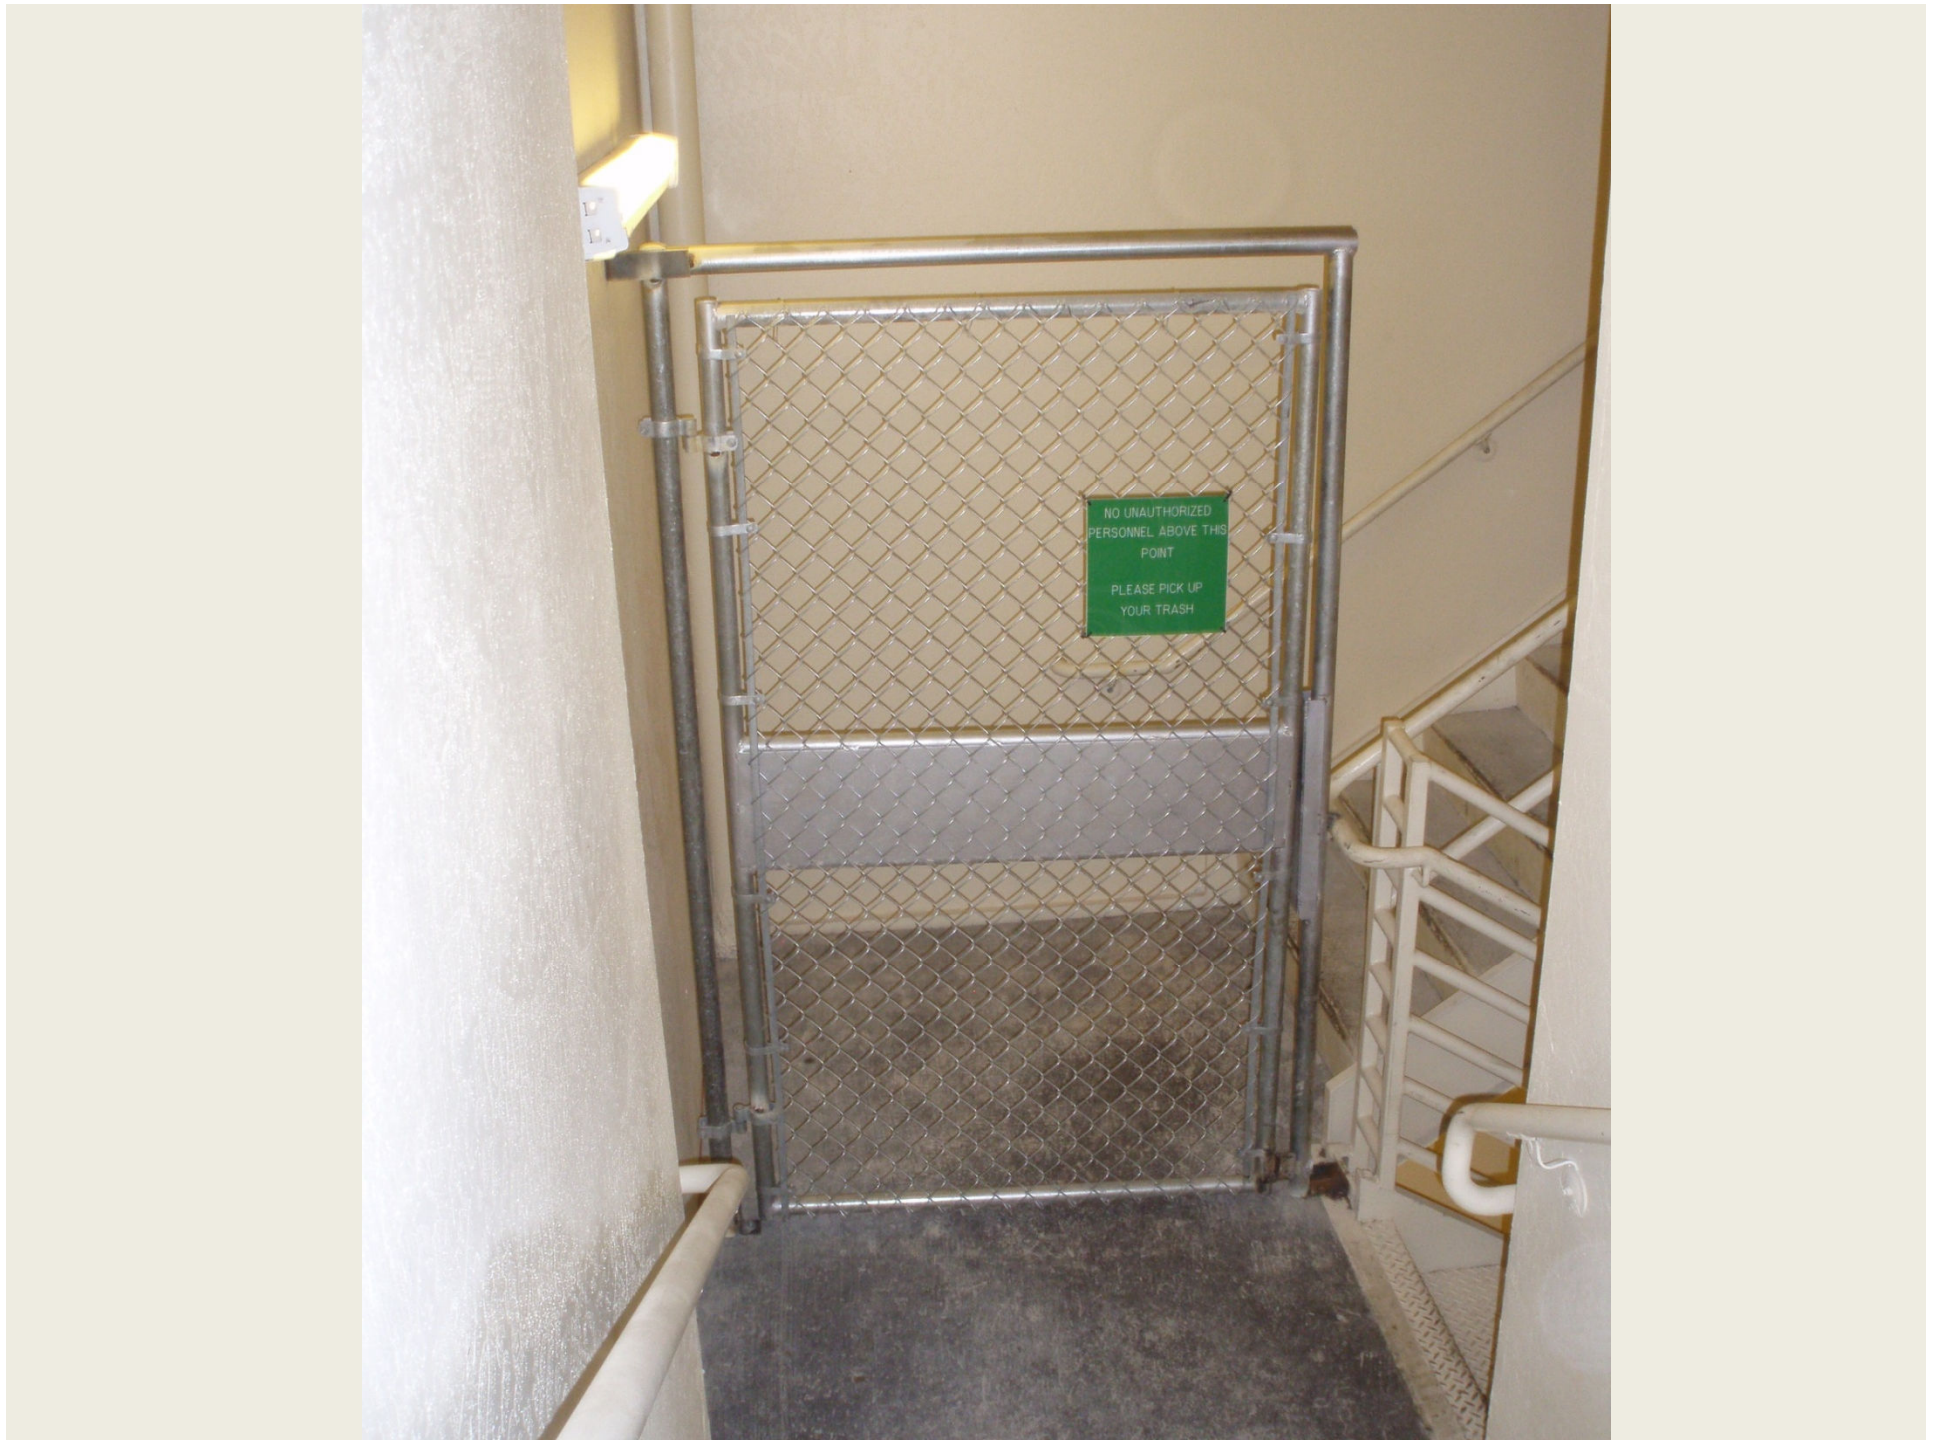
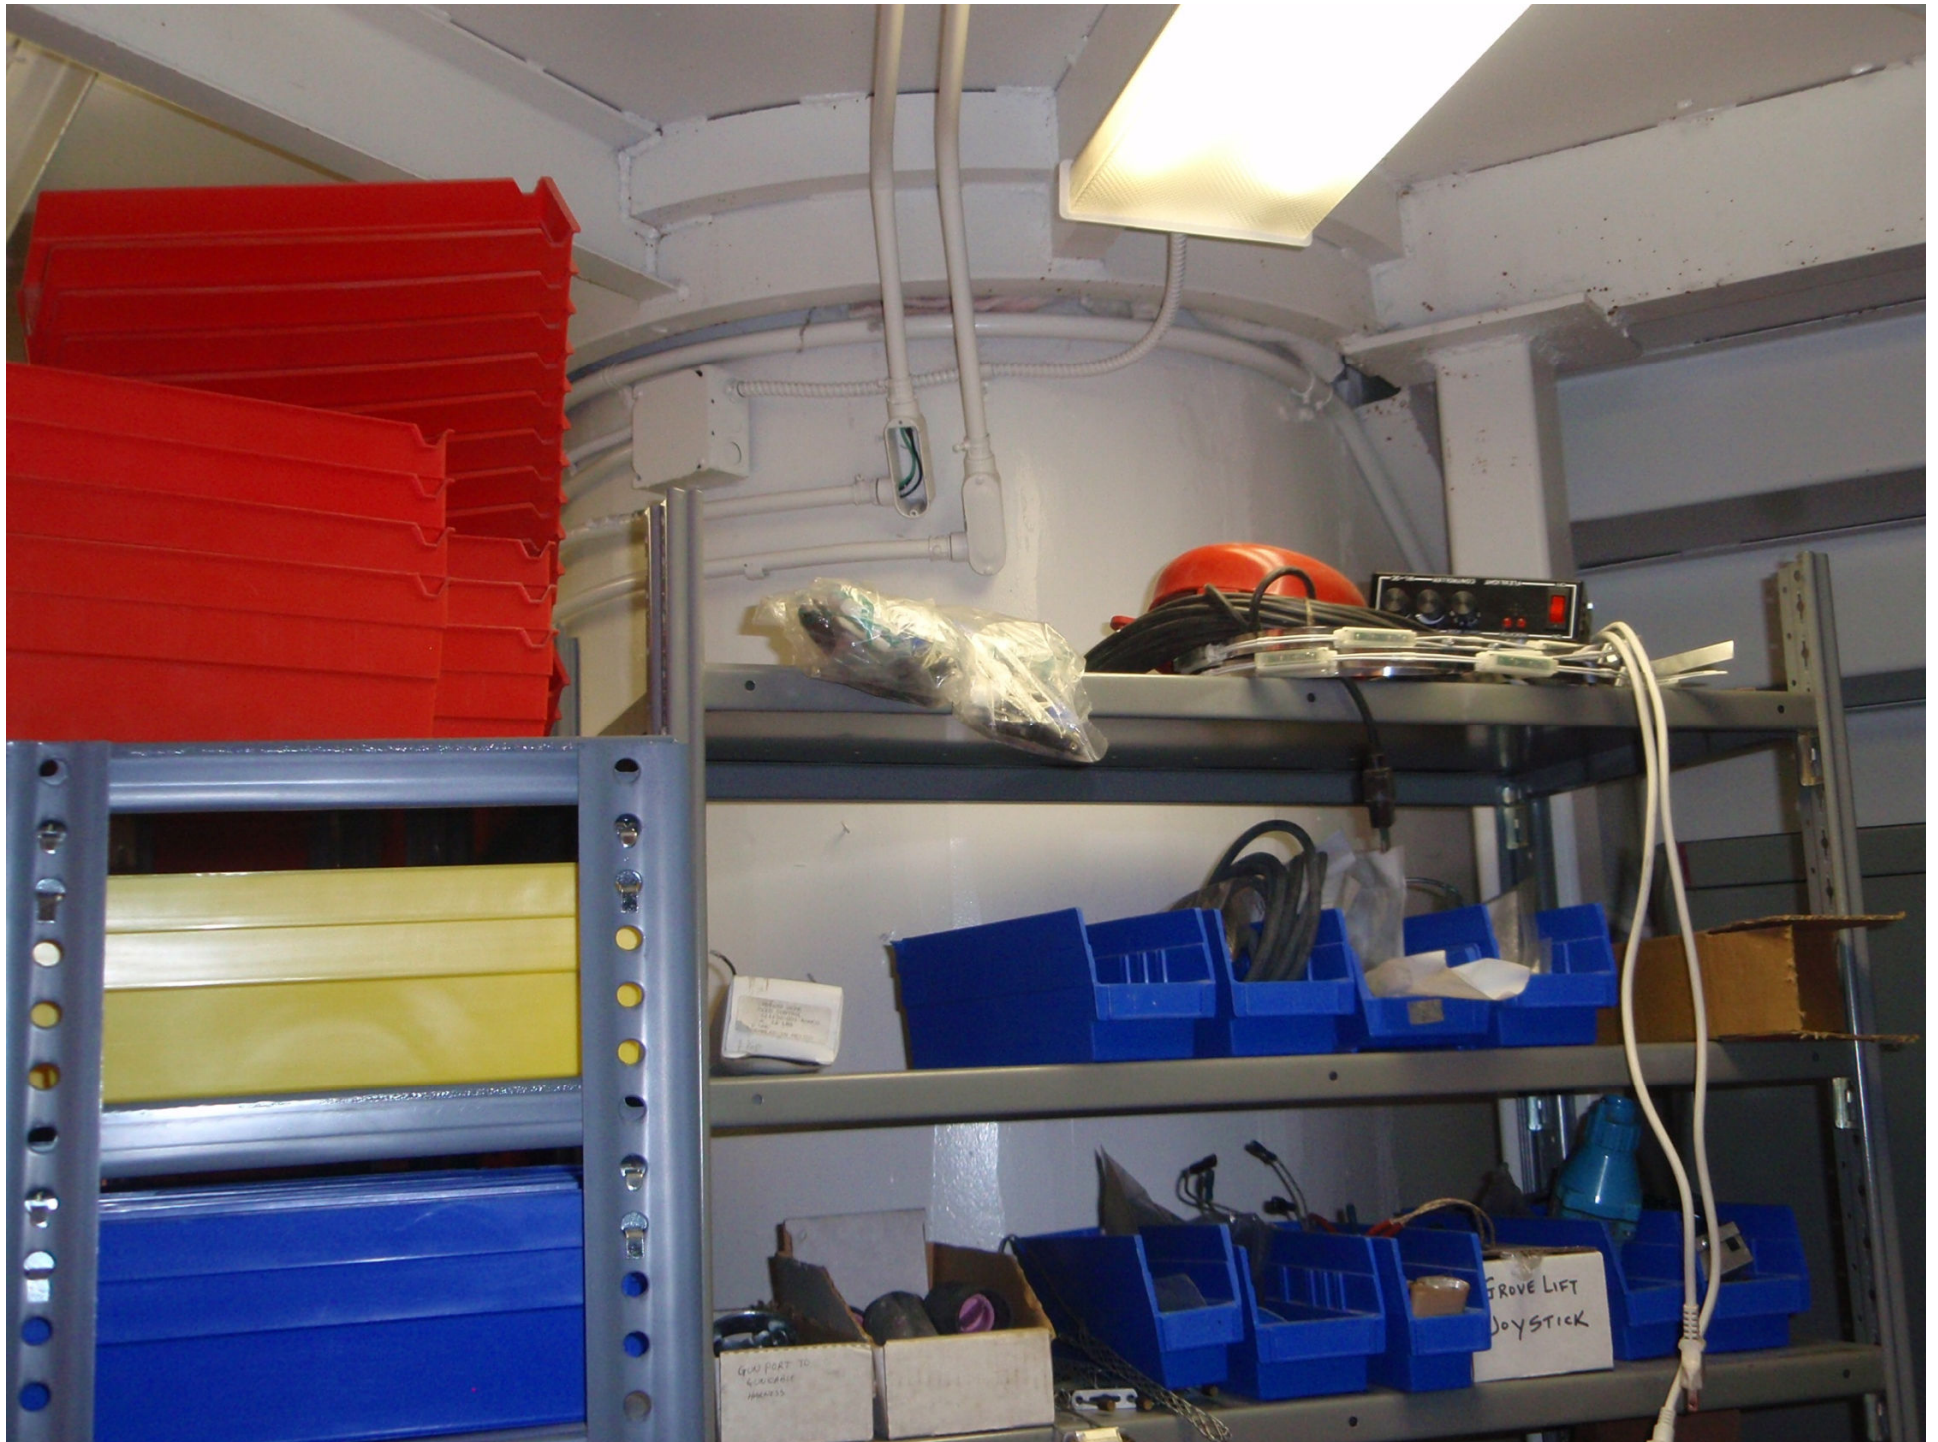
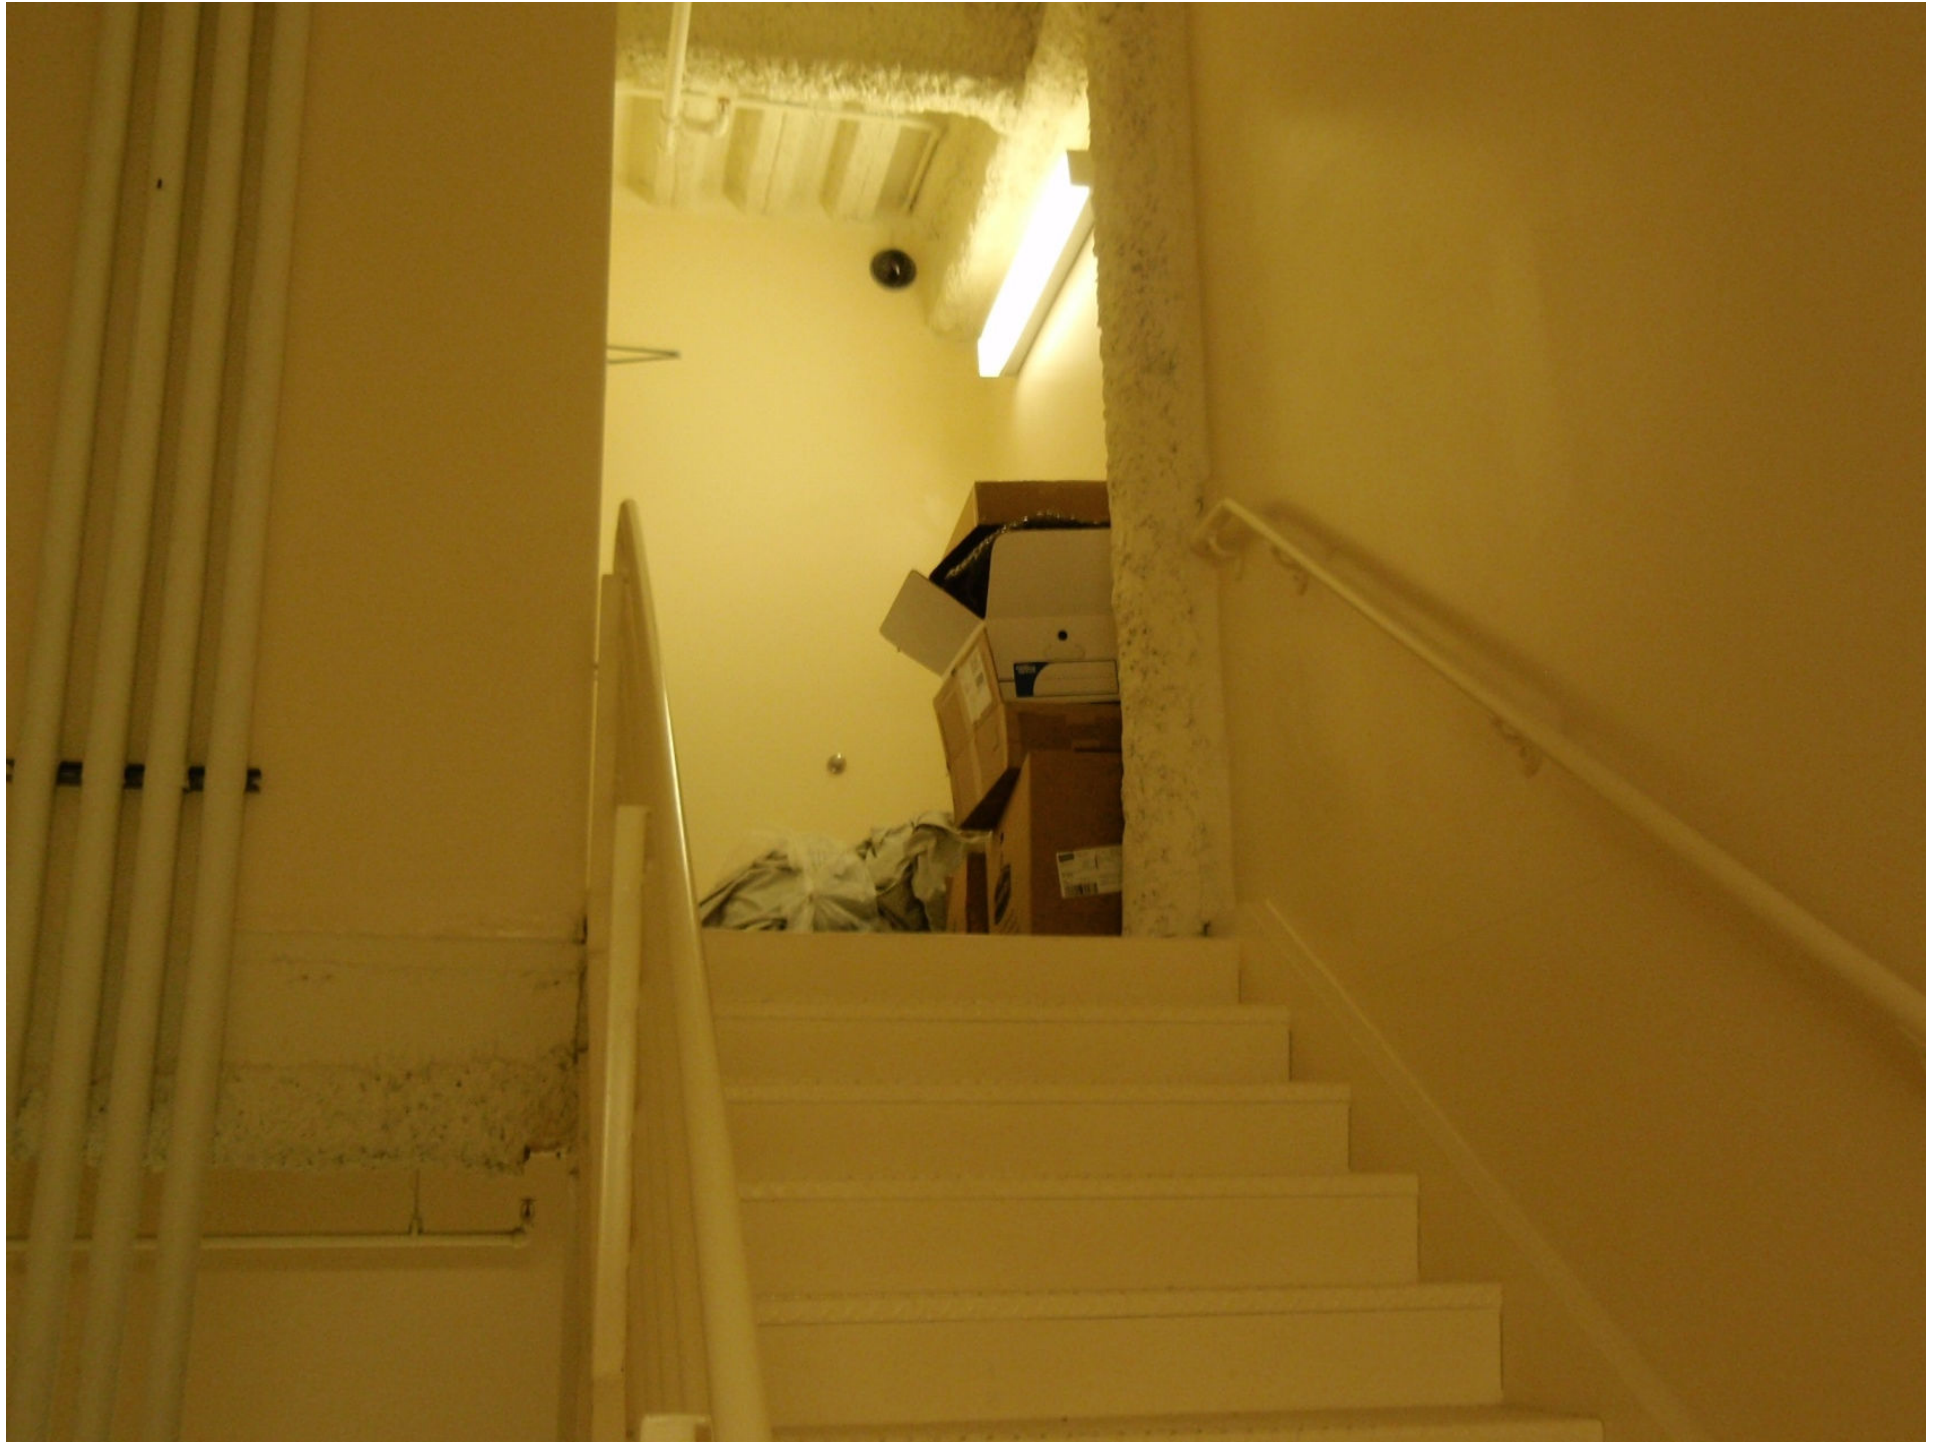
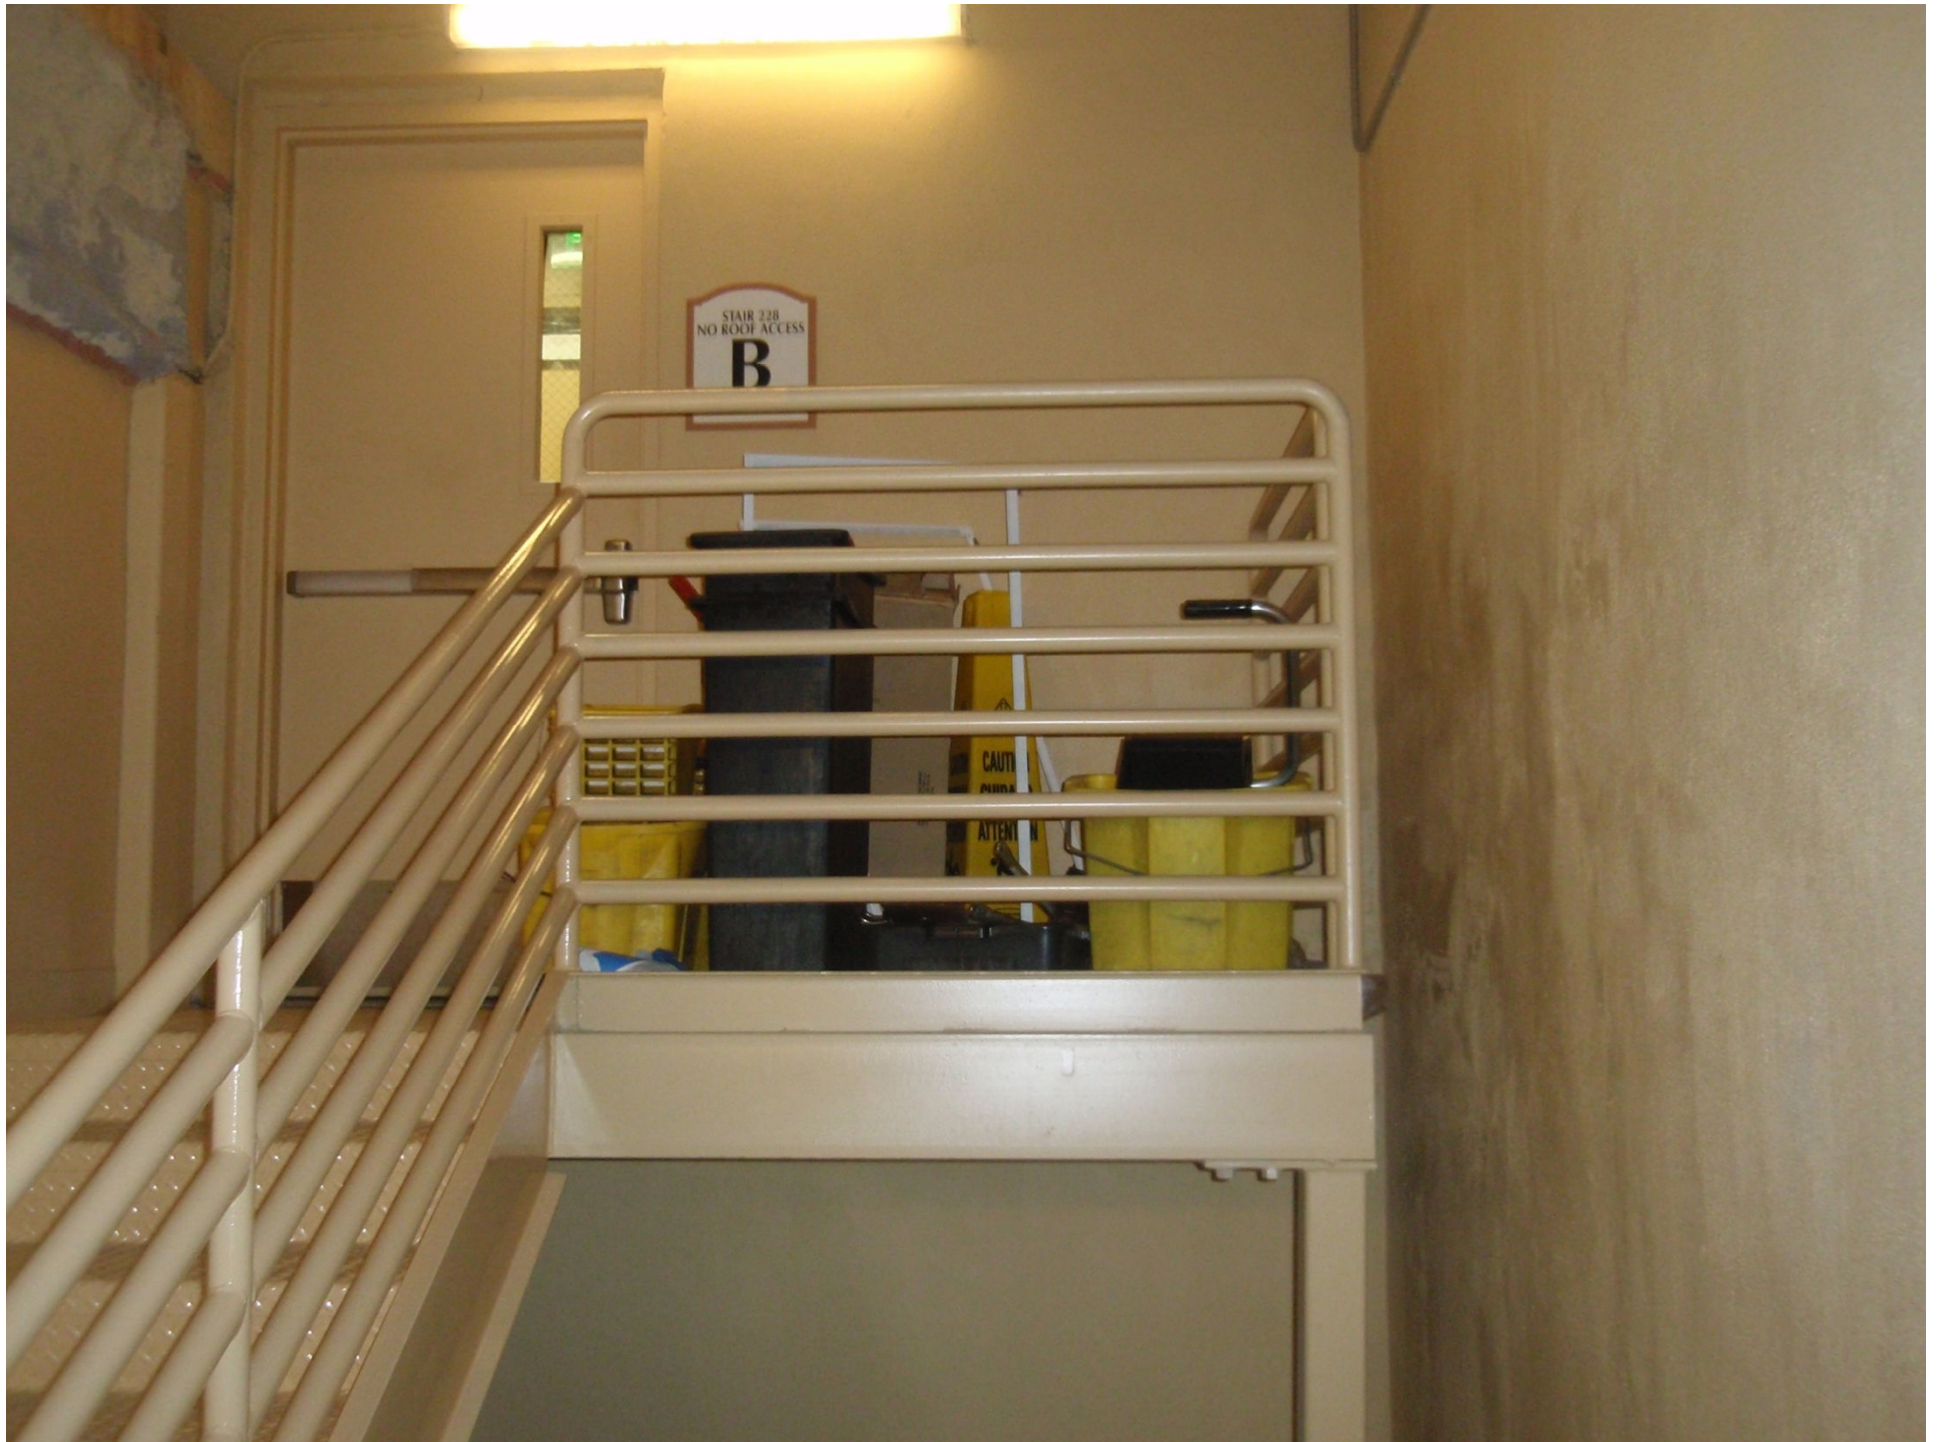
Egress Violations
