CONSTRUCTION WITHOUT OVERSIGHT

Douglas H. Evans, P.E., FSFPE
DHE FPE LLC
Las Vegas, NV

In 2008, Clark County Building Department instituted a rigorous inspections program to uncover unreported building code violations in the existing resorts on the world-famous Las Vegas Strip. The violations discovered were primarily due to substantial work conducted without permits or inspections and inadequate or improper maintenance. An overview of the various types of violations and their extent will be discussed.

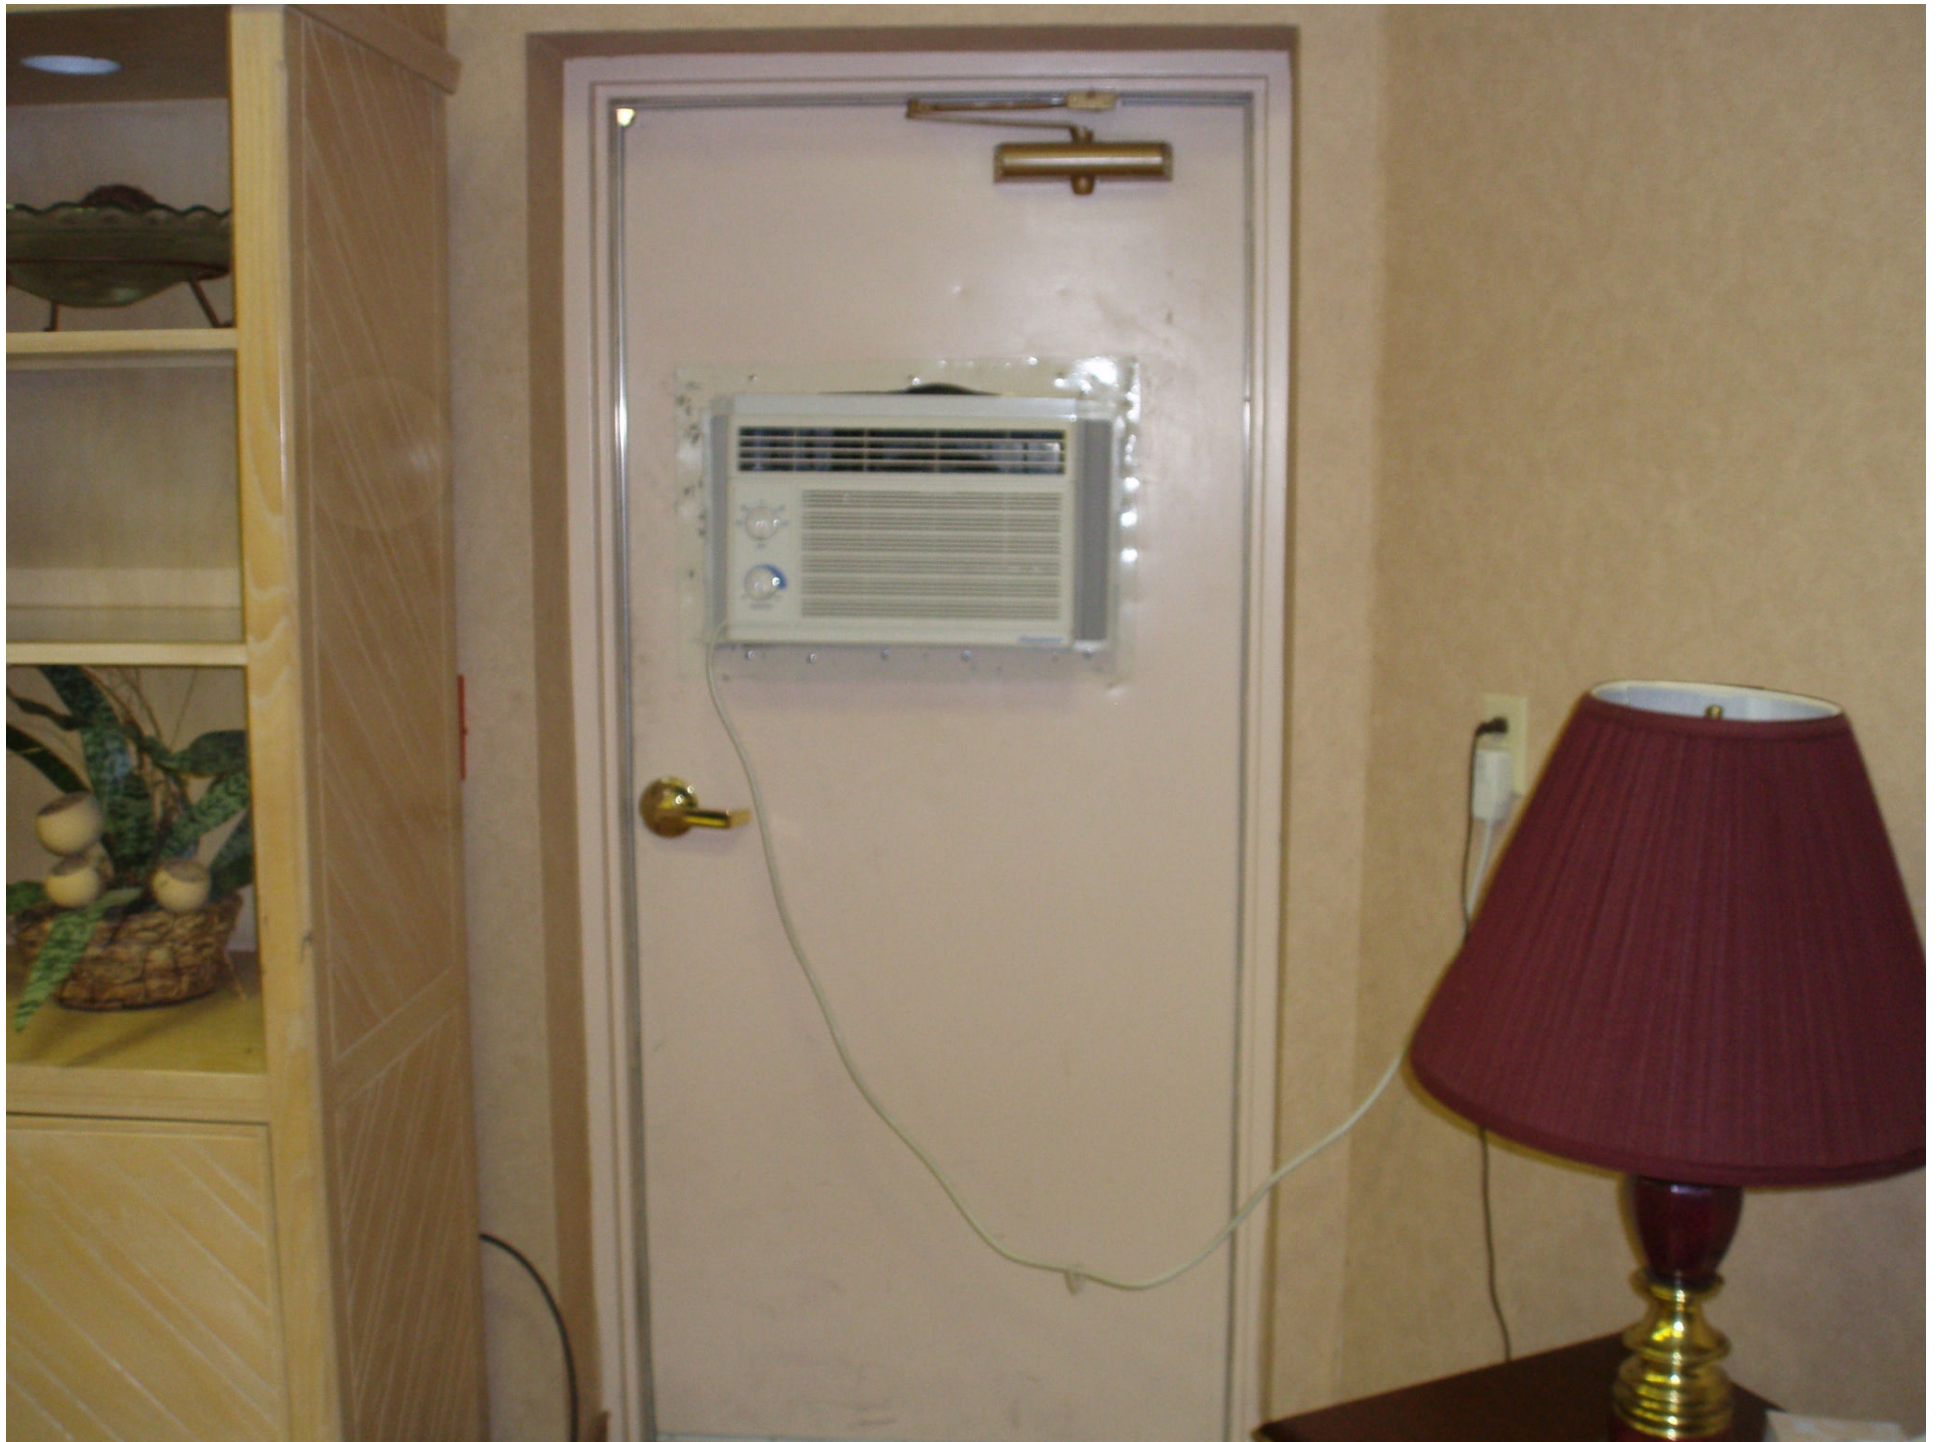
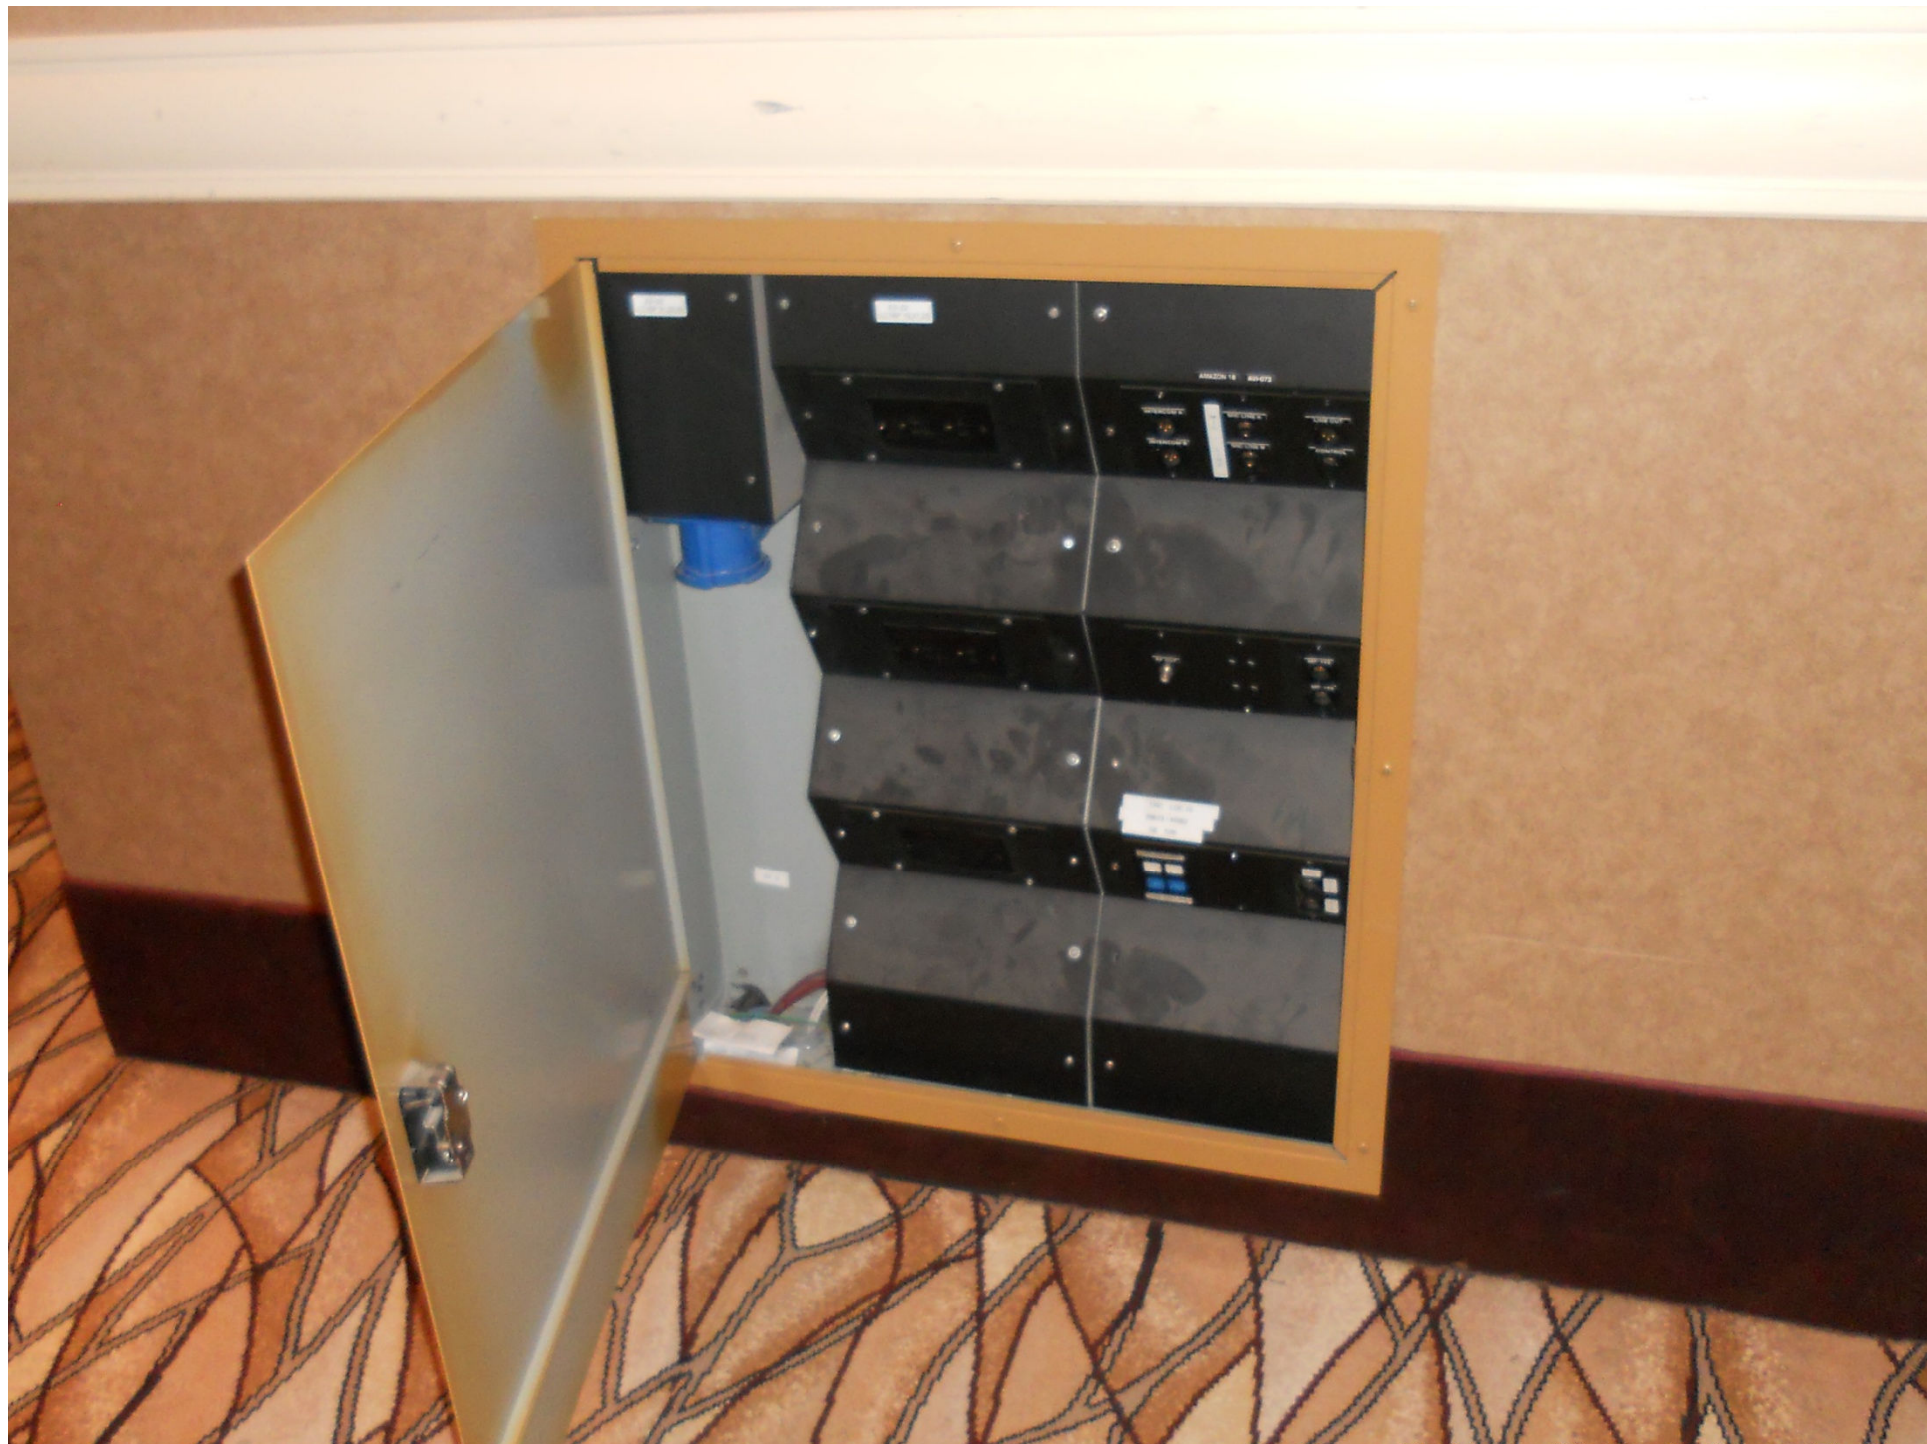
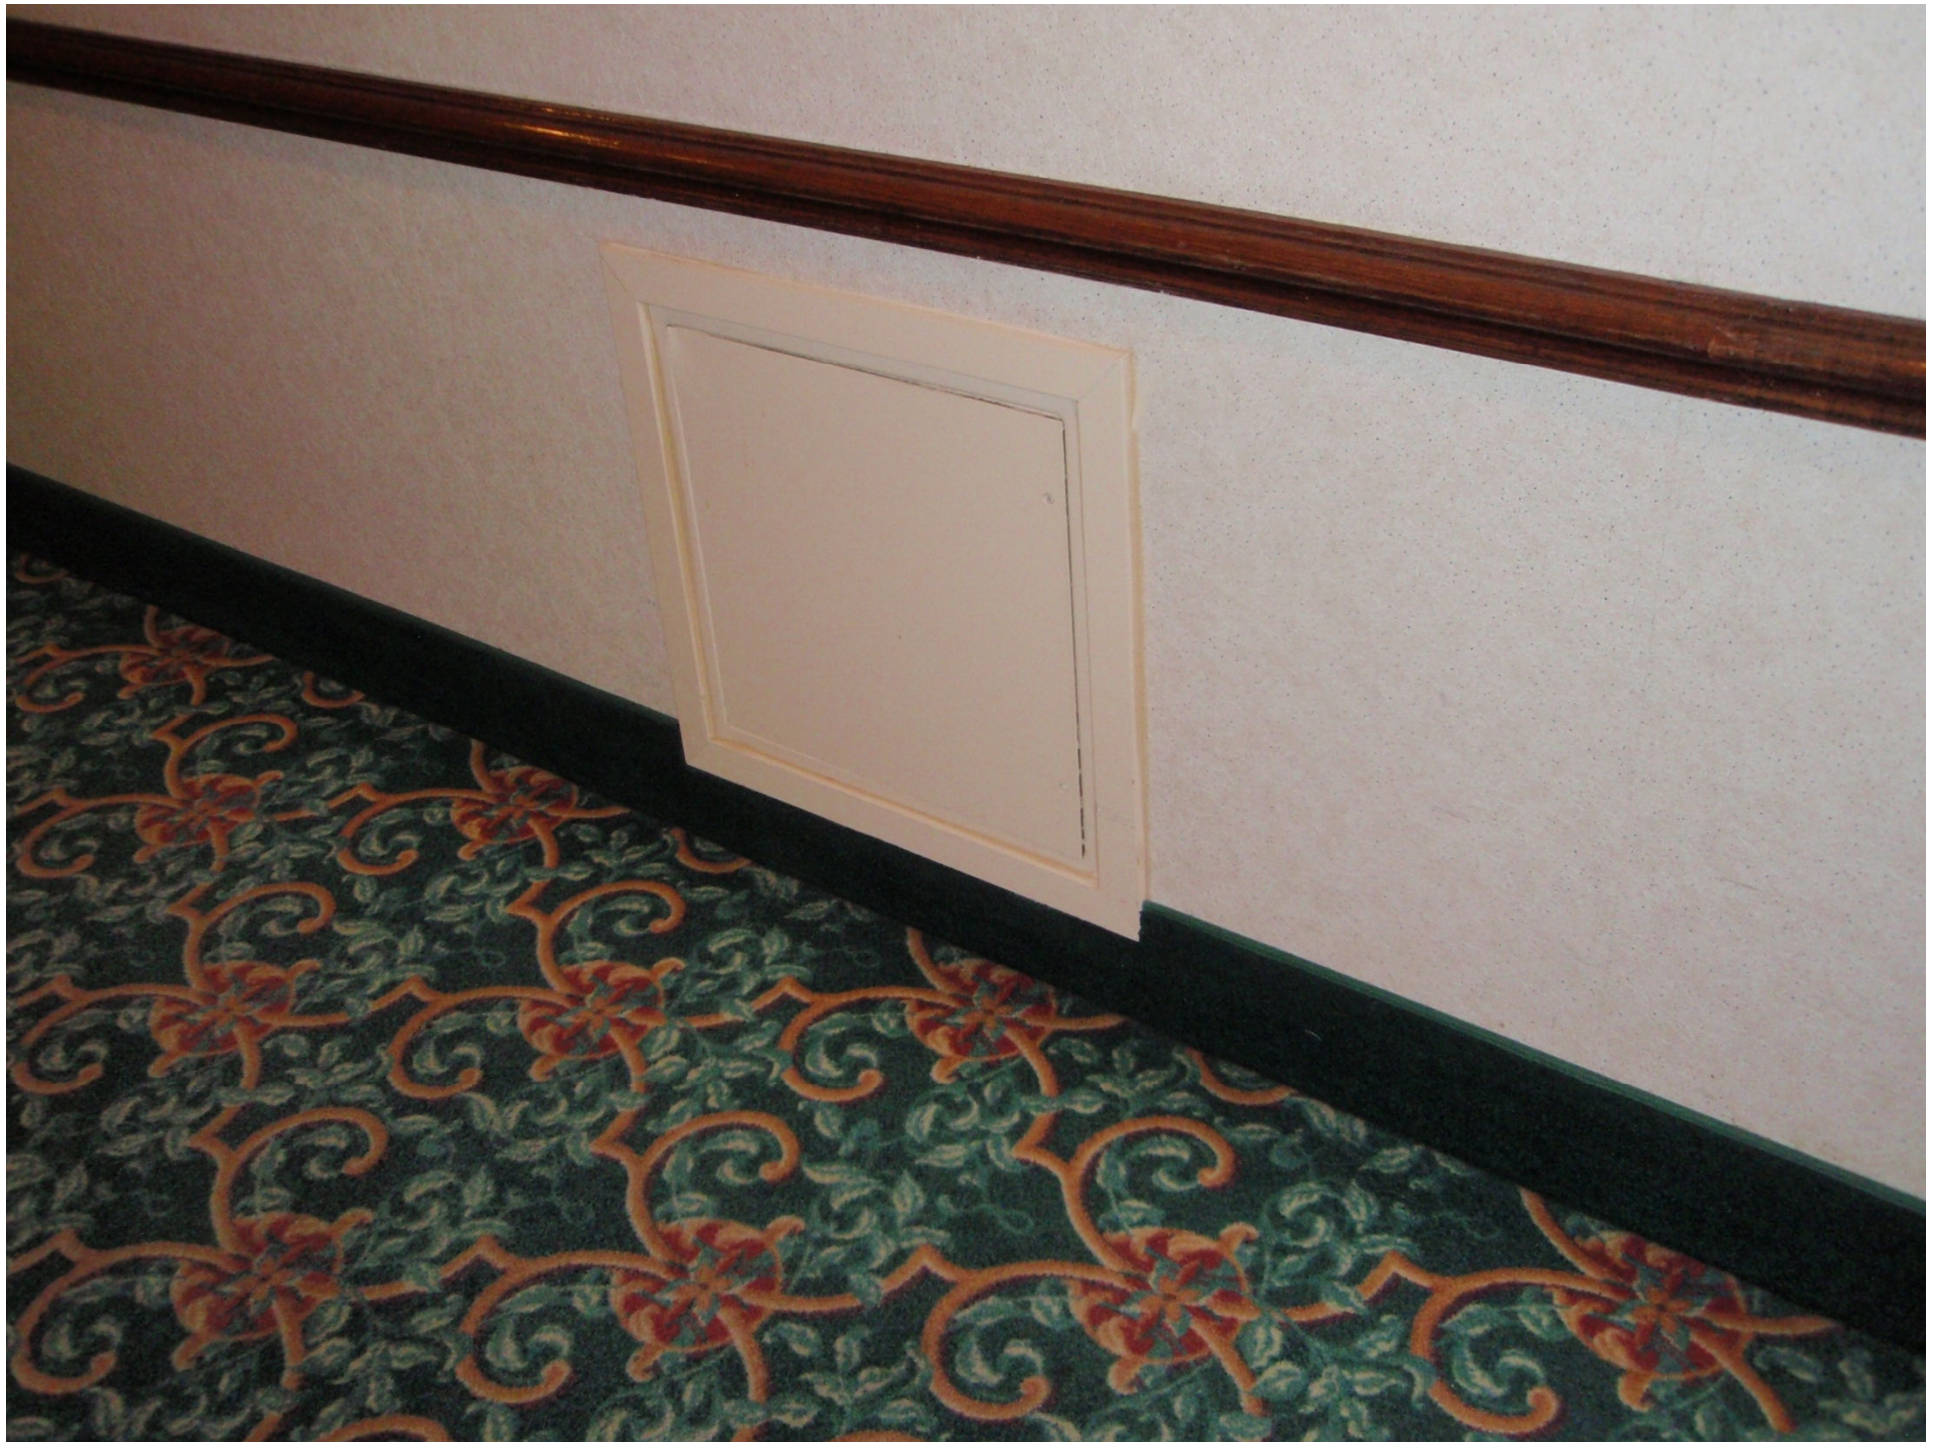
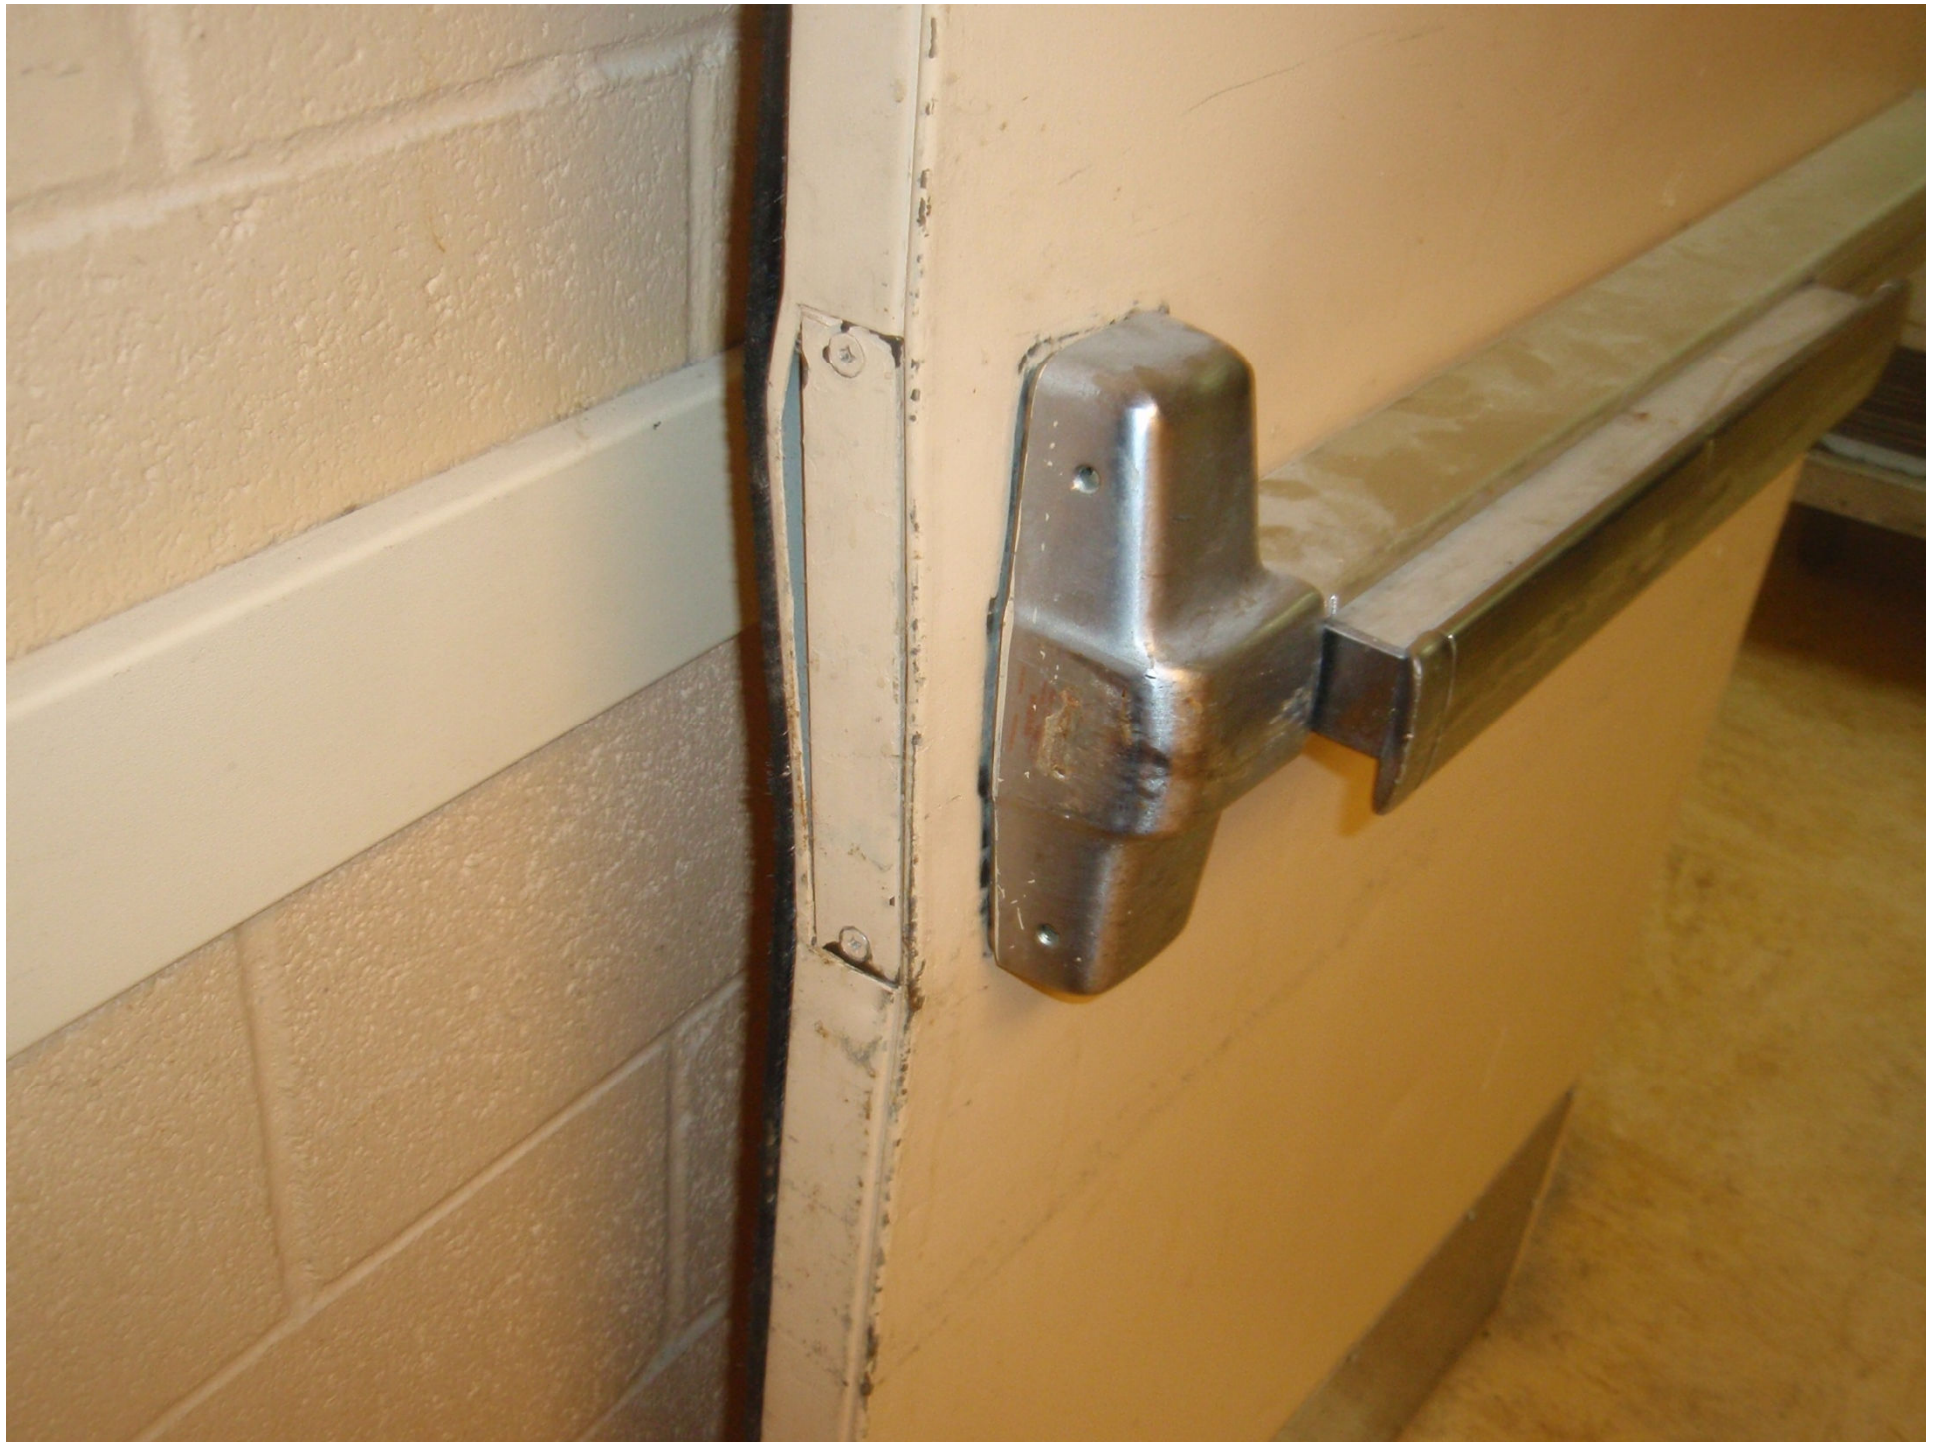
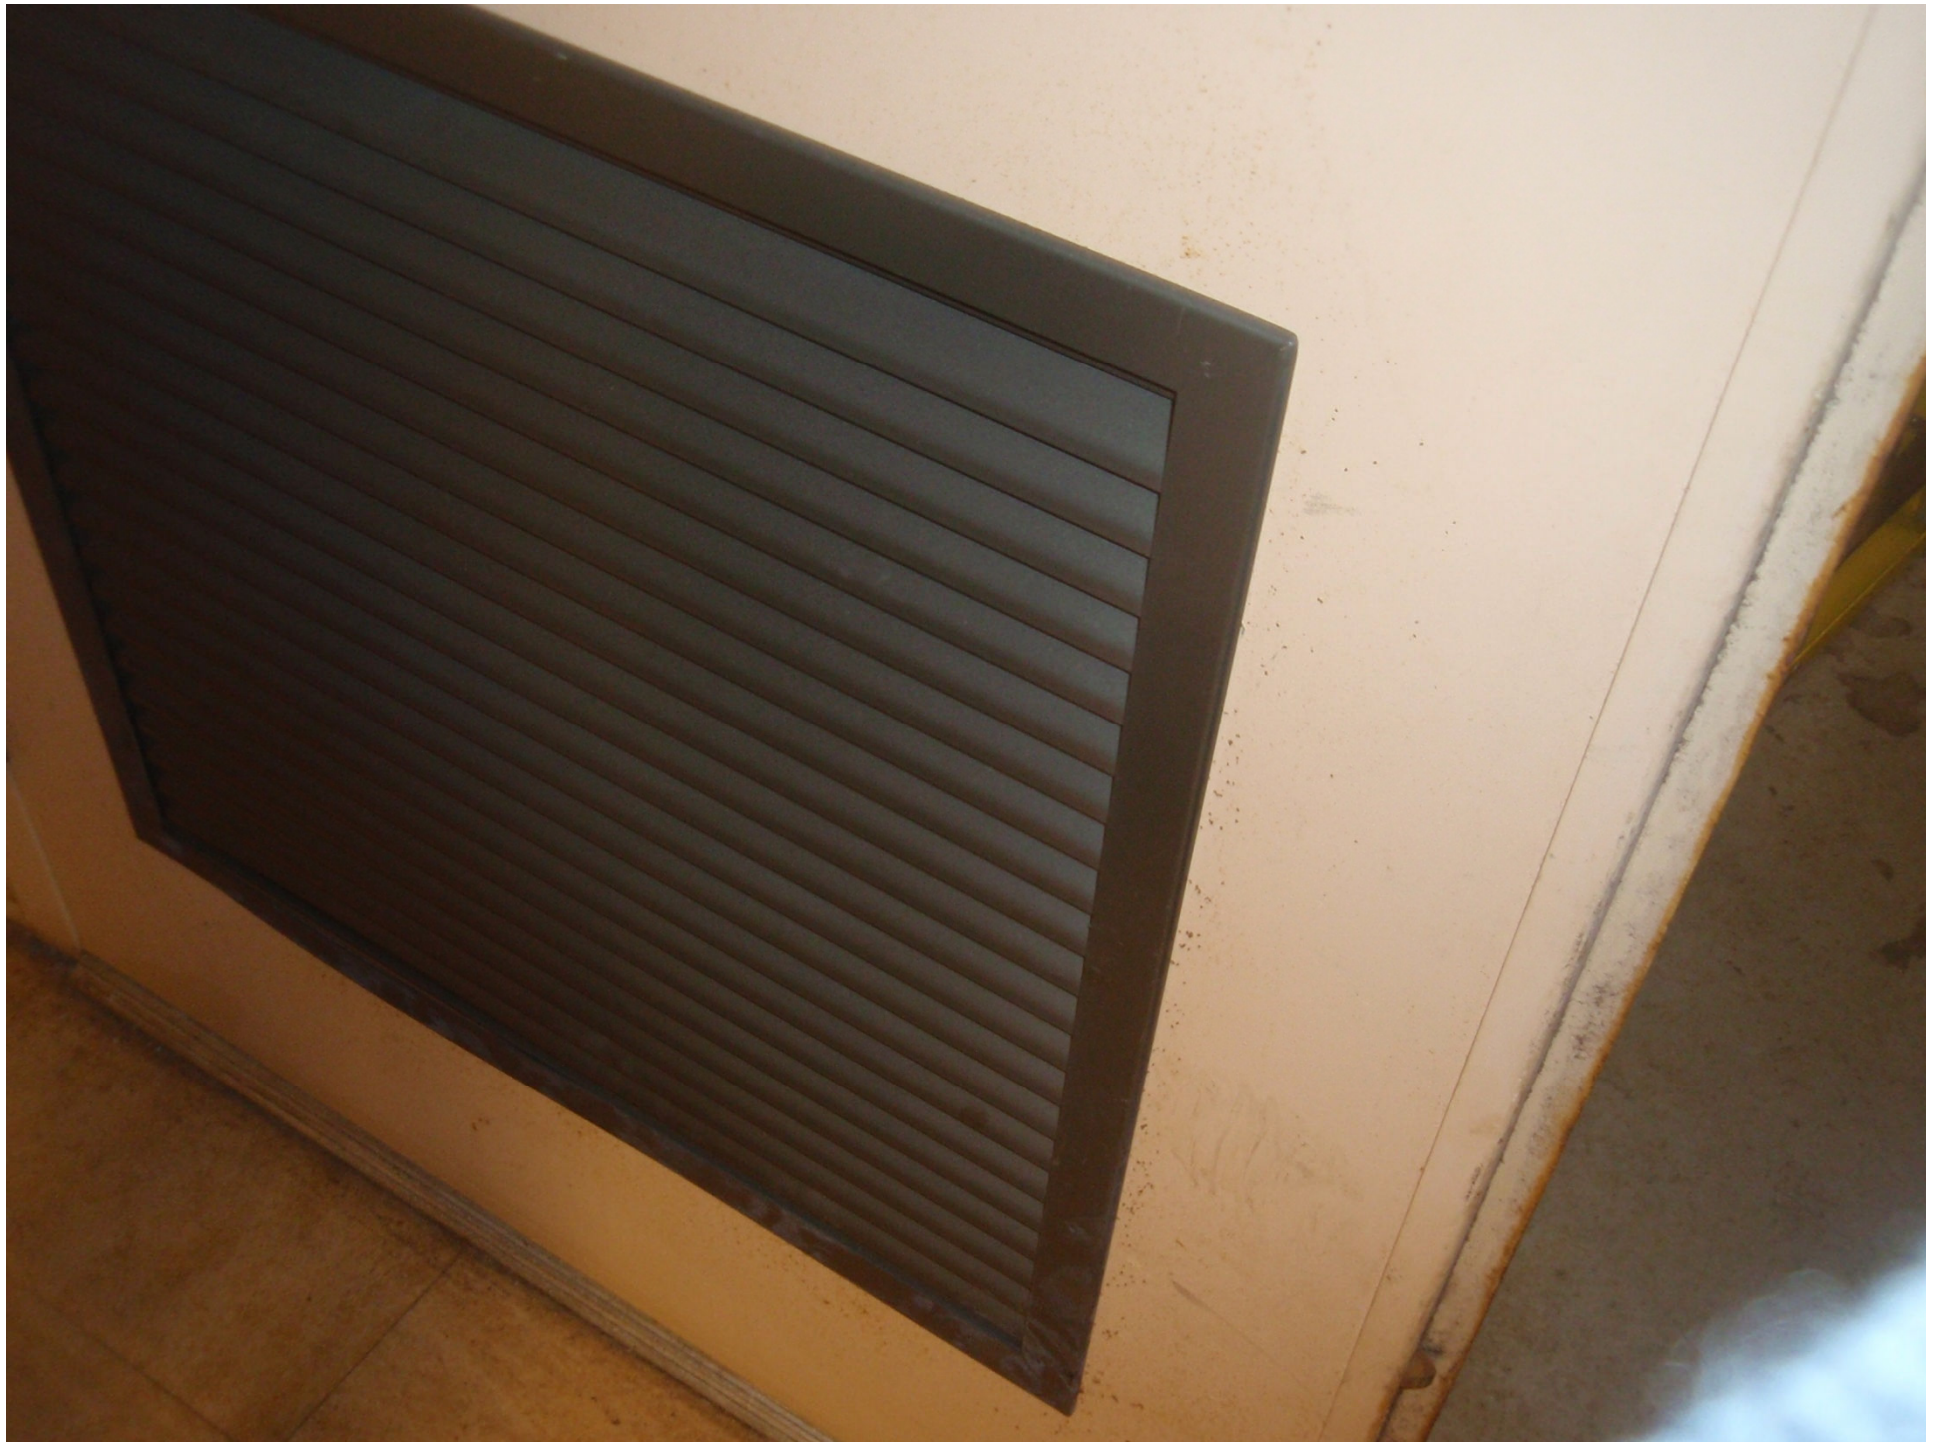
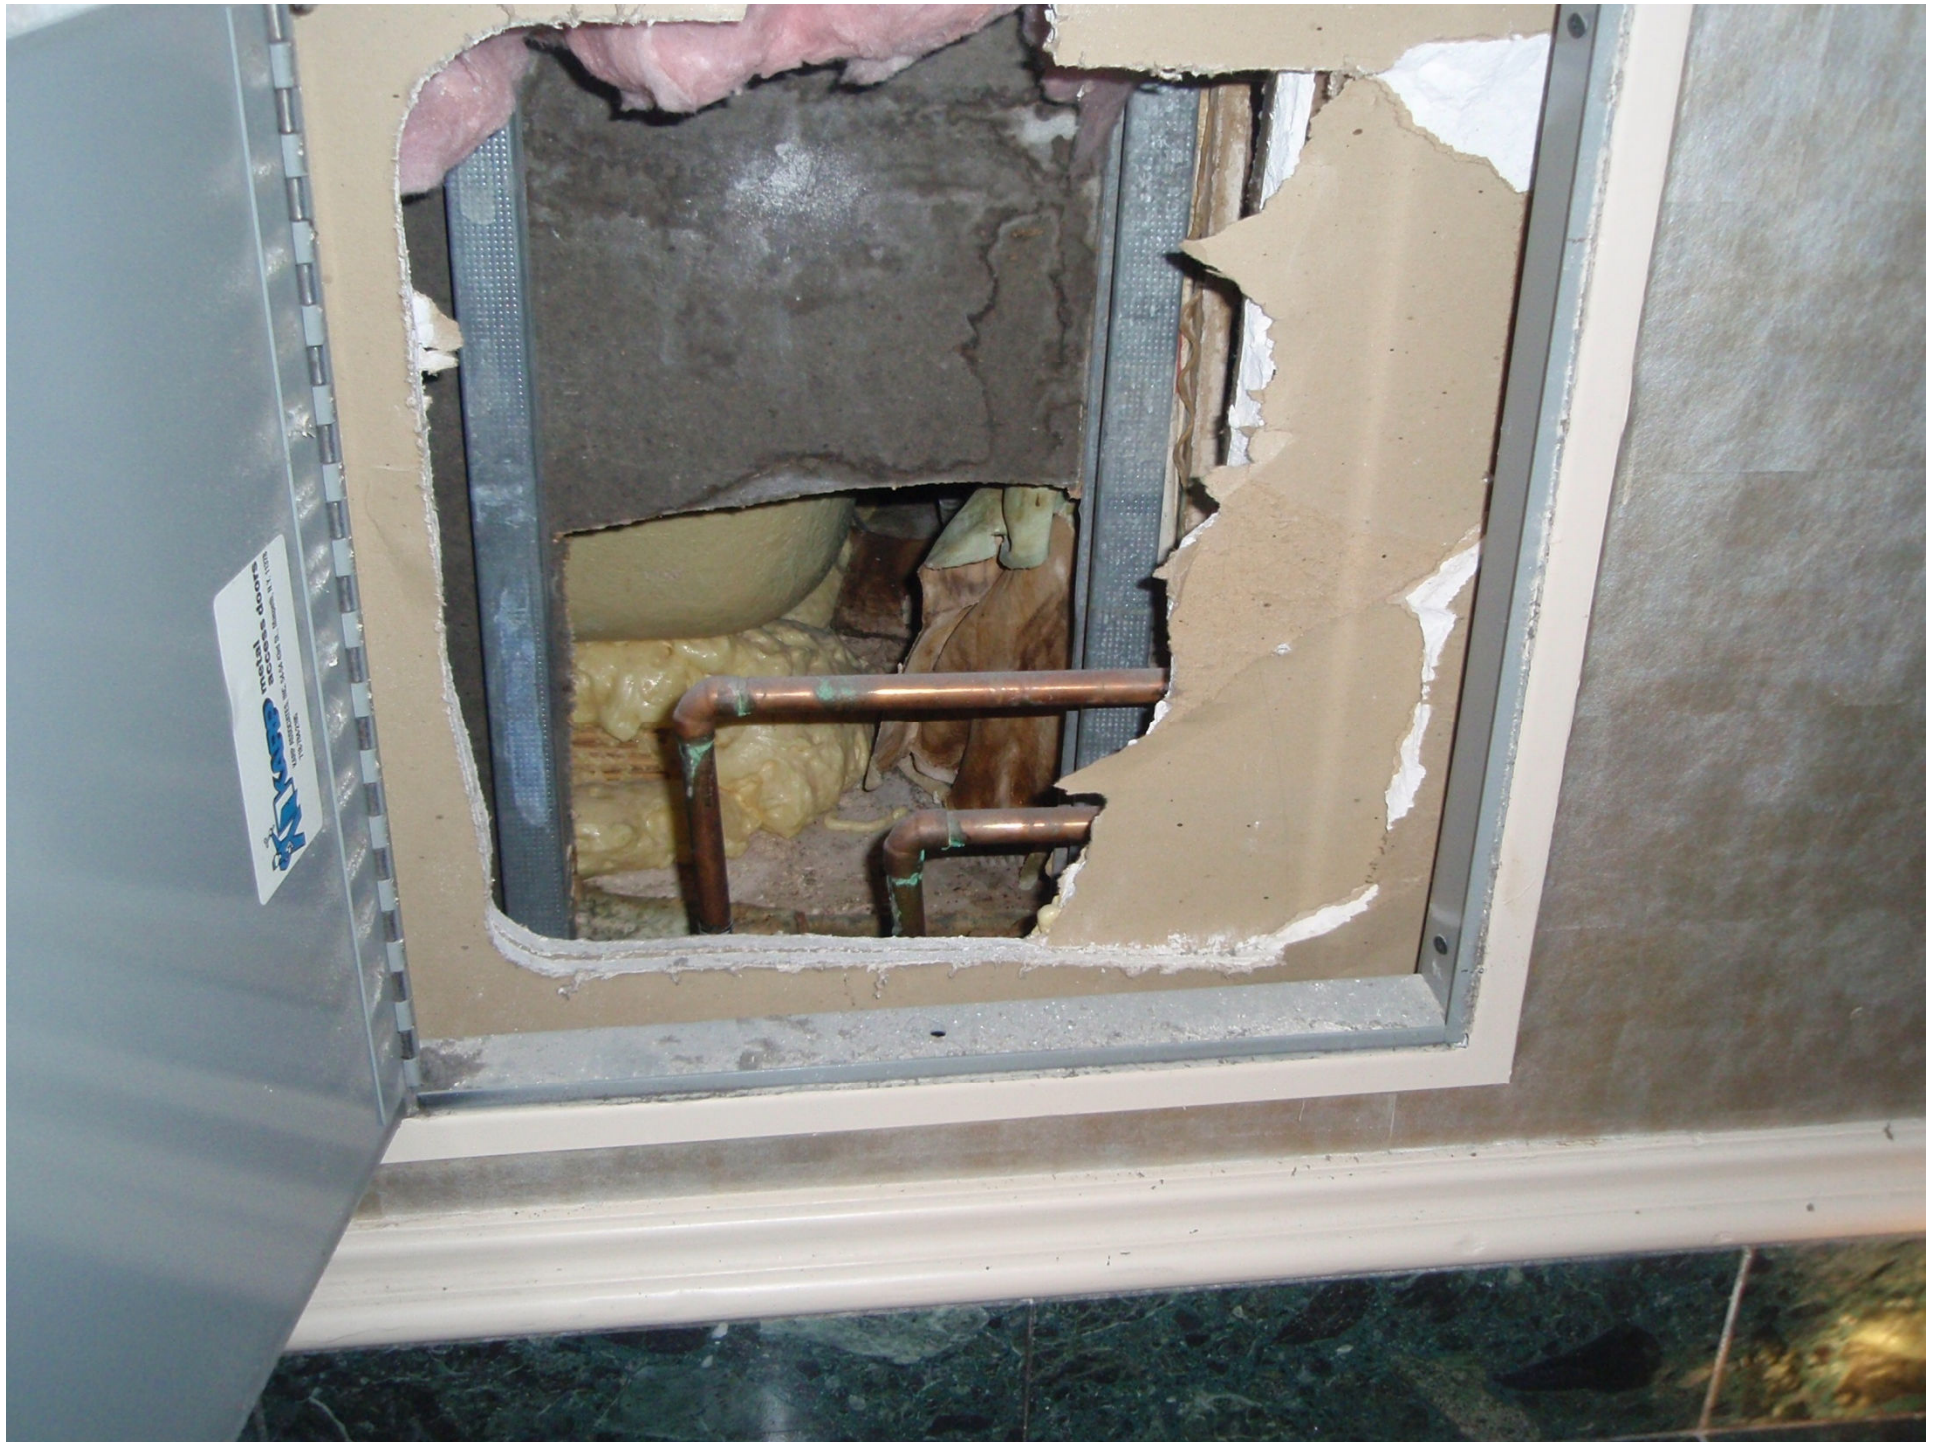
OPENING PROTECTIVES
