CONSTRUCTION WITHOUT OVERSIGHT

Douglas H. Evans, P.E., FSFPE
DHE FPE LLC
Las Vegas, NV

In 2008, Clark County Building Department instituted a rigorous inspections program to uncover unreported building code violations in the existing resorts on the world-famous Las Vegas Strip. The violations discovered were primarily due to substantial work conducted without permits or inspections and inadequate or improper maintenance. An overview of the various types of violations and their extent will be discussed.

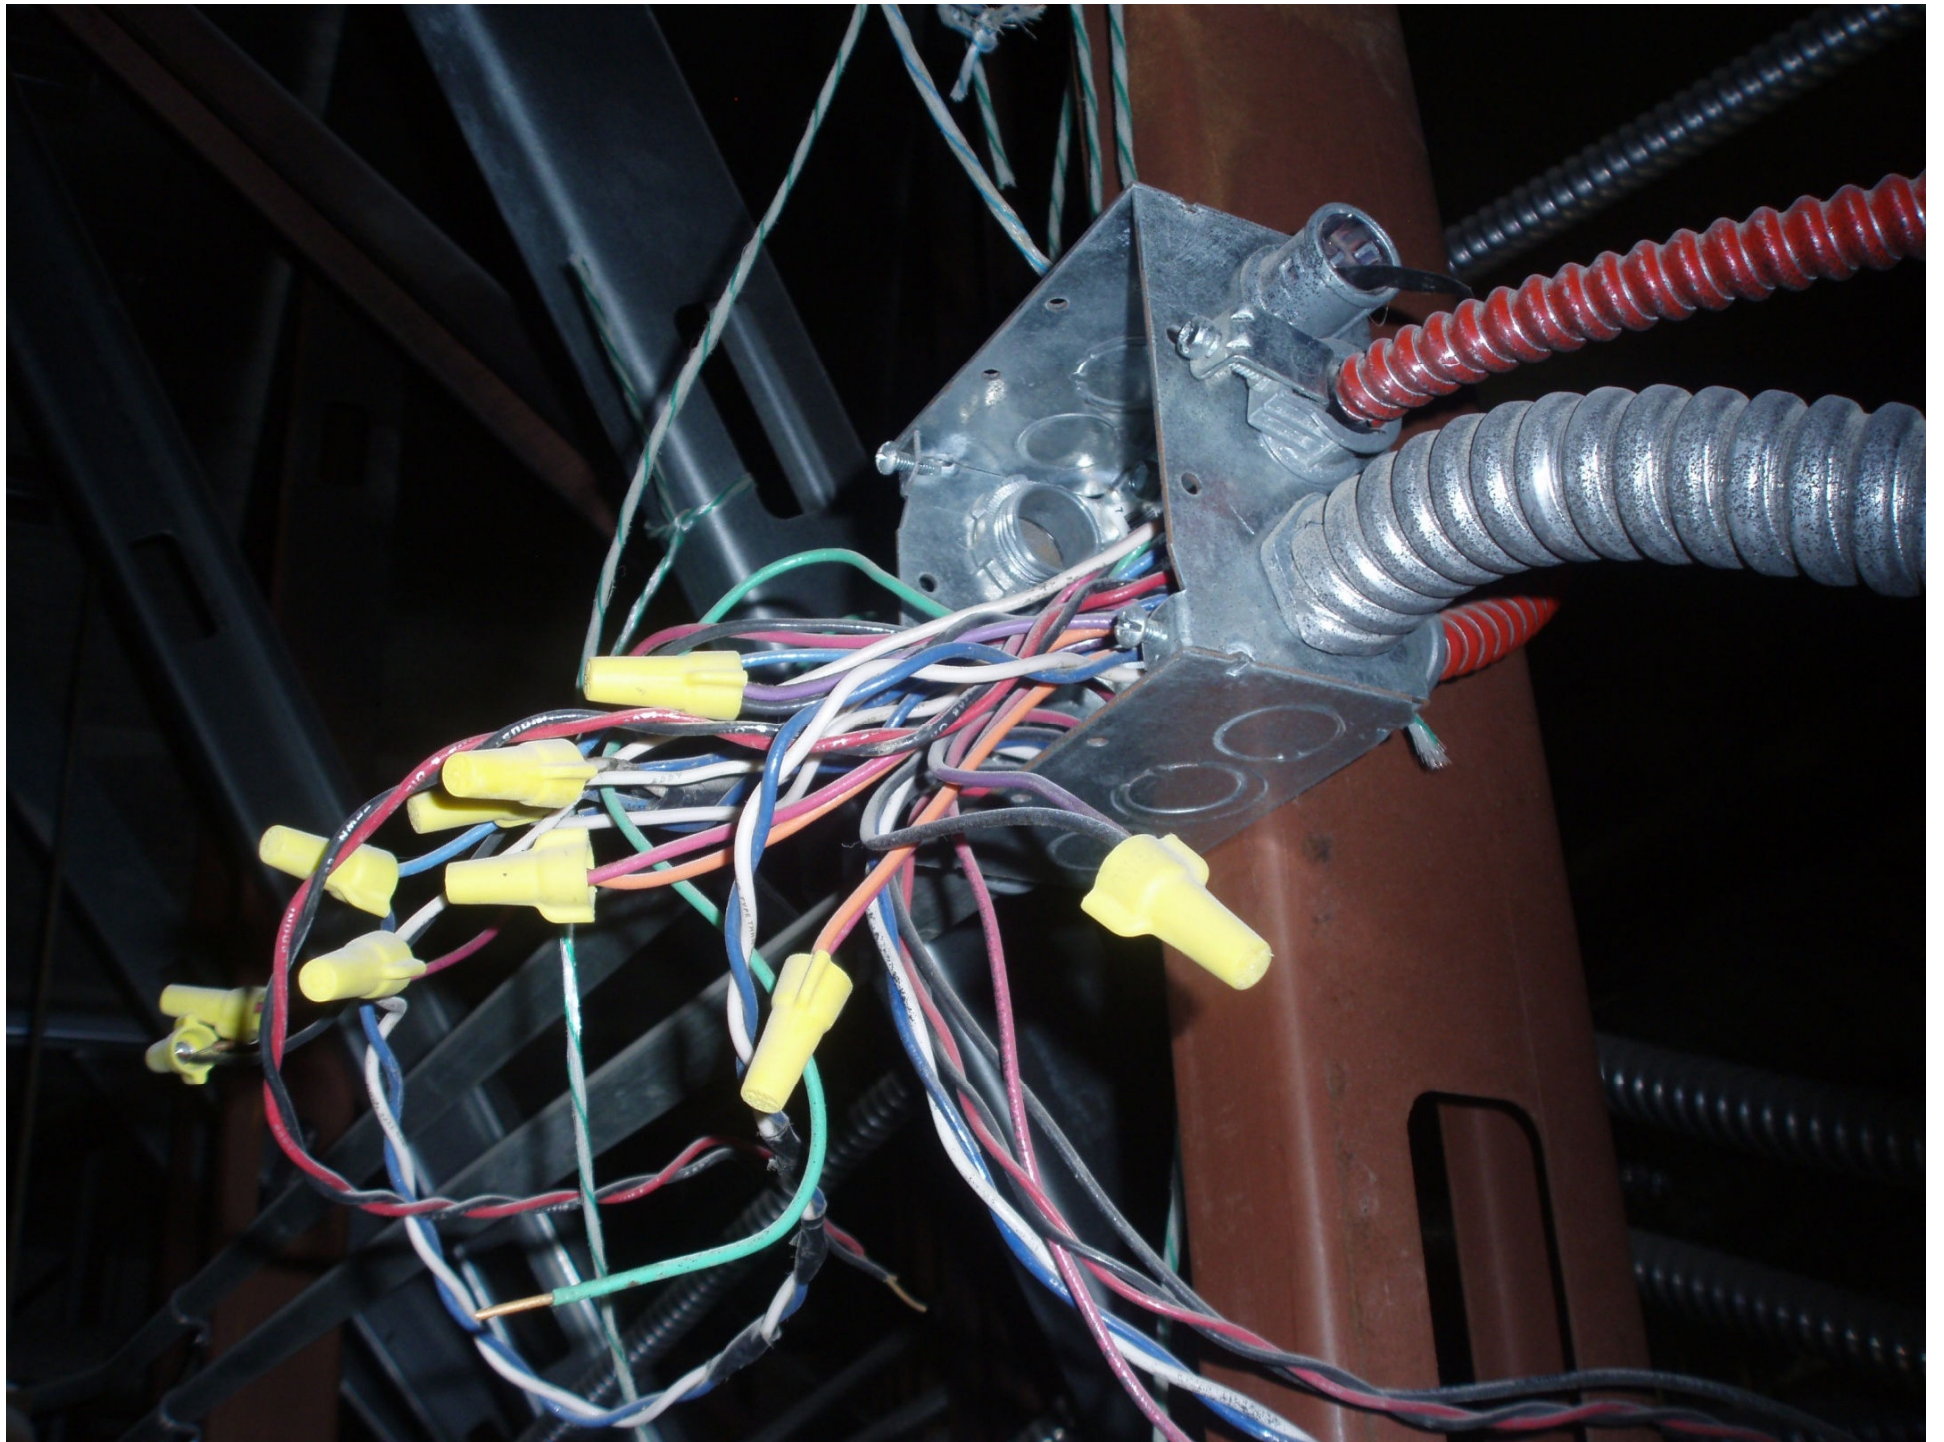
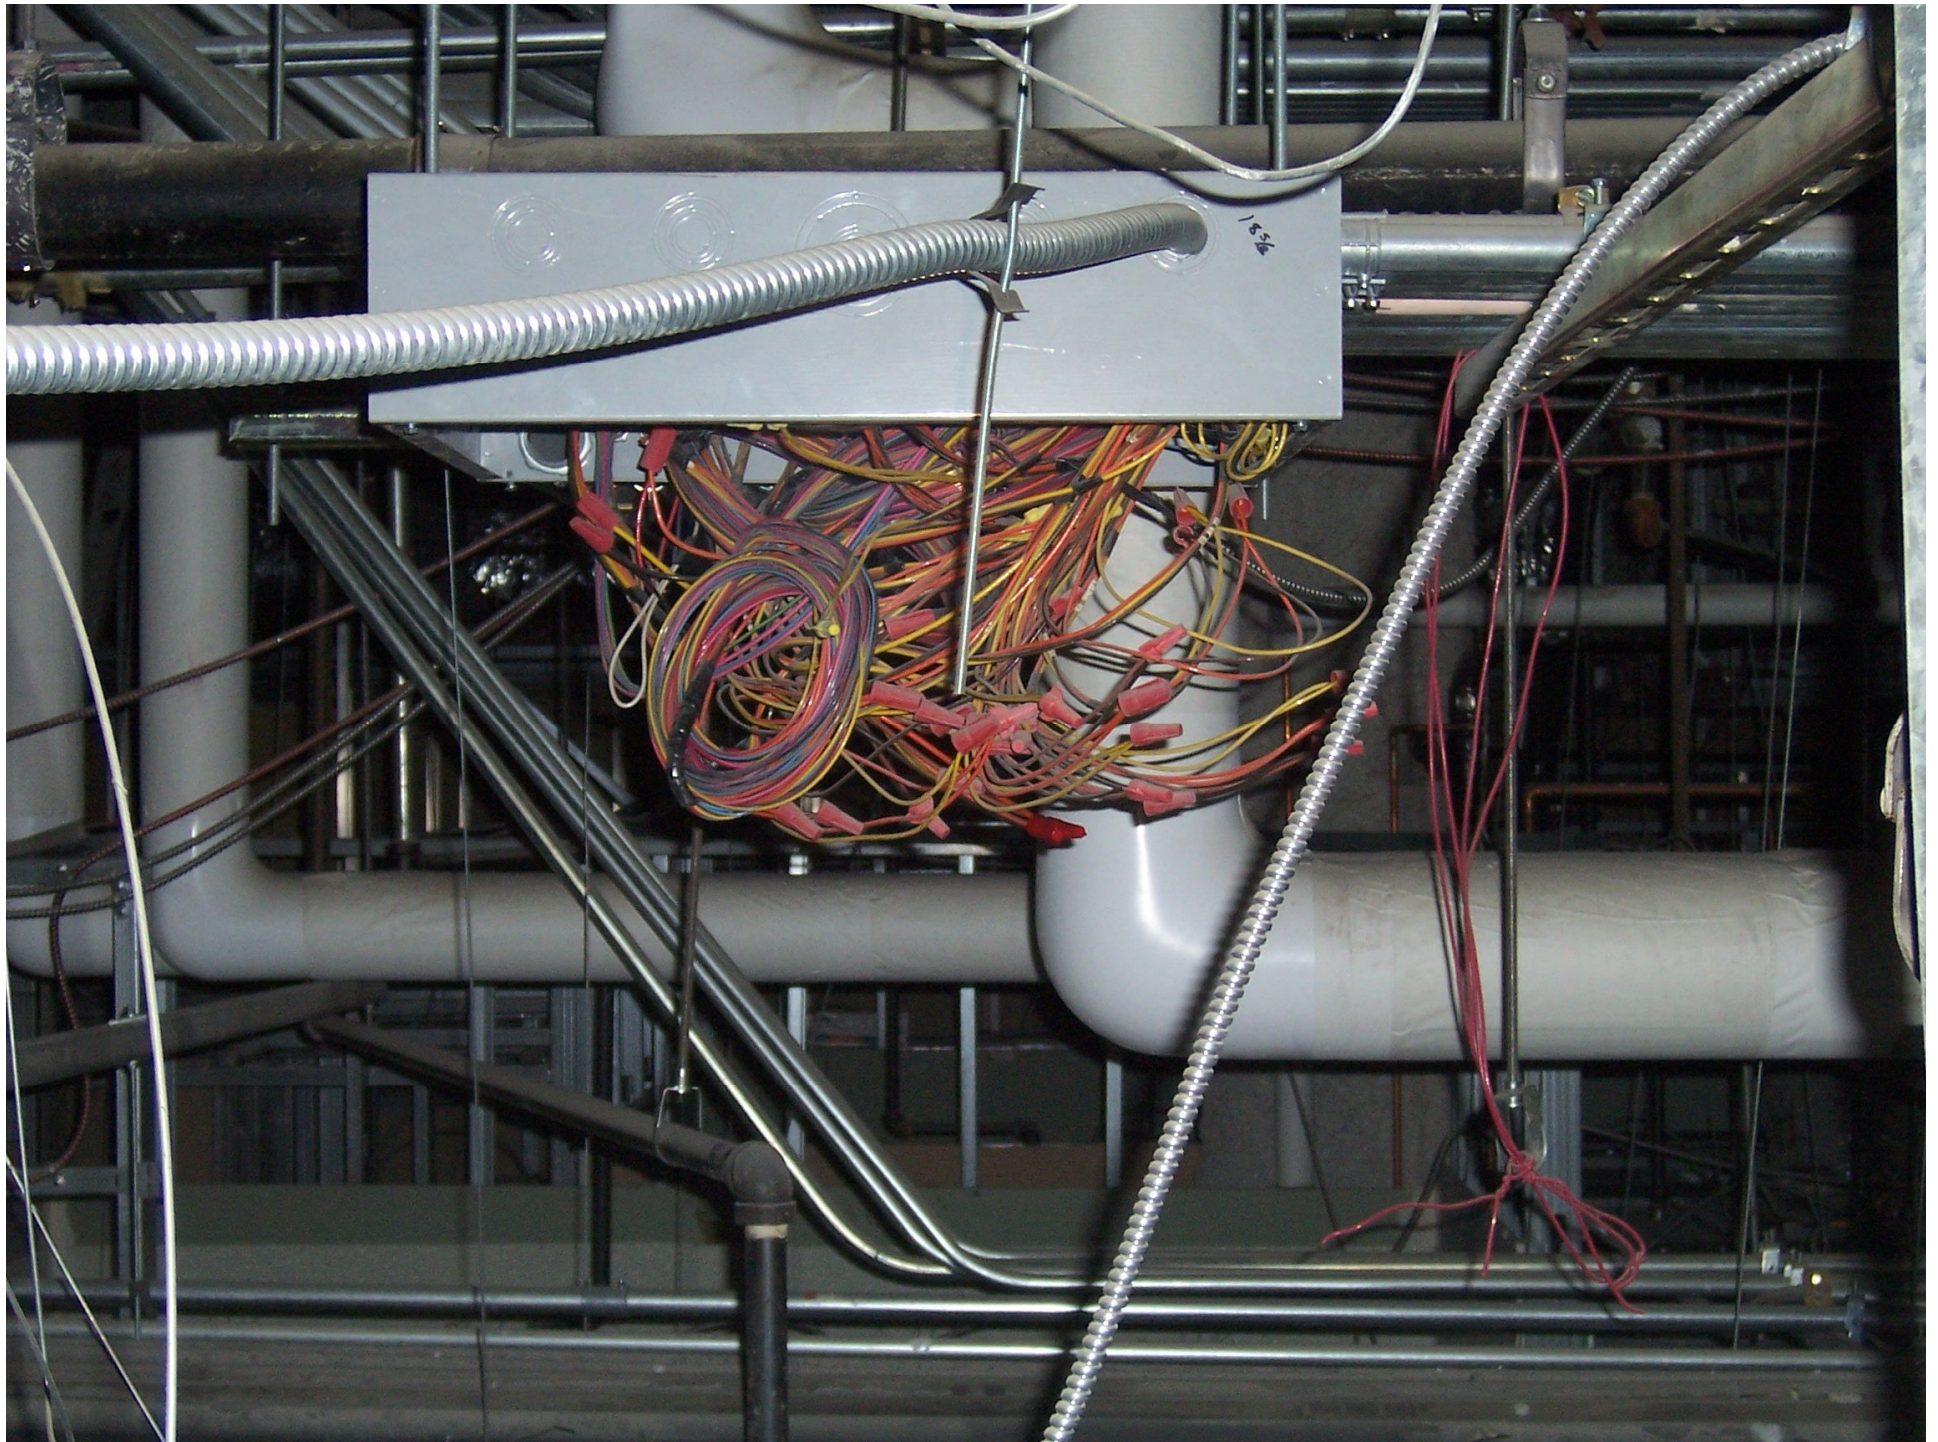
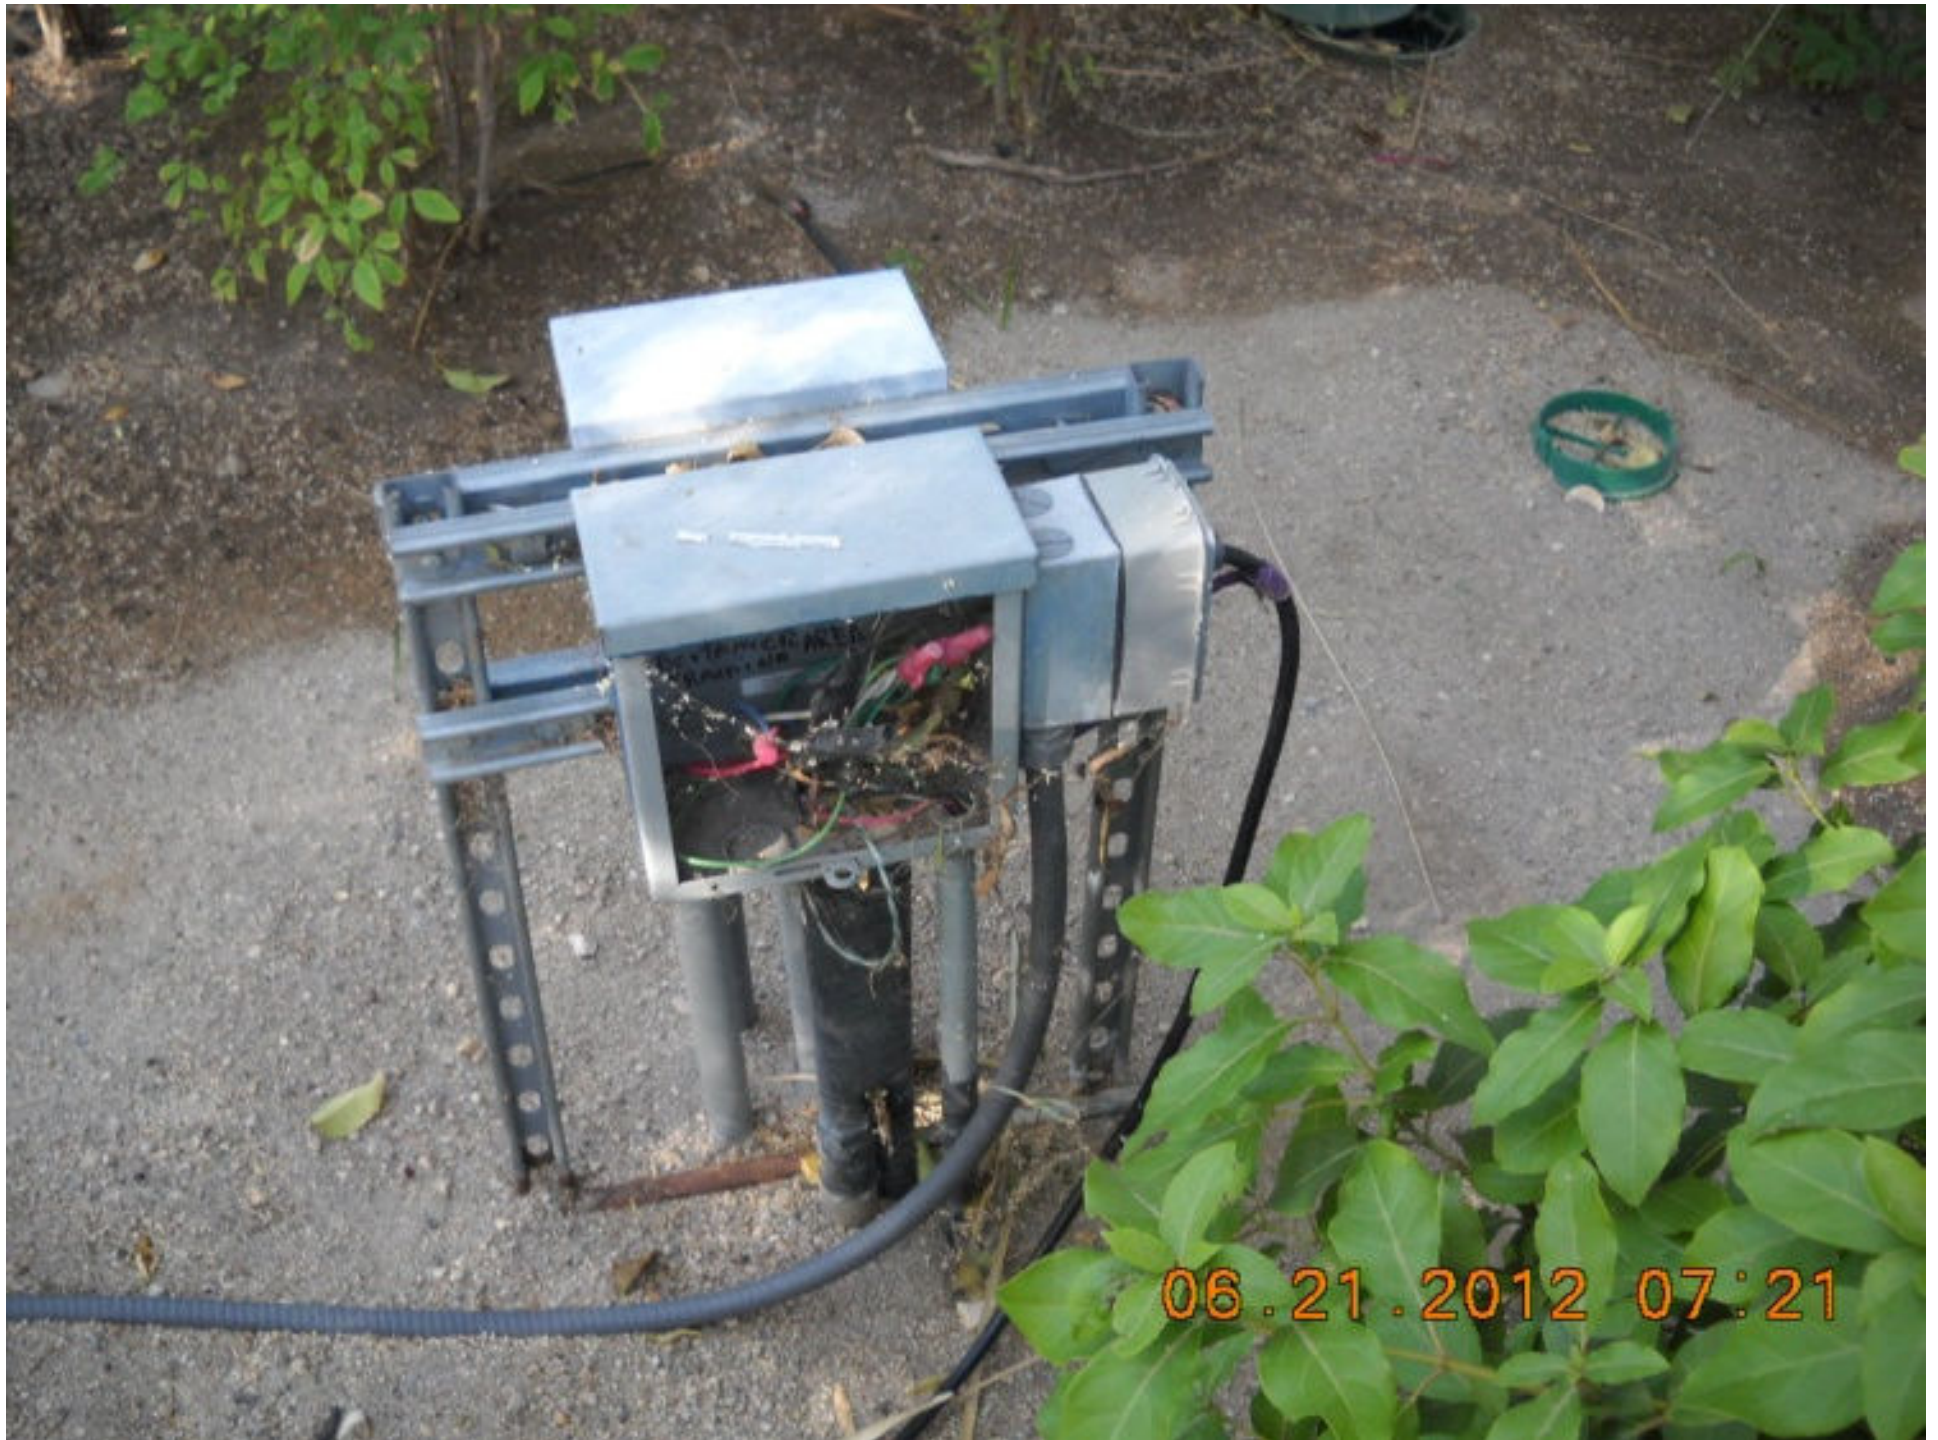
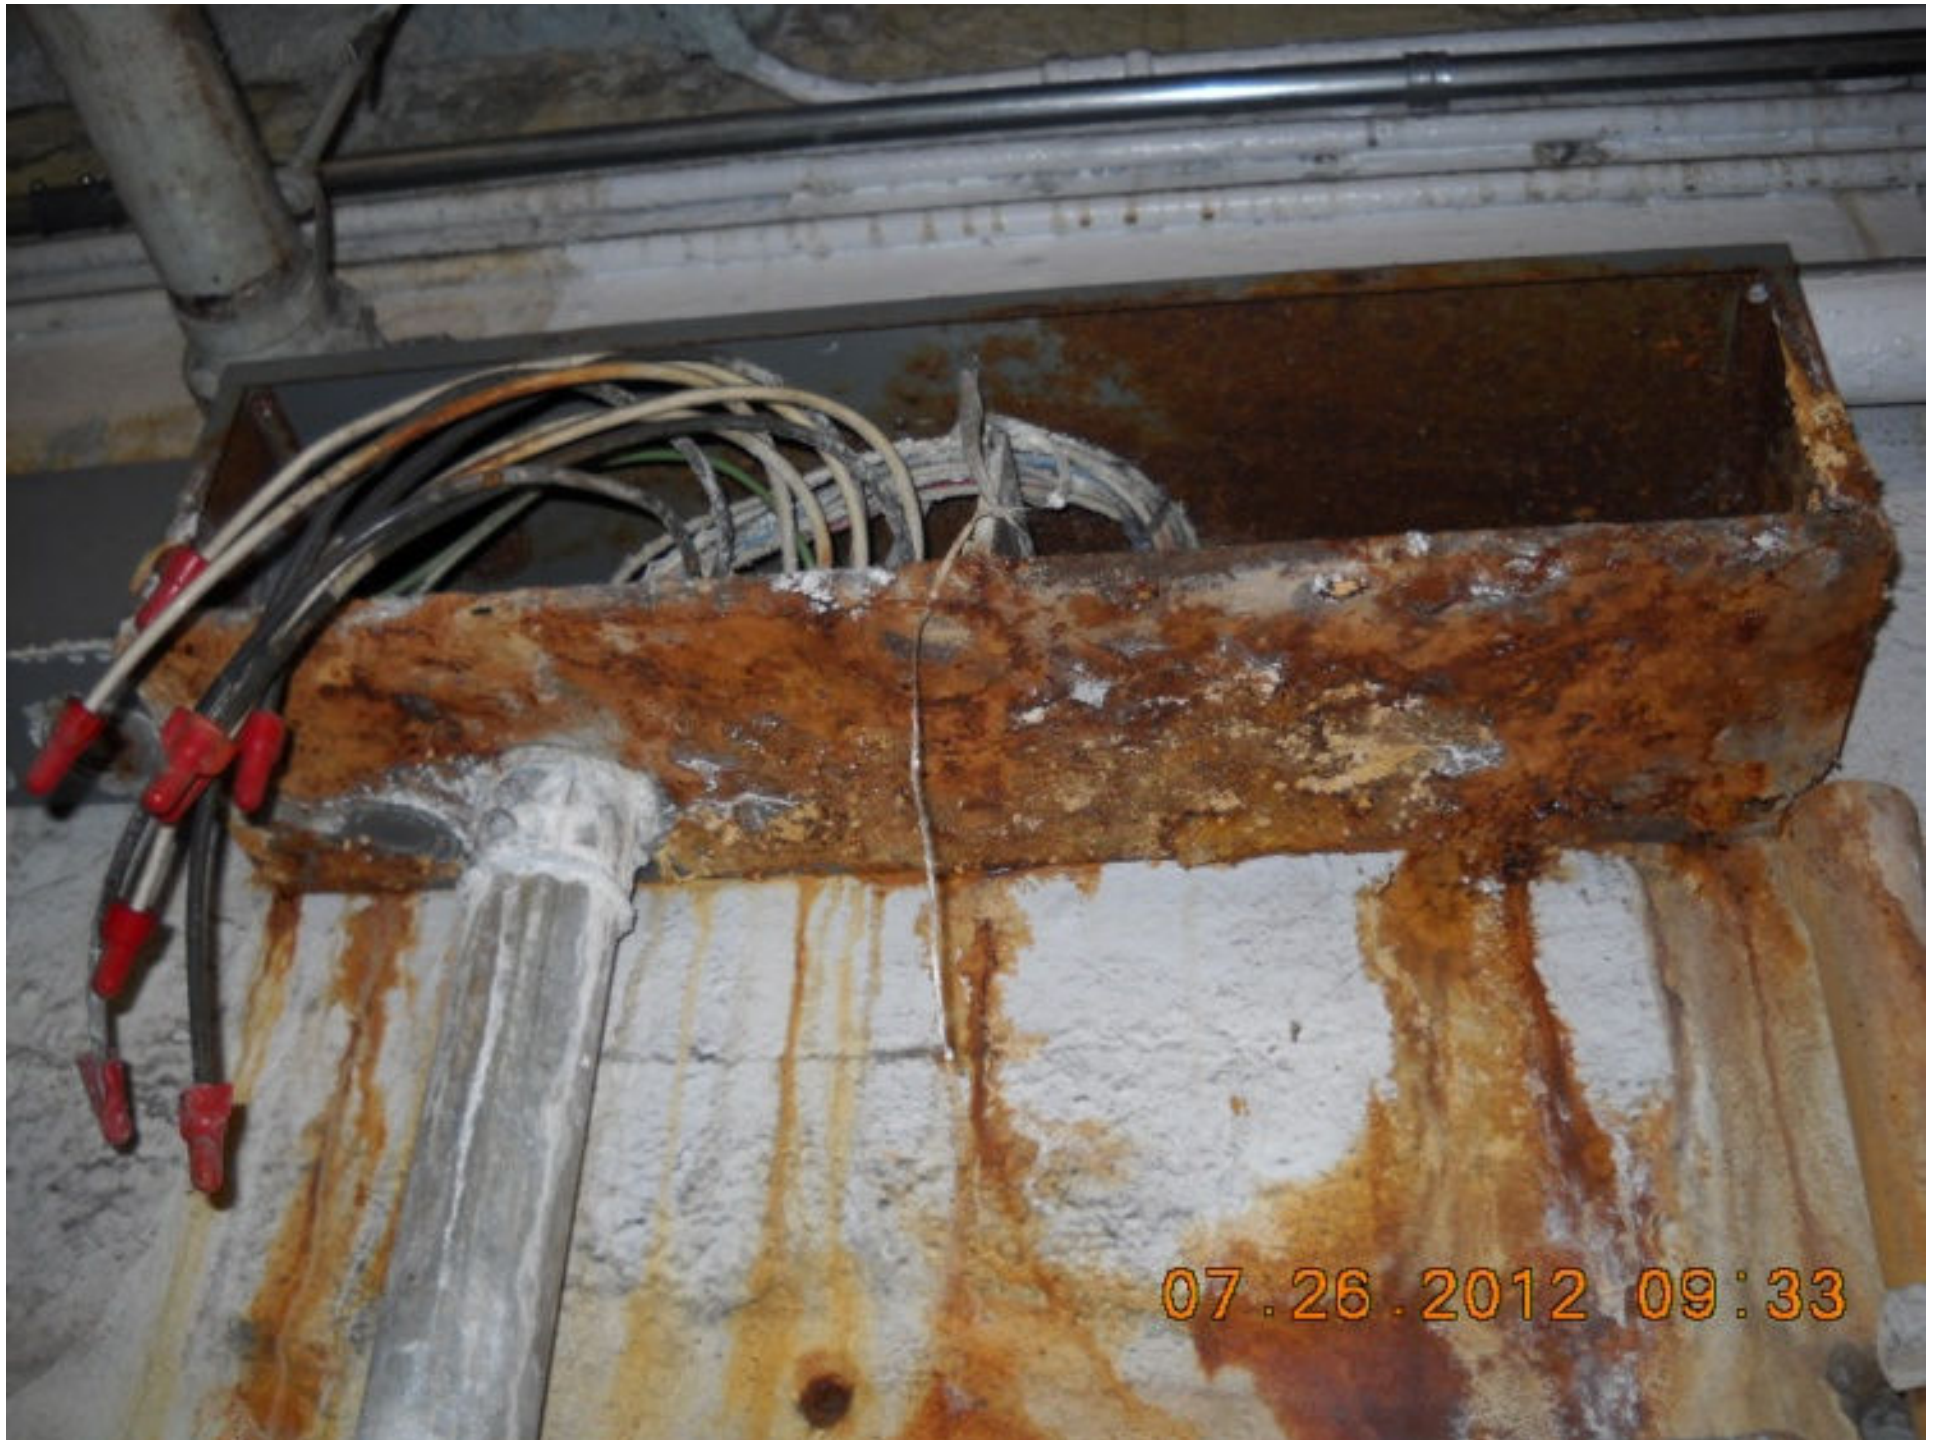
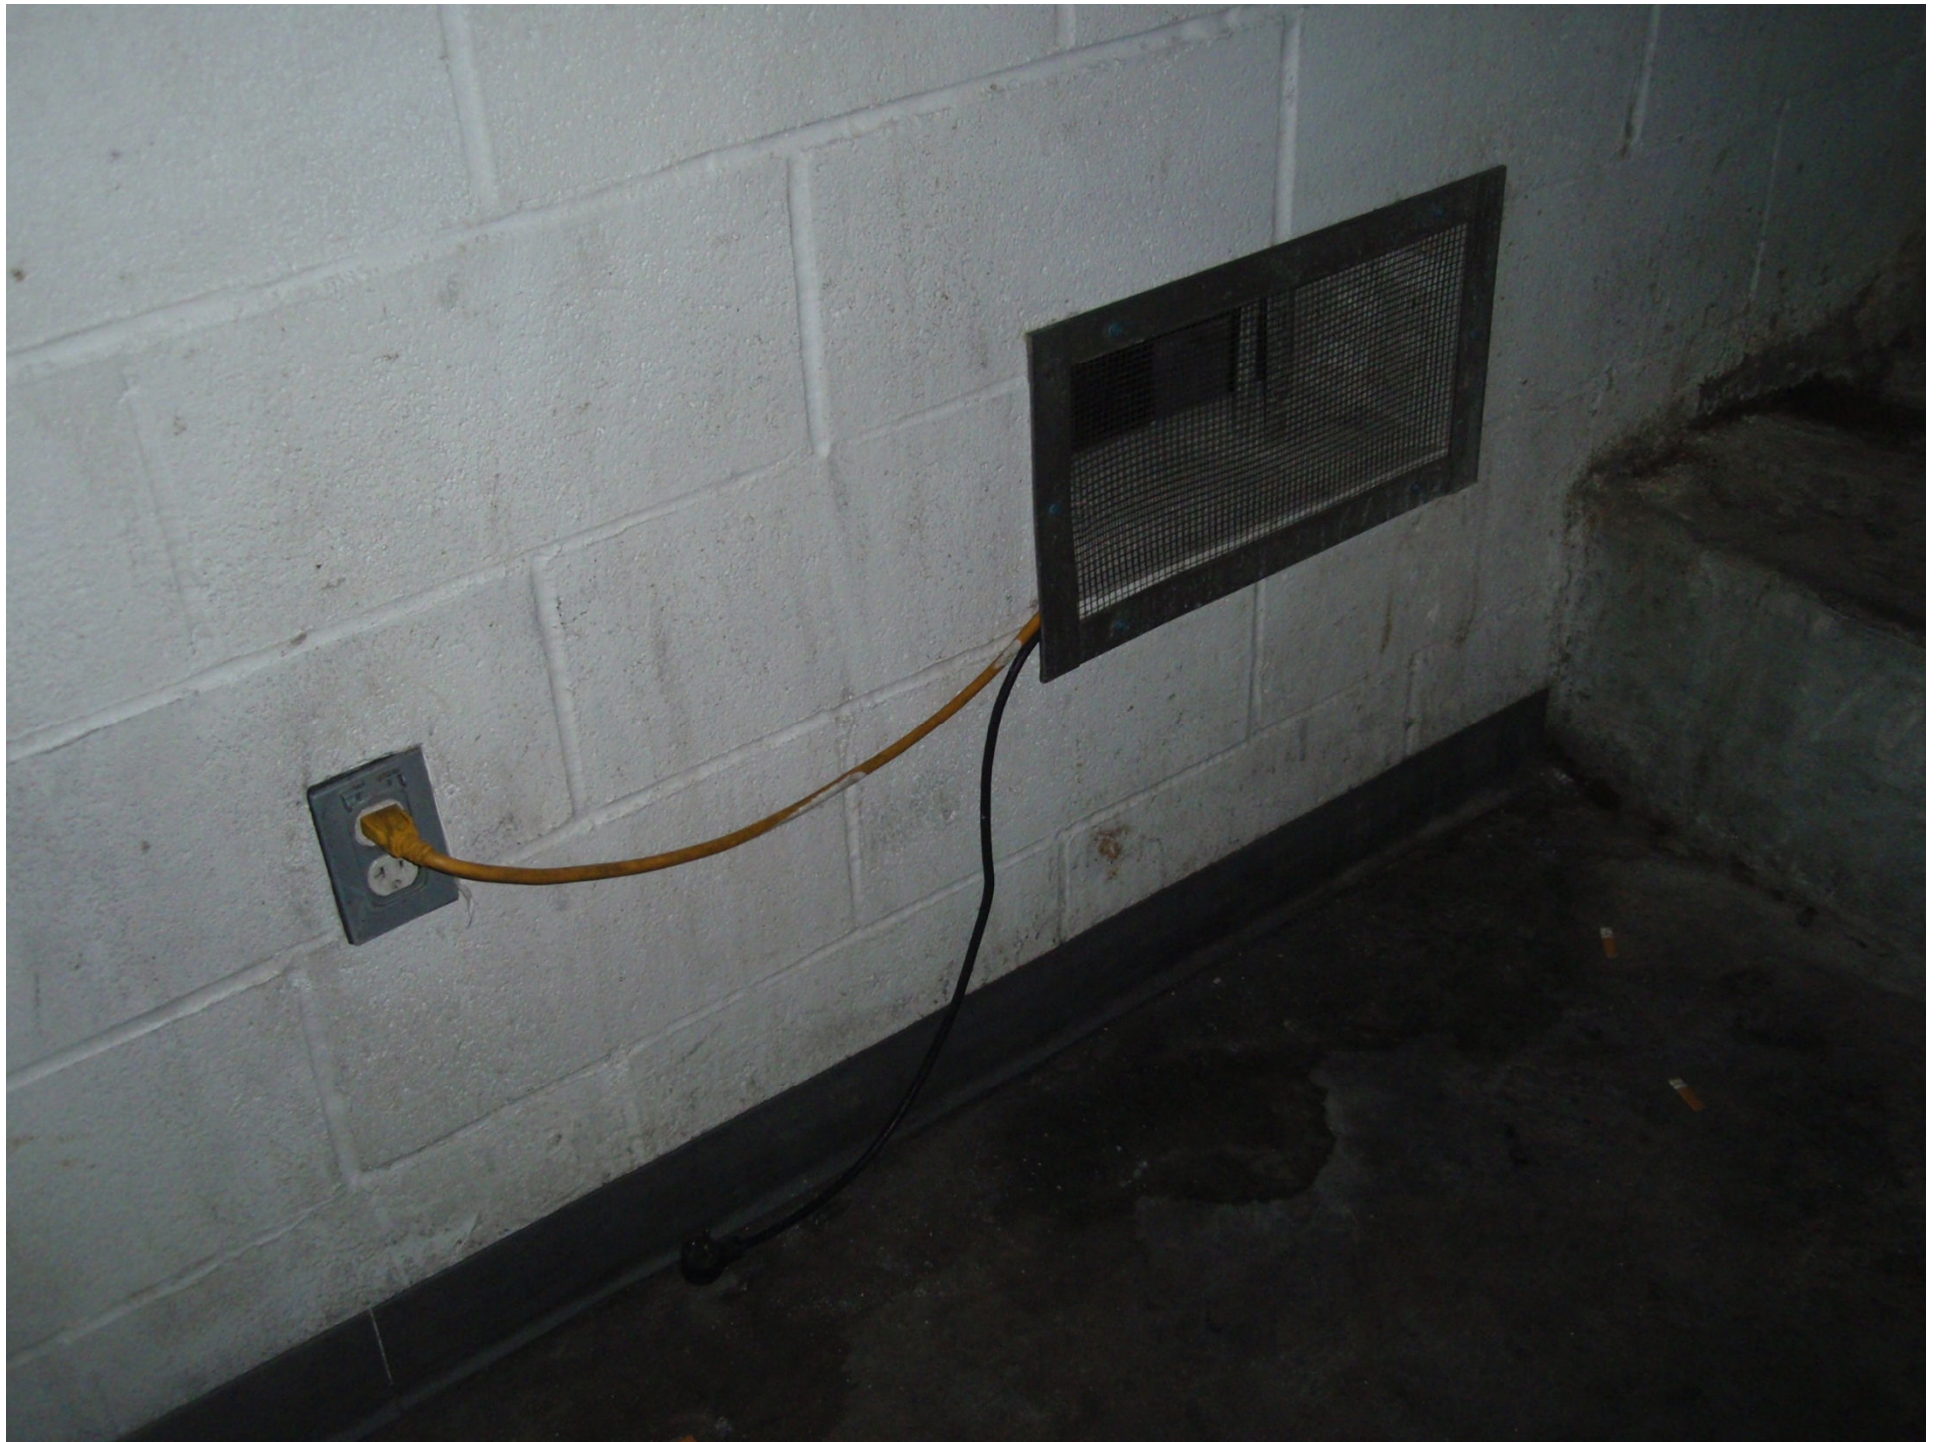
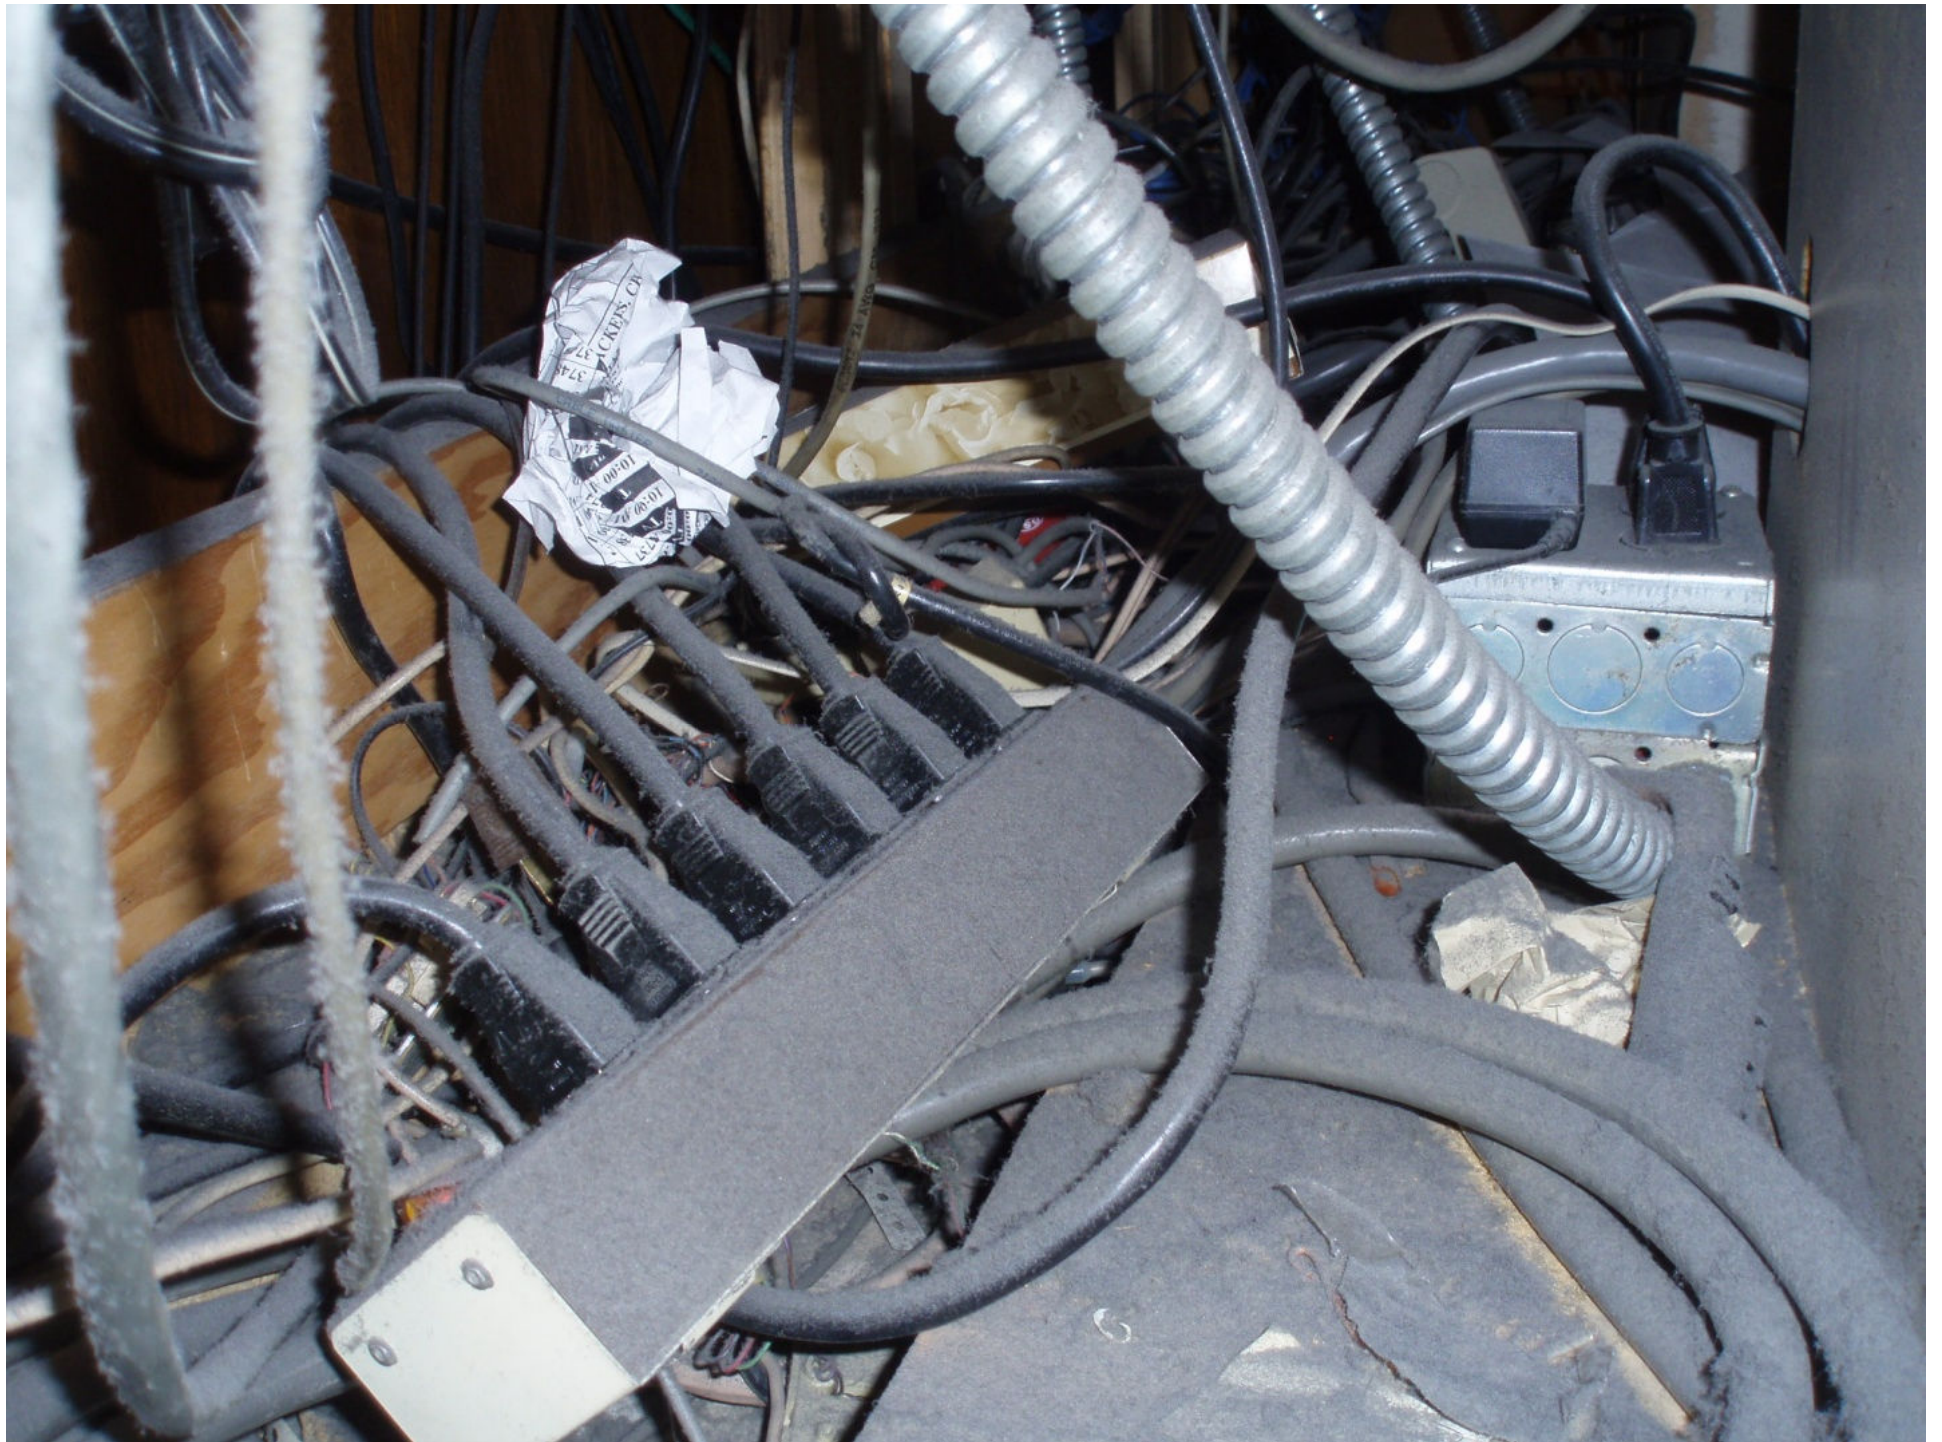
Electrical Violations
