CONSTRUCTION WITHOUT OVERSIGHT

Douglas H. Evans, P.E., FSFPE
DHE FPE LLC
Las Vegas, NV

In 2008, Clark County Building Department instituted a rigorous inspections program to uncover unreported building code violations in the existing resorts on the world-famous Las Vegas Strip. The violations discovered were primarily due to substantial work conducted without permits or inspections and inadequate or improper maintenance. An overview of the various types of violations and their extent will be discussed.

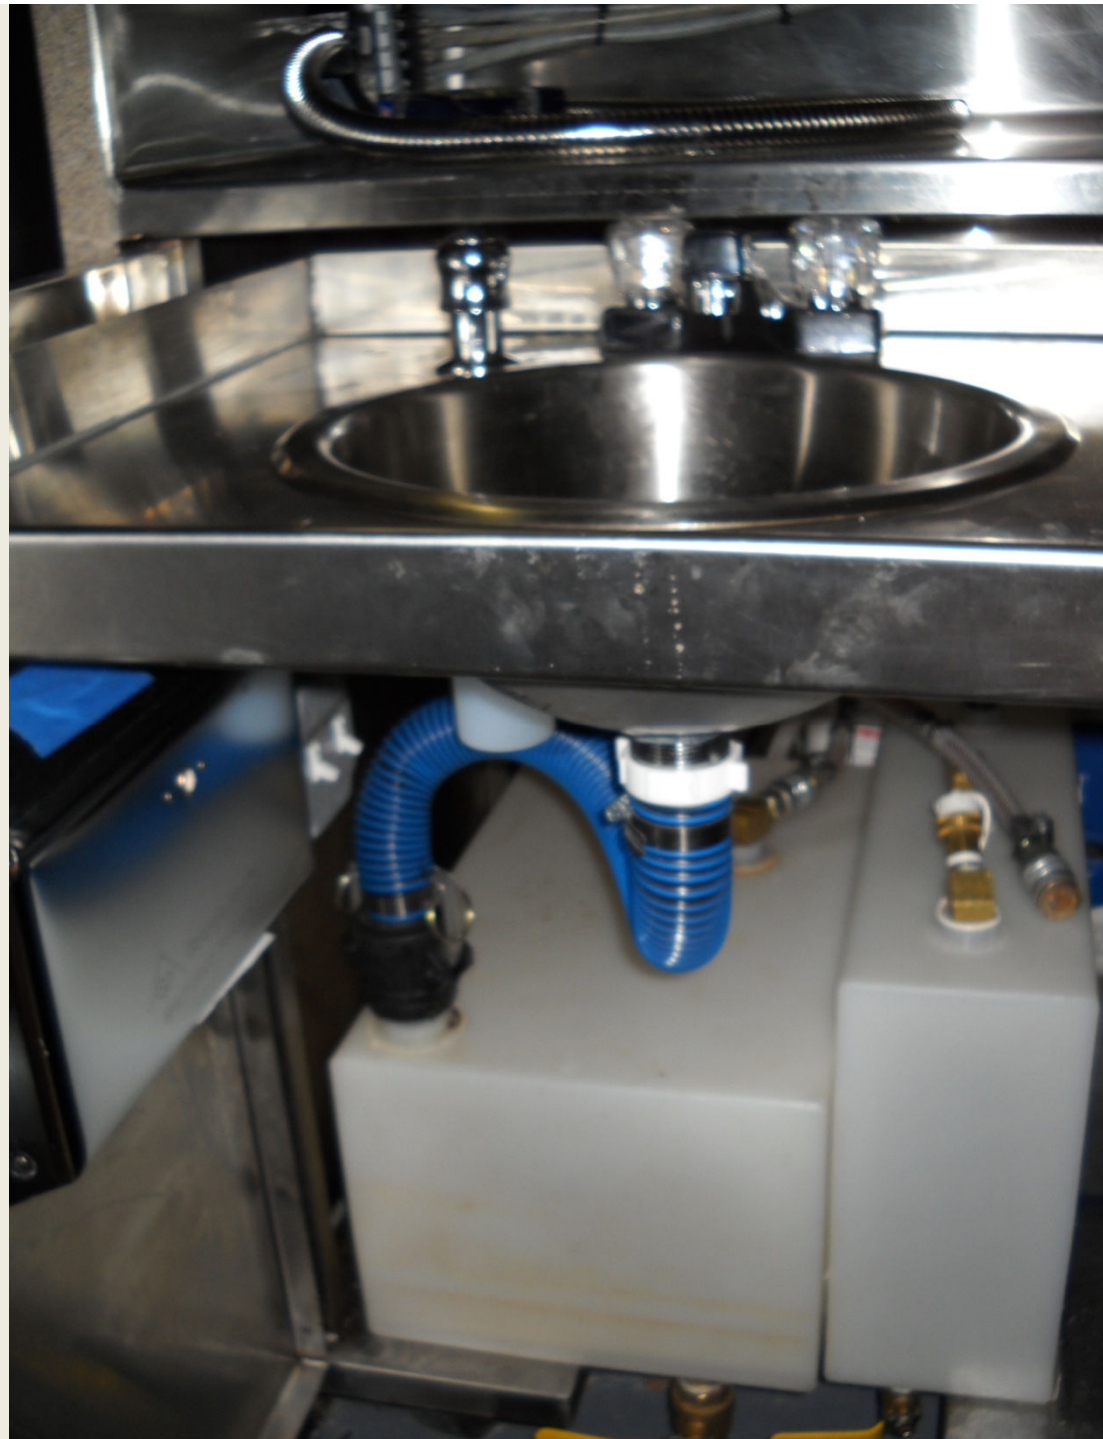
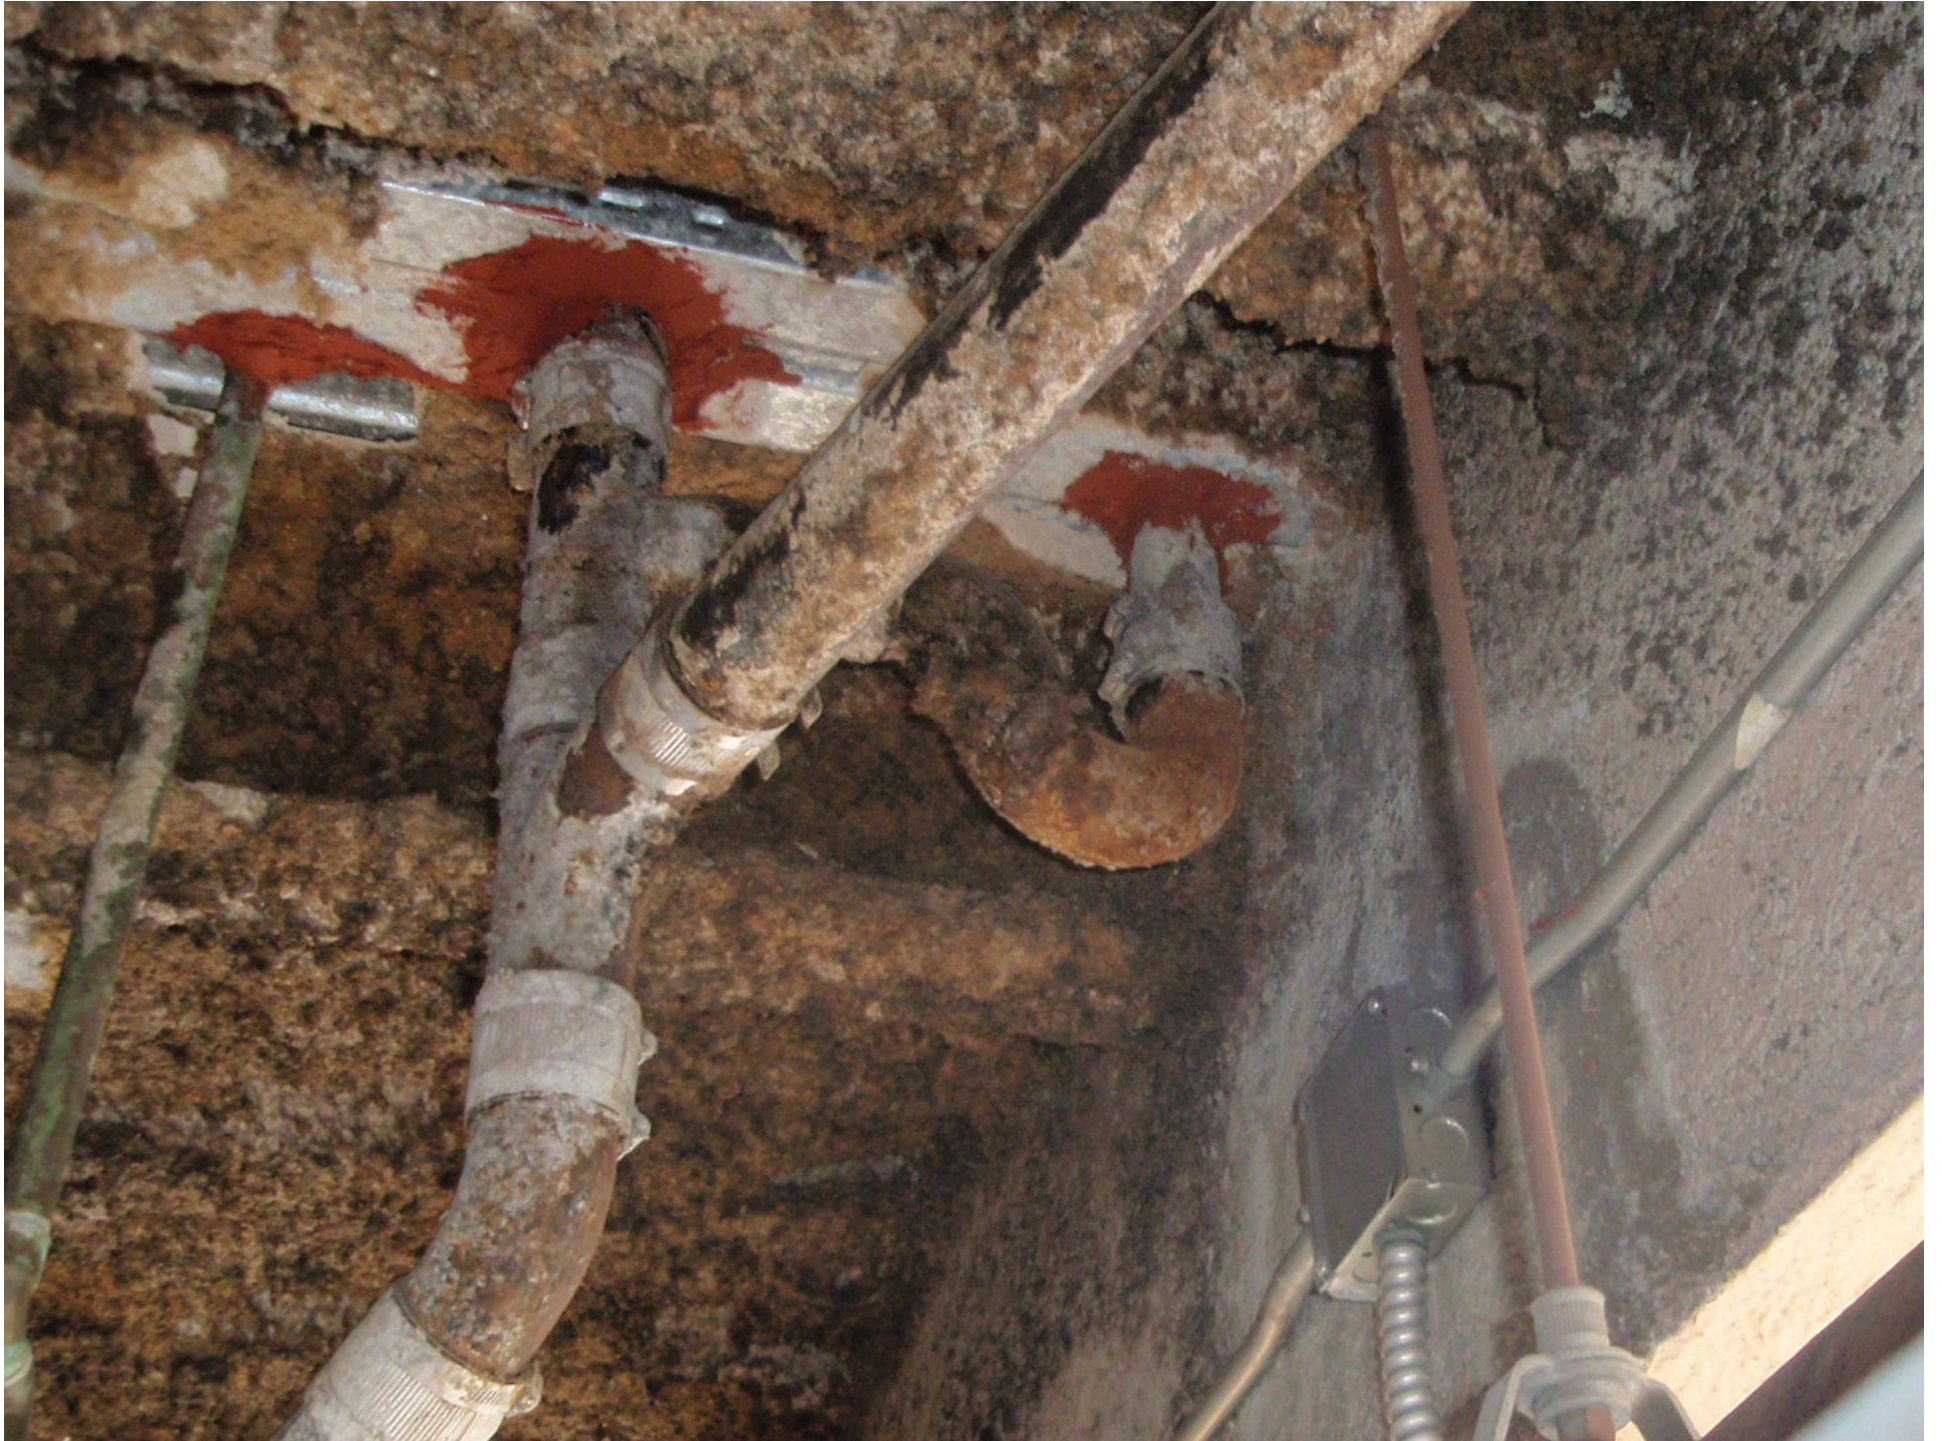
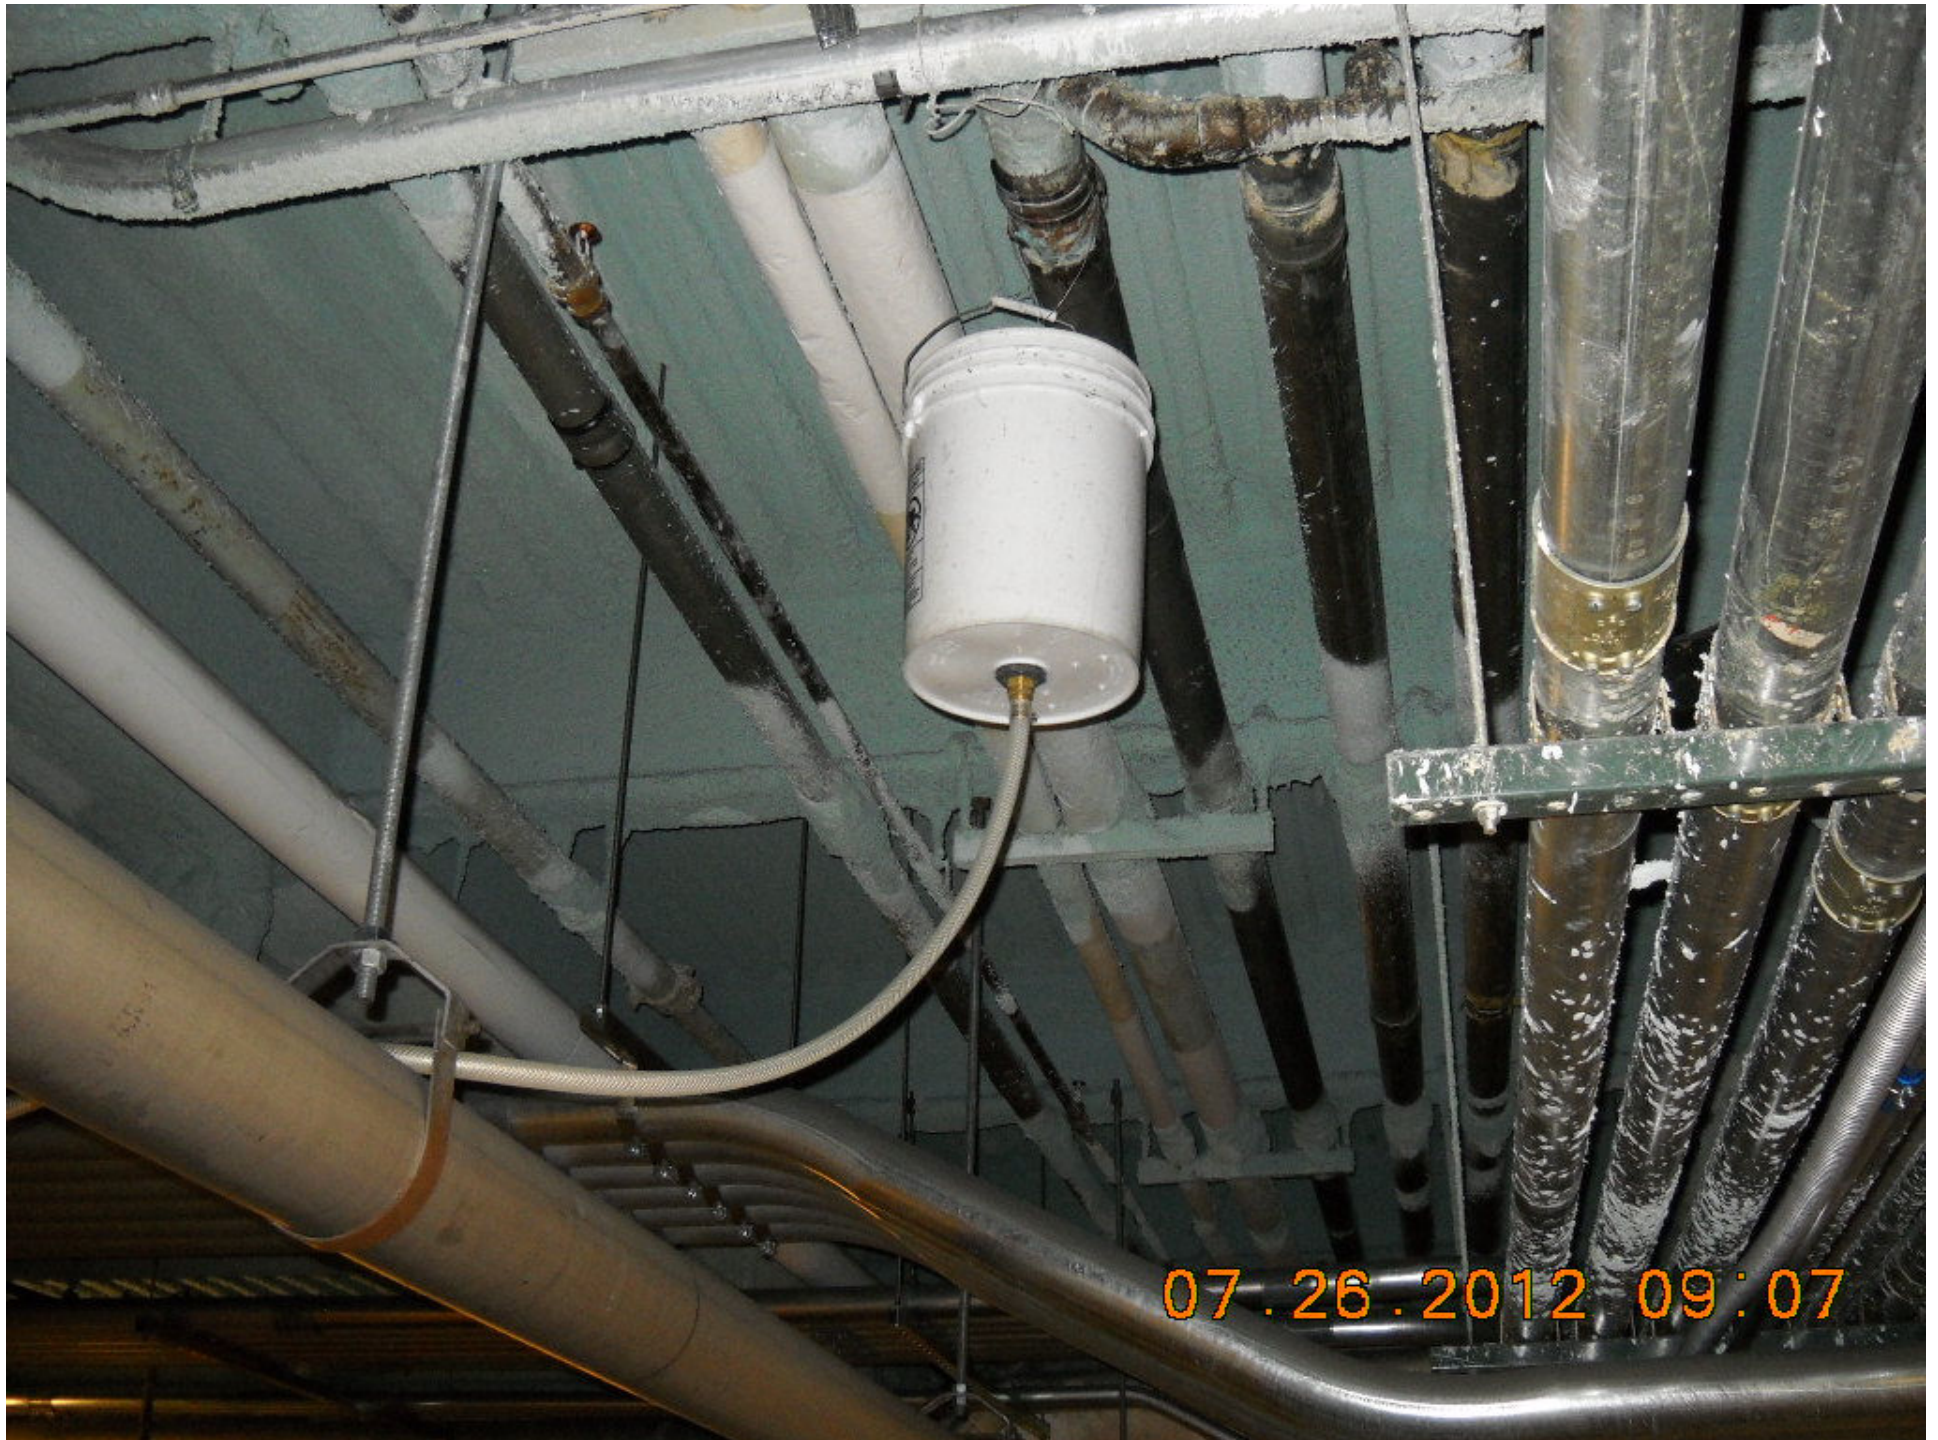
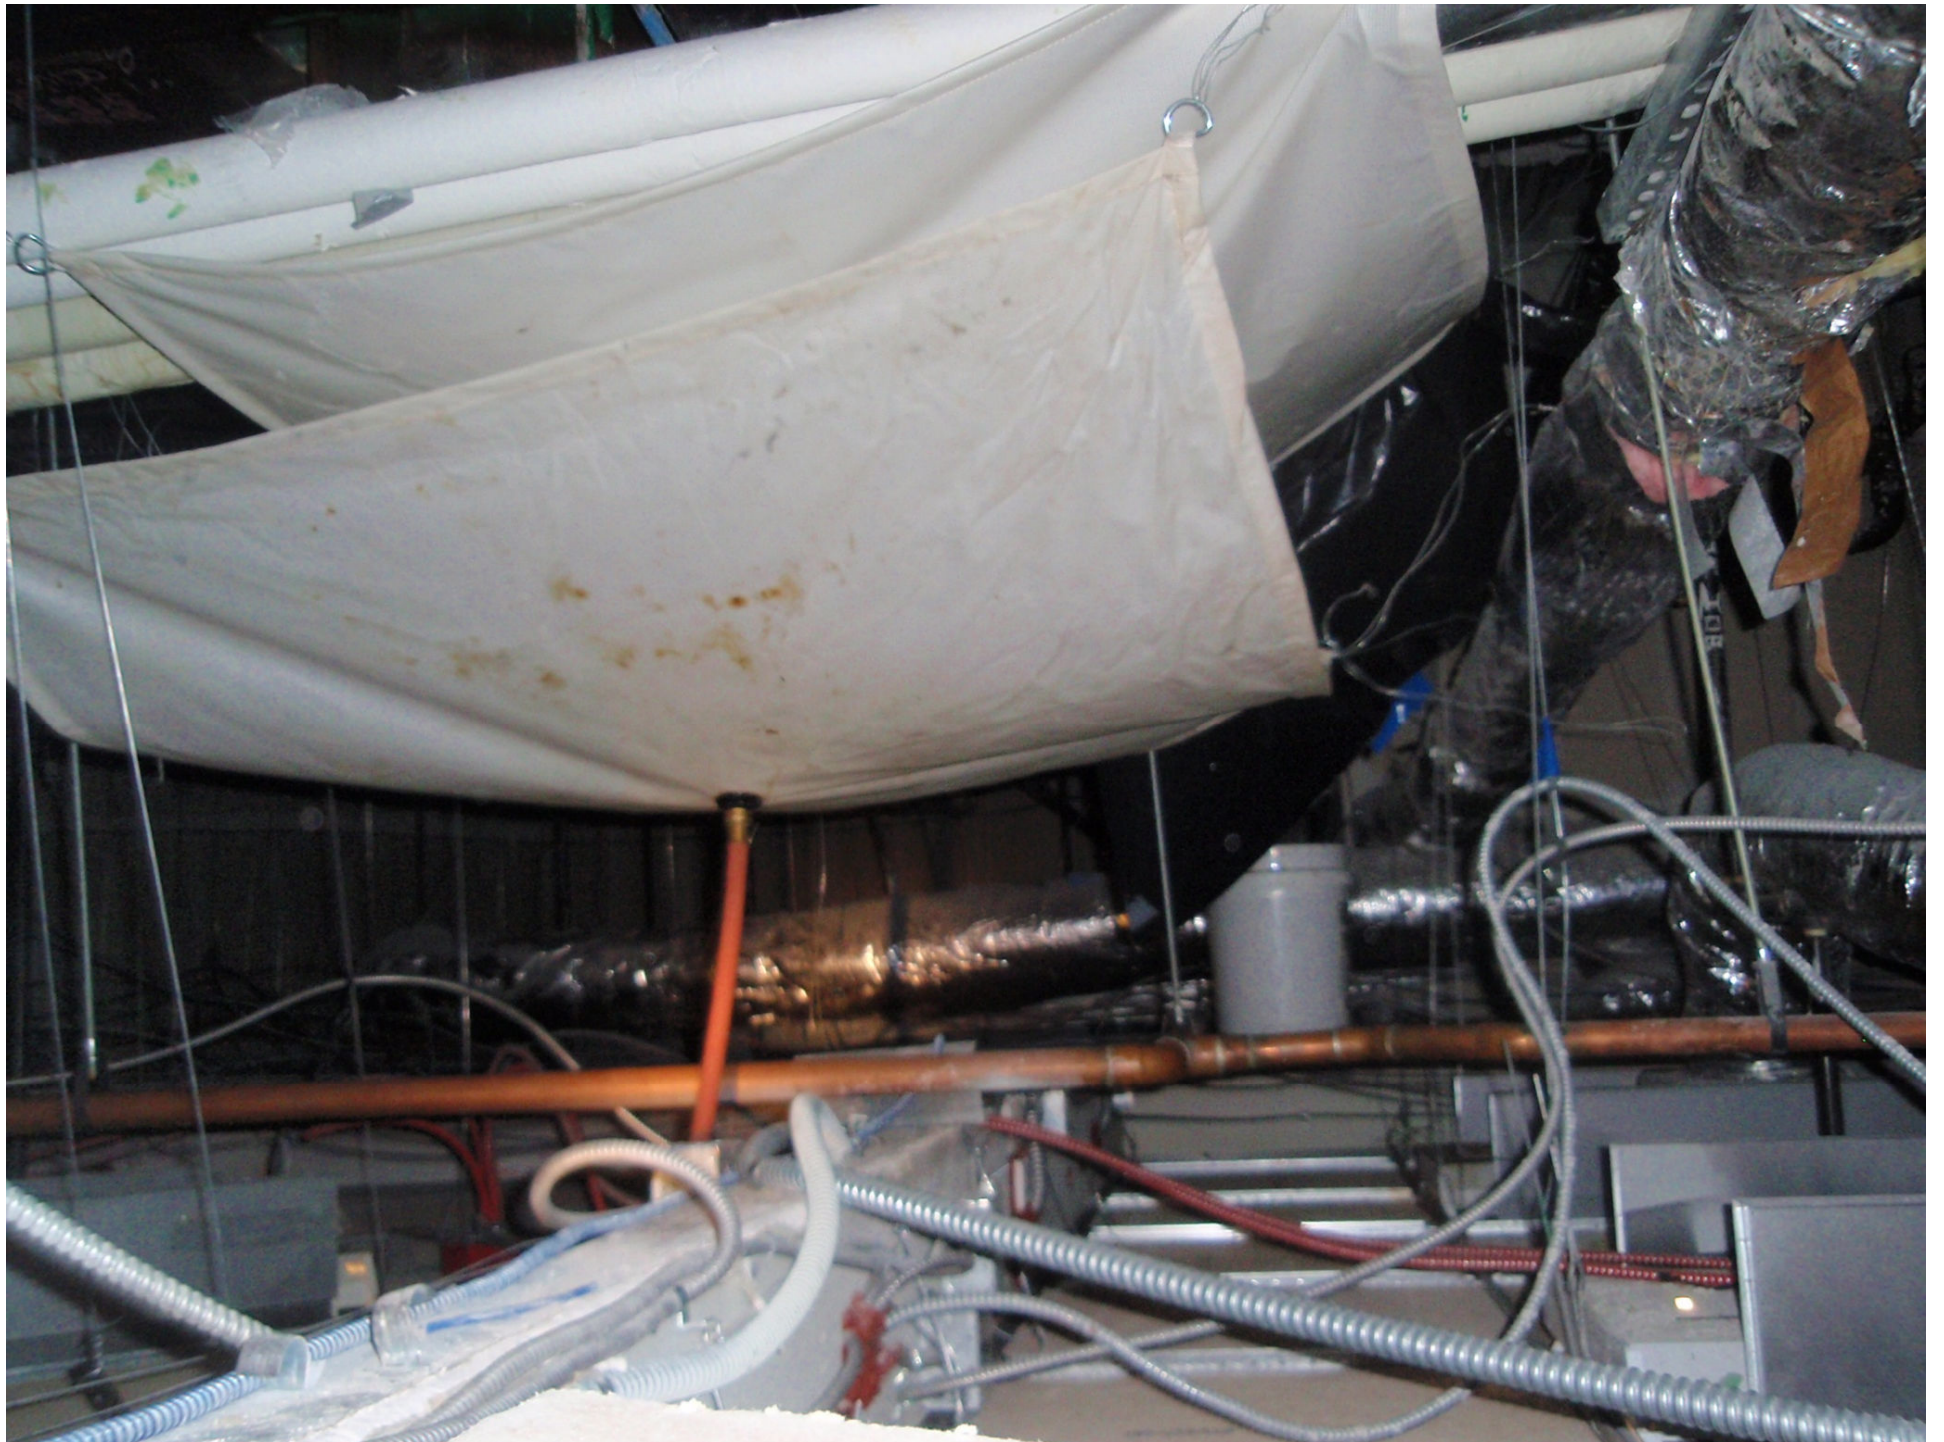
Plumbing Violations
