CONSTRUCTION WITHOUT OVERSIGHT

Douglas H. Evans, P.E., FSFPE
DHE FPE LLC
Las Vegas, NV

In 2008, Clark County Building Department instituted a rigorous inspections program to uncover unreported building code violations in the existing resorts on the world-famous Las Vegas Strip. The violations discovered were primarily due to substantial work conducted without permits or inspections and inadequate or improper maintenance. An overview of the various types of violations and their extent will be discussed.

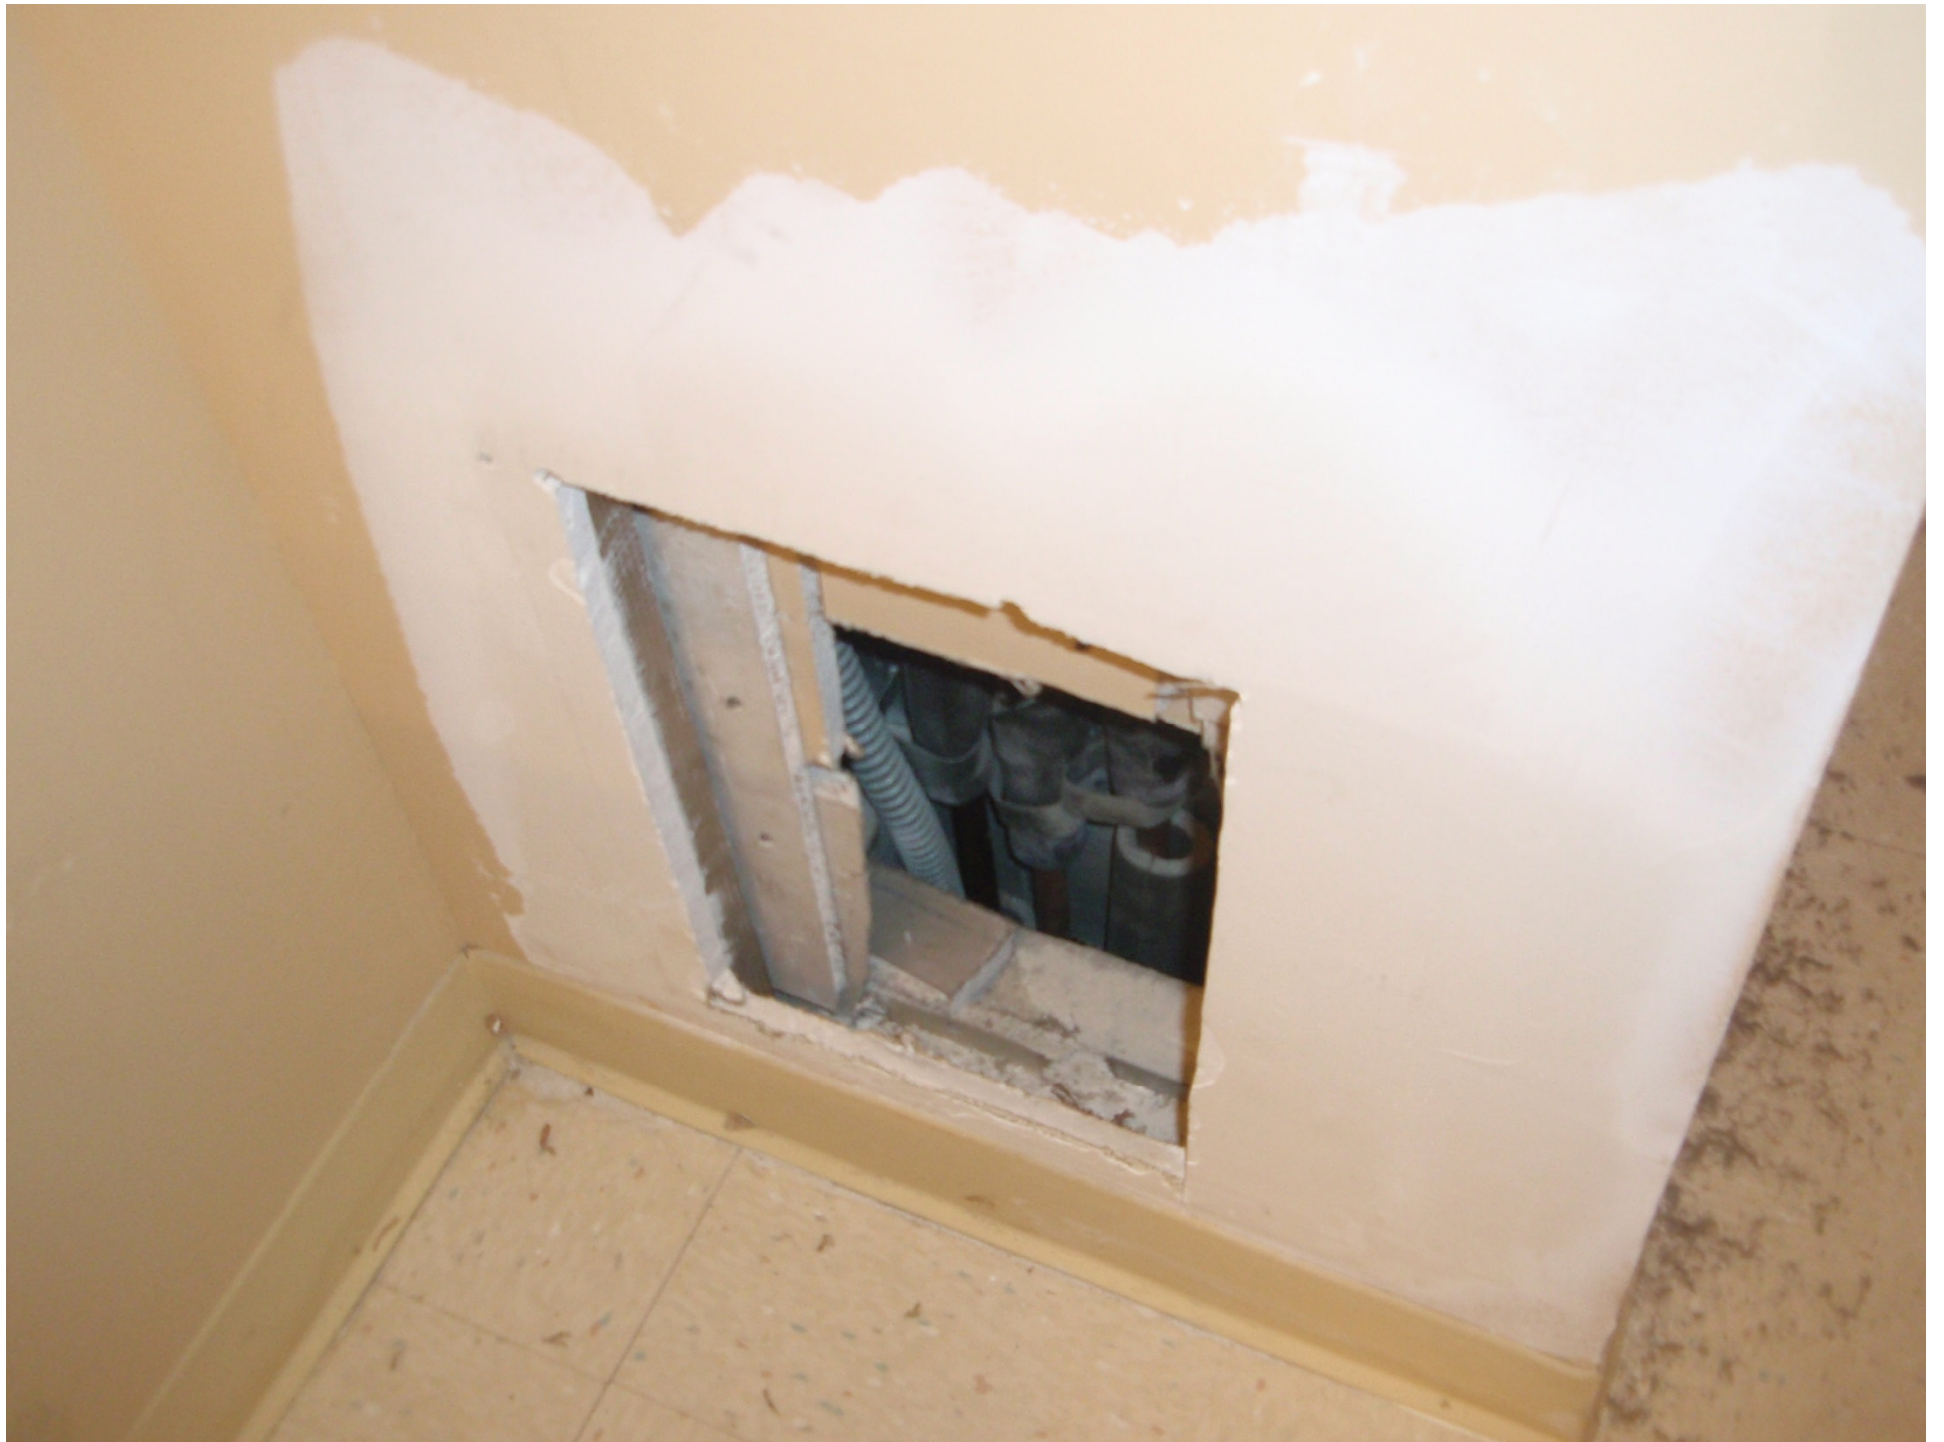
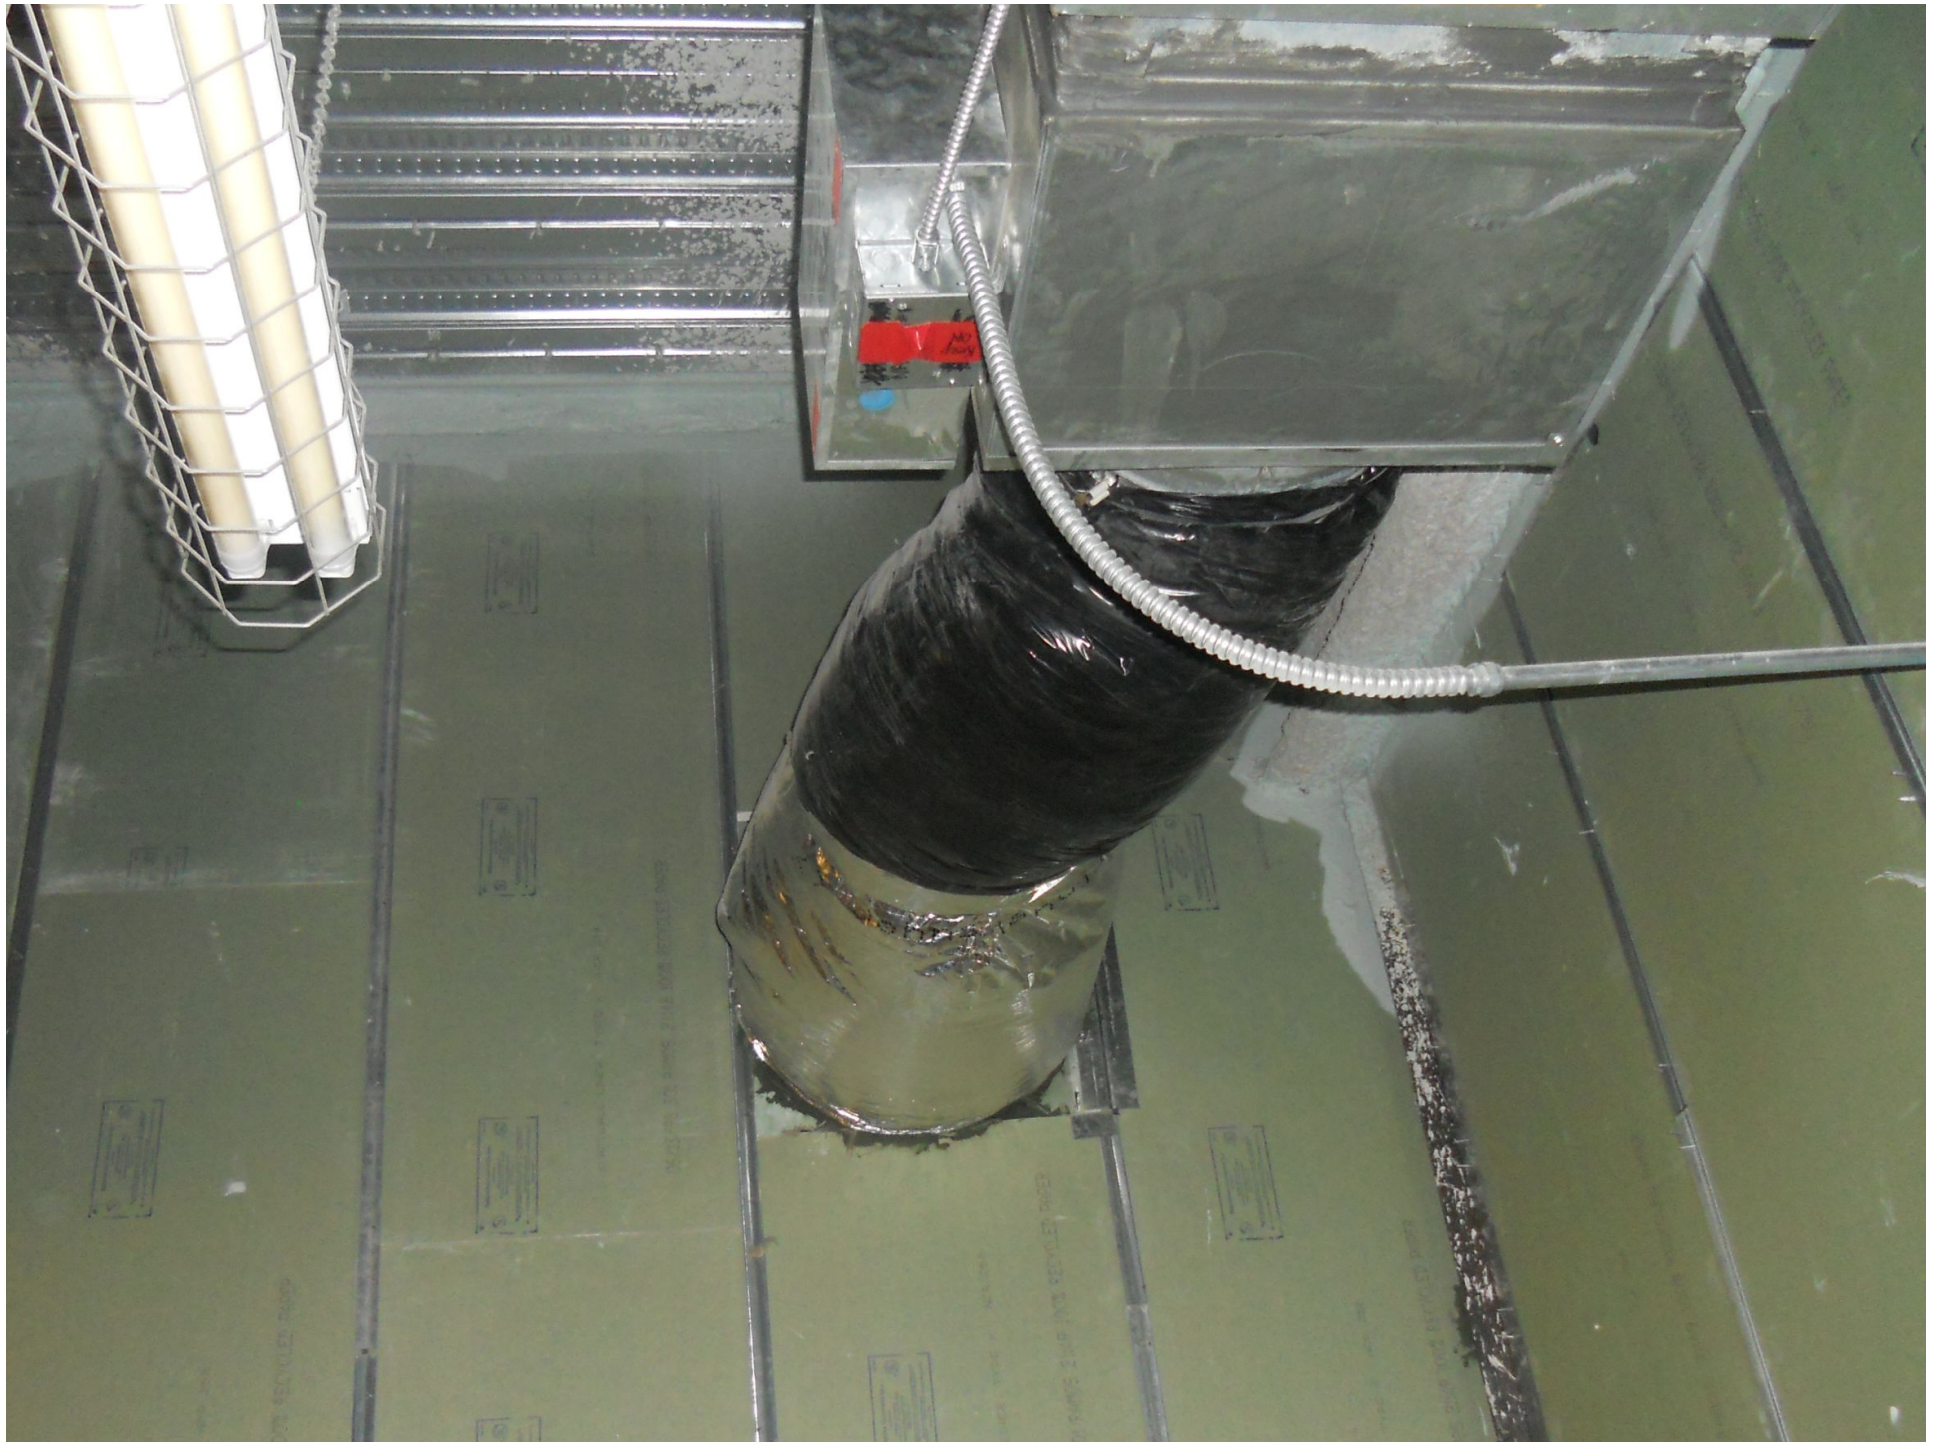
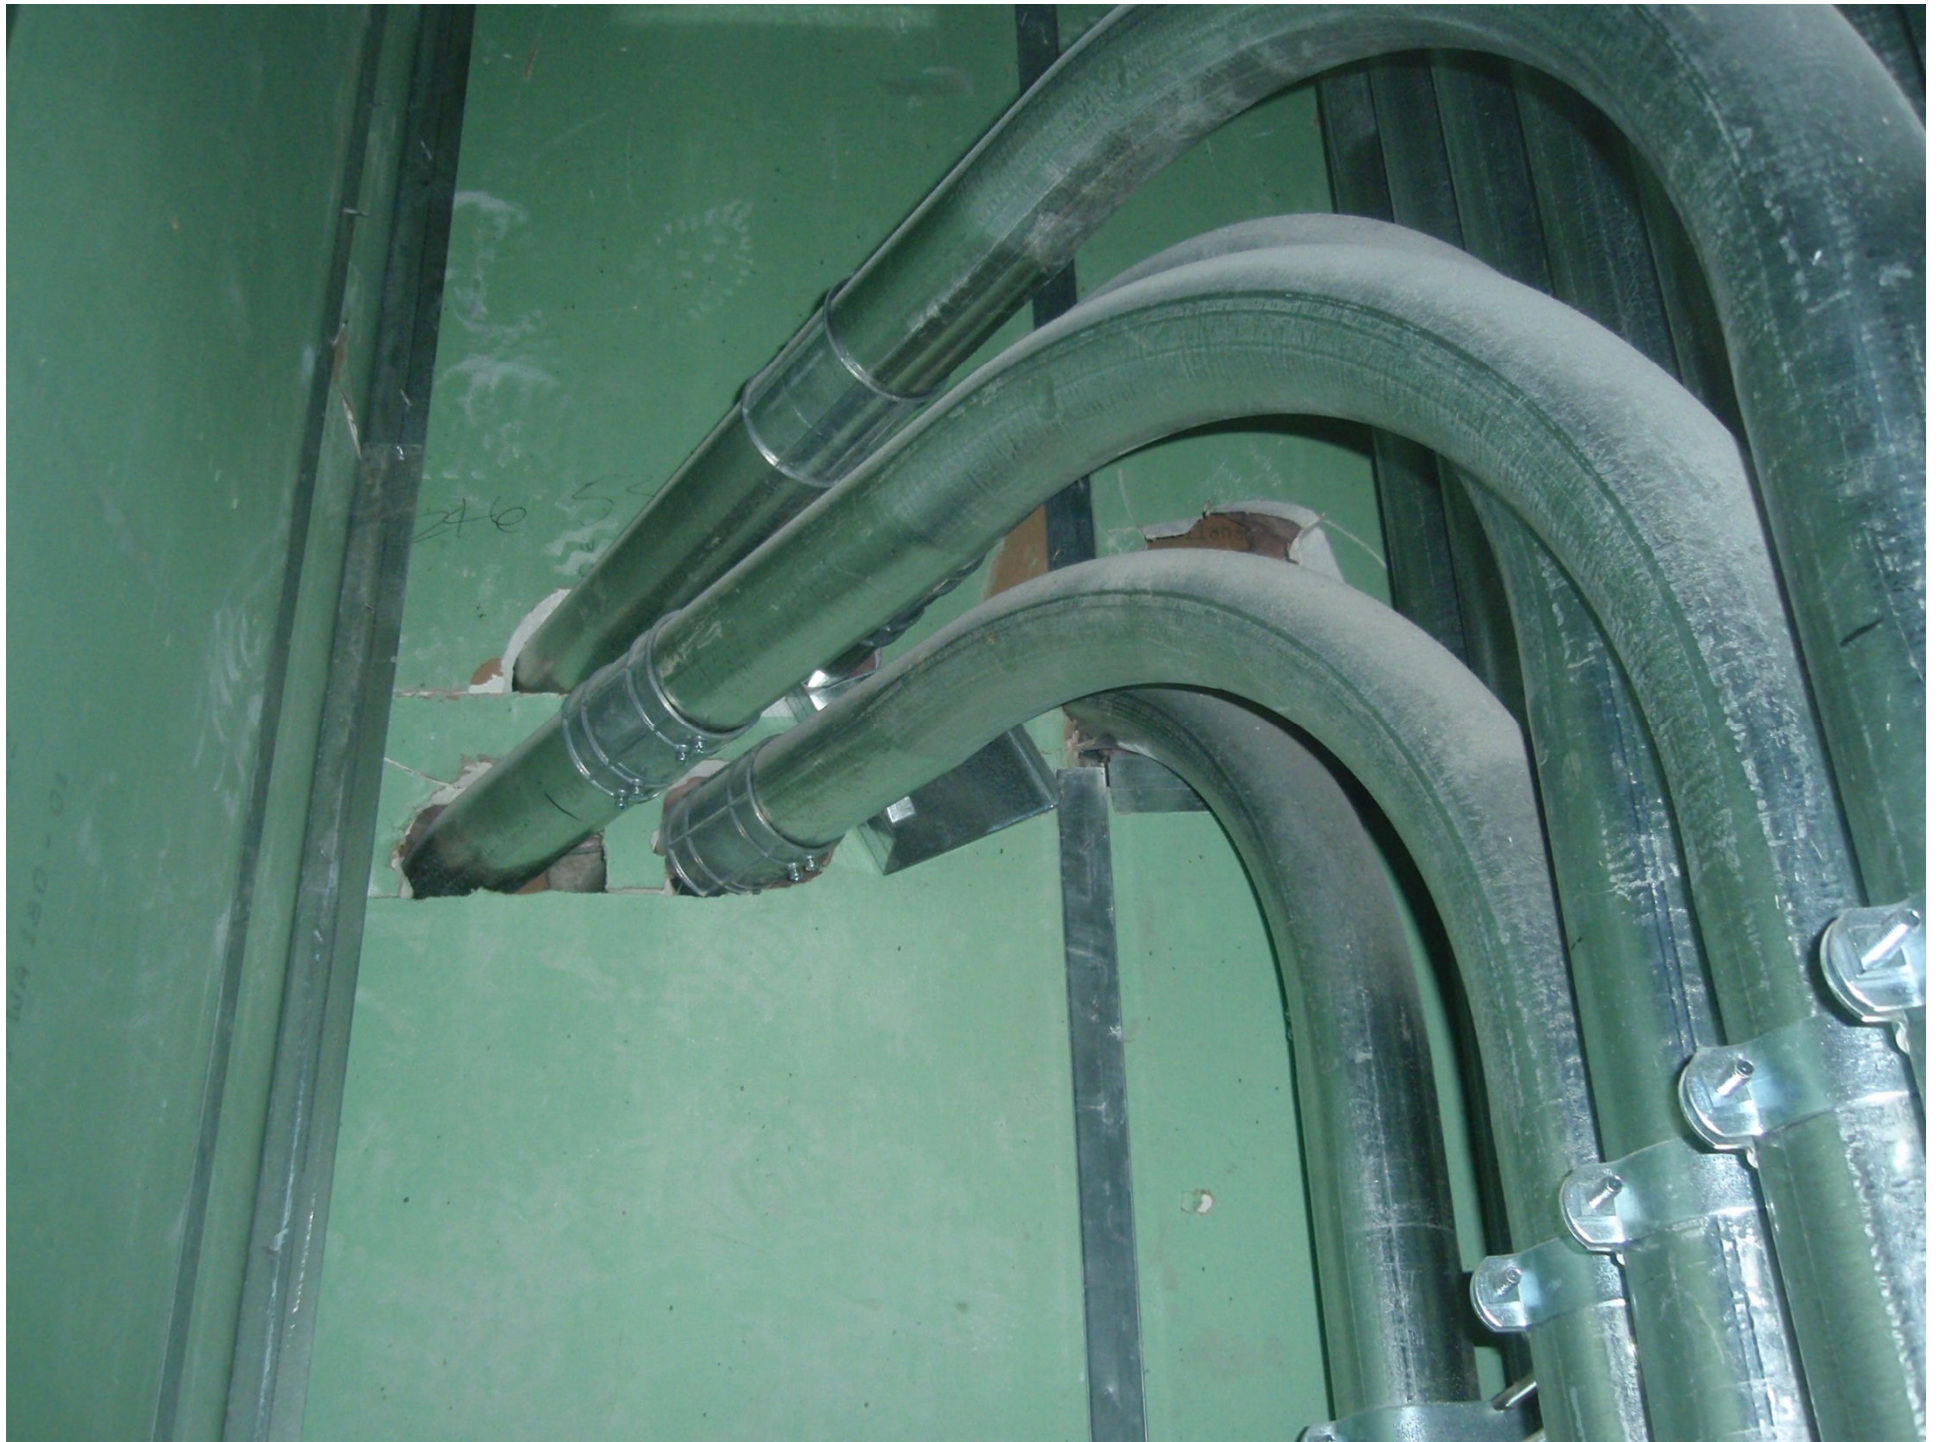
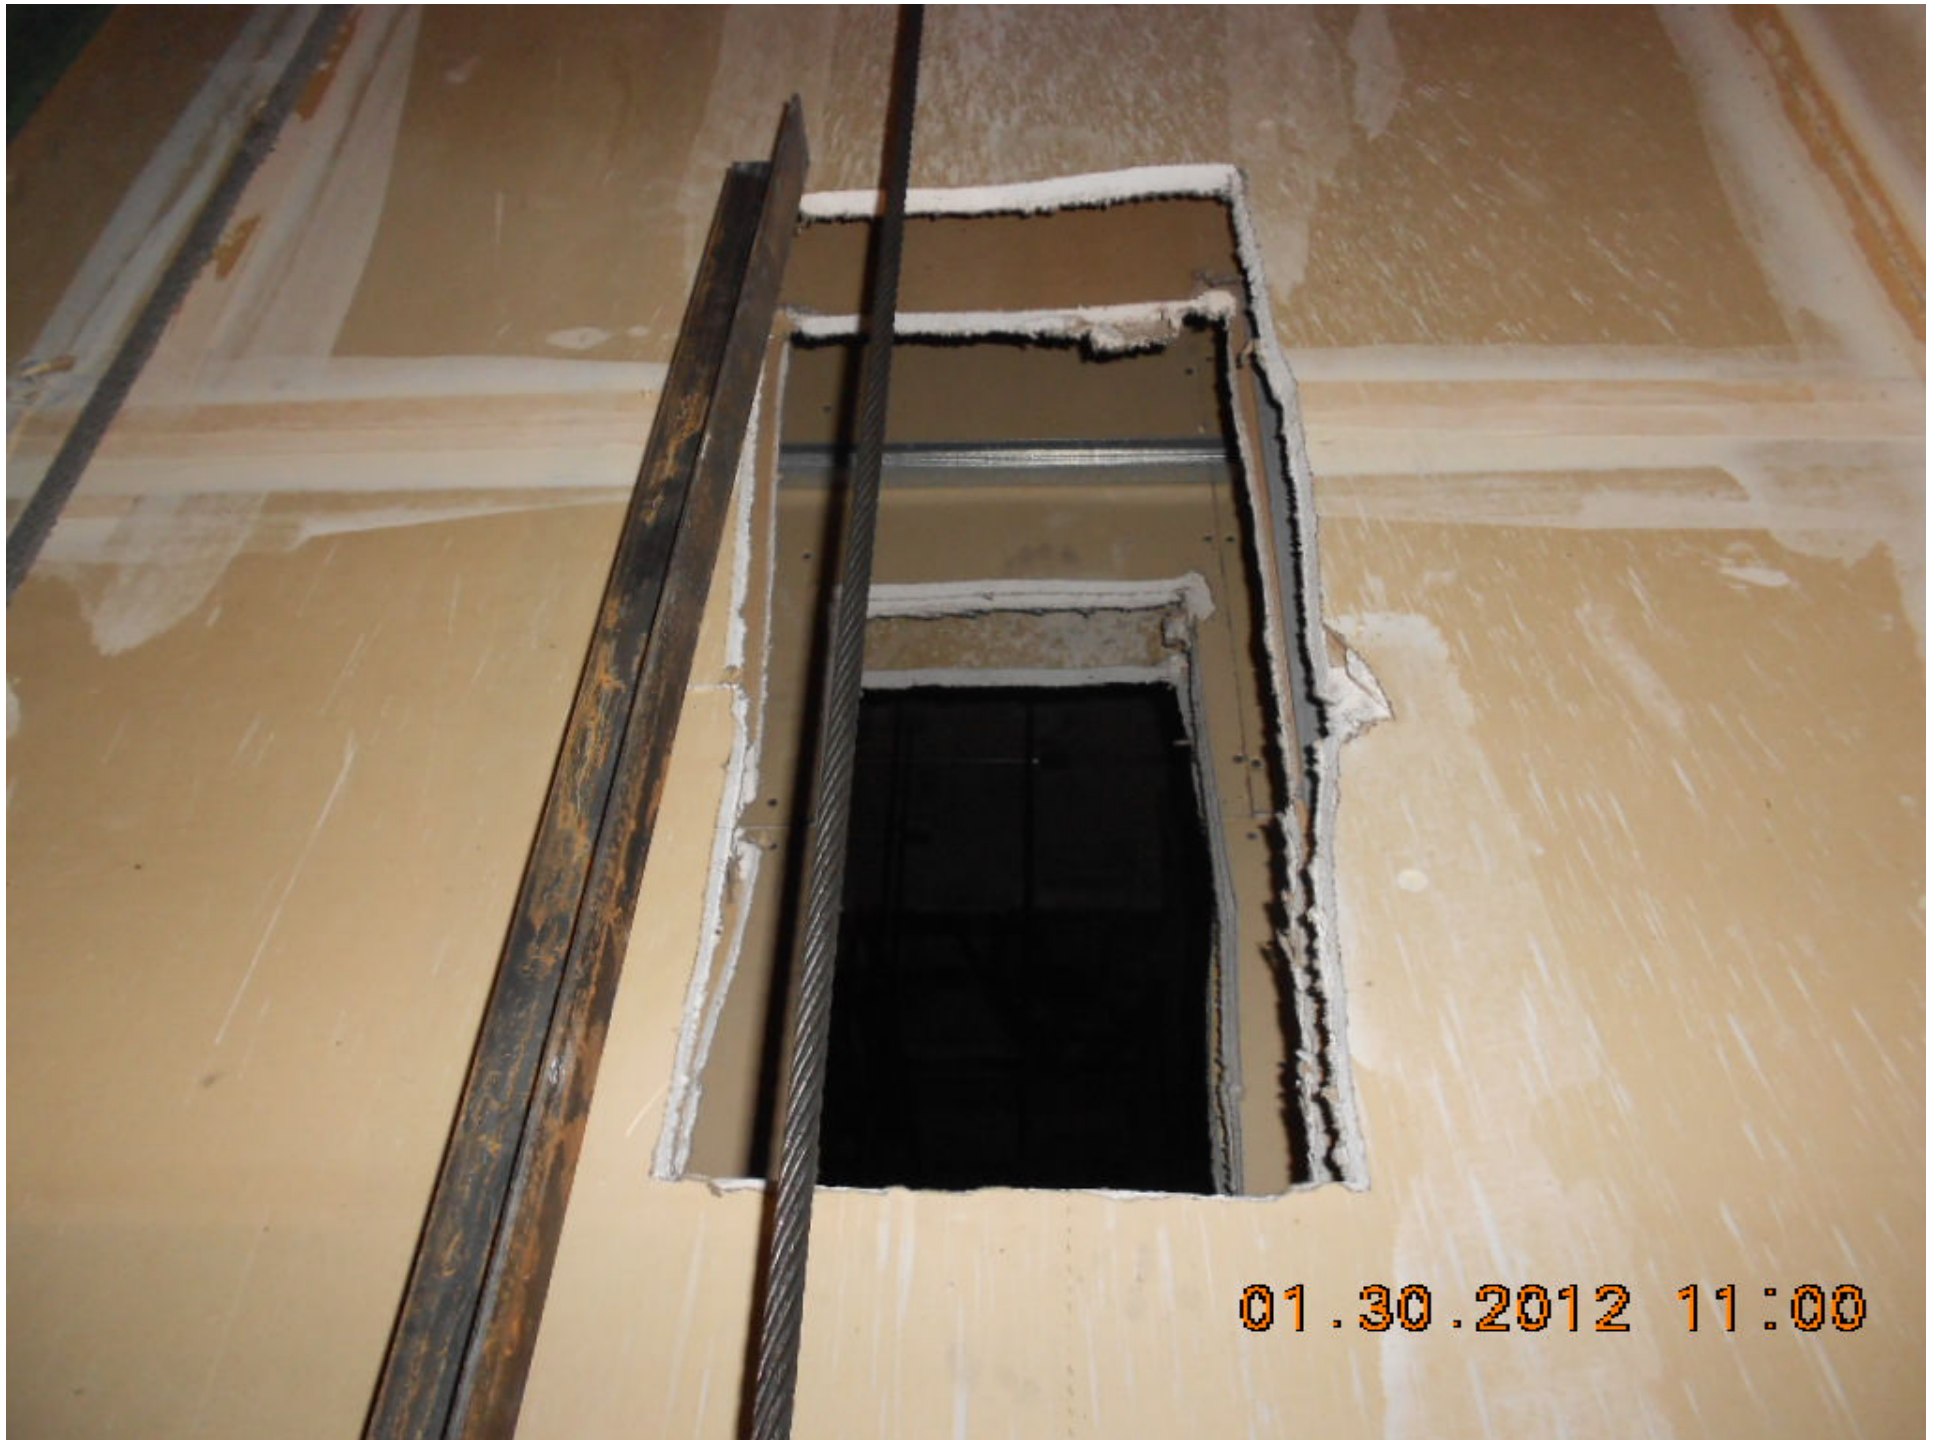
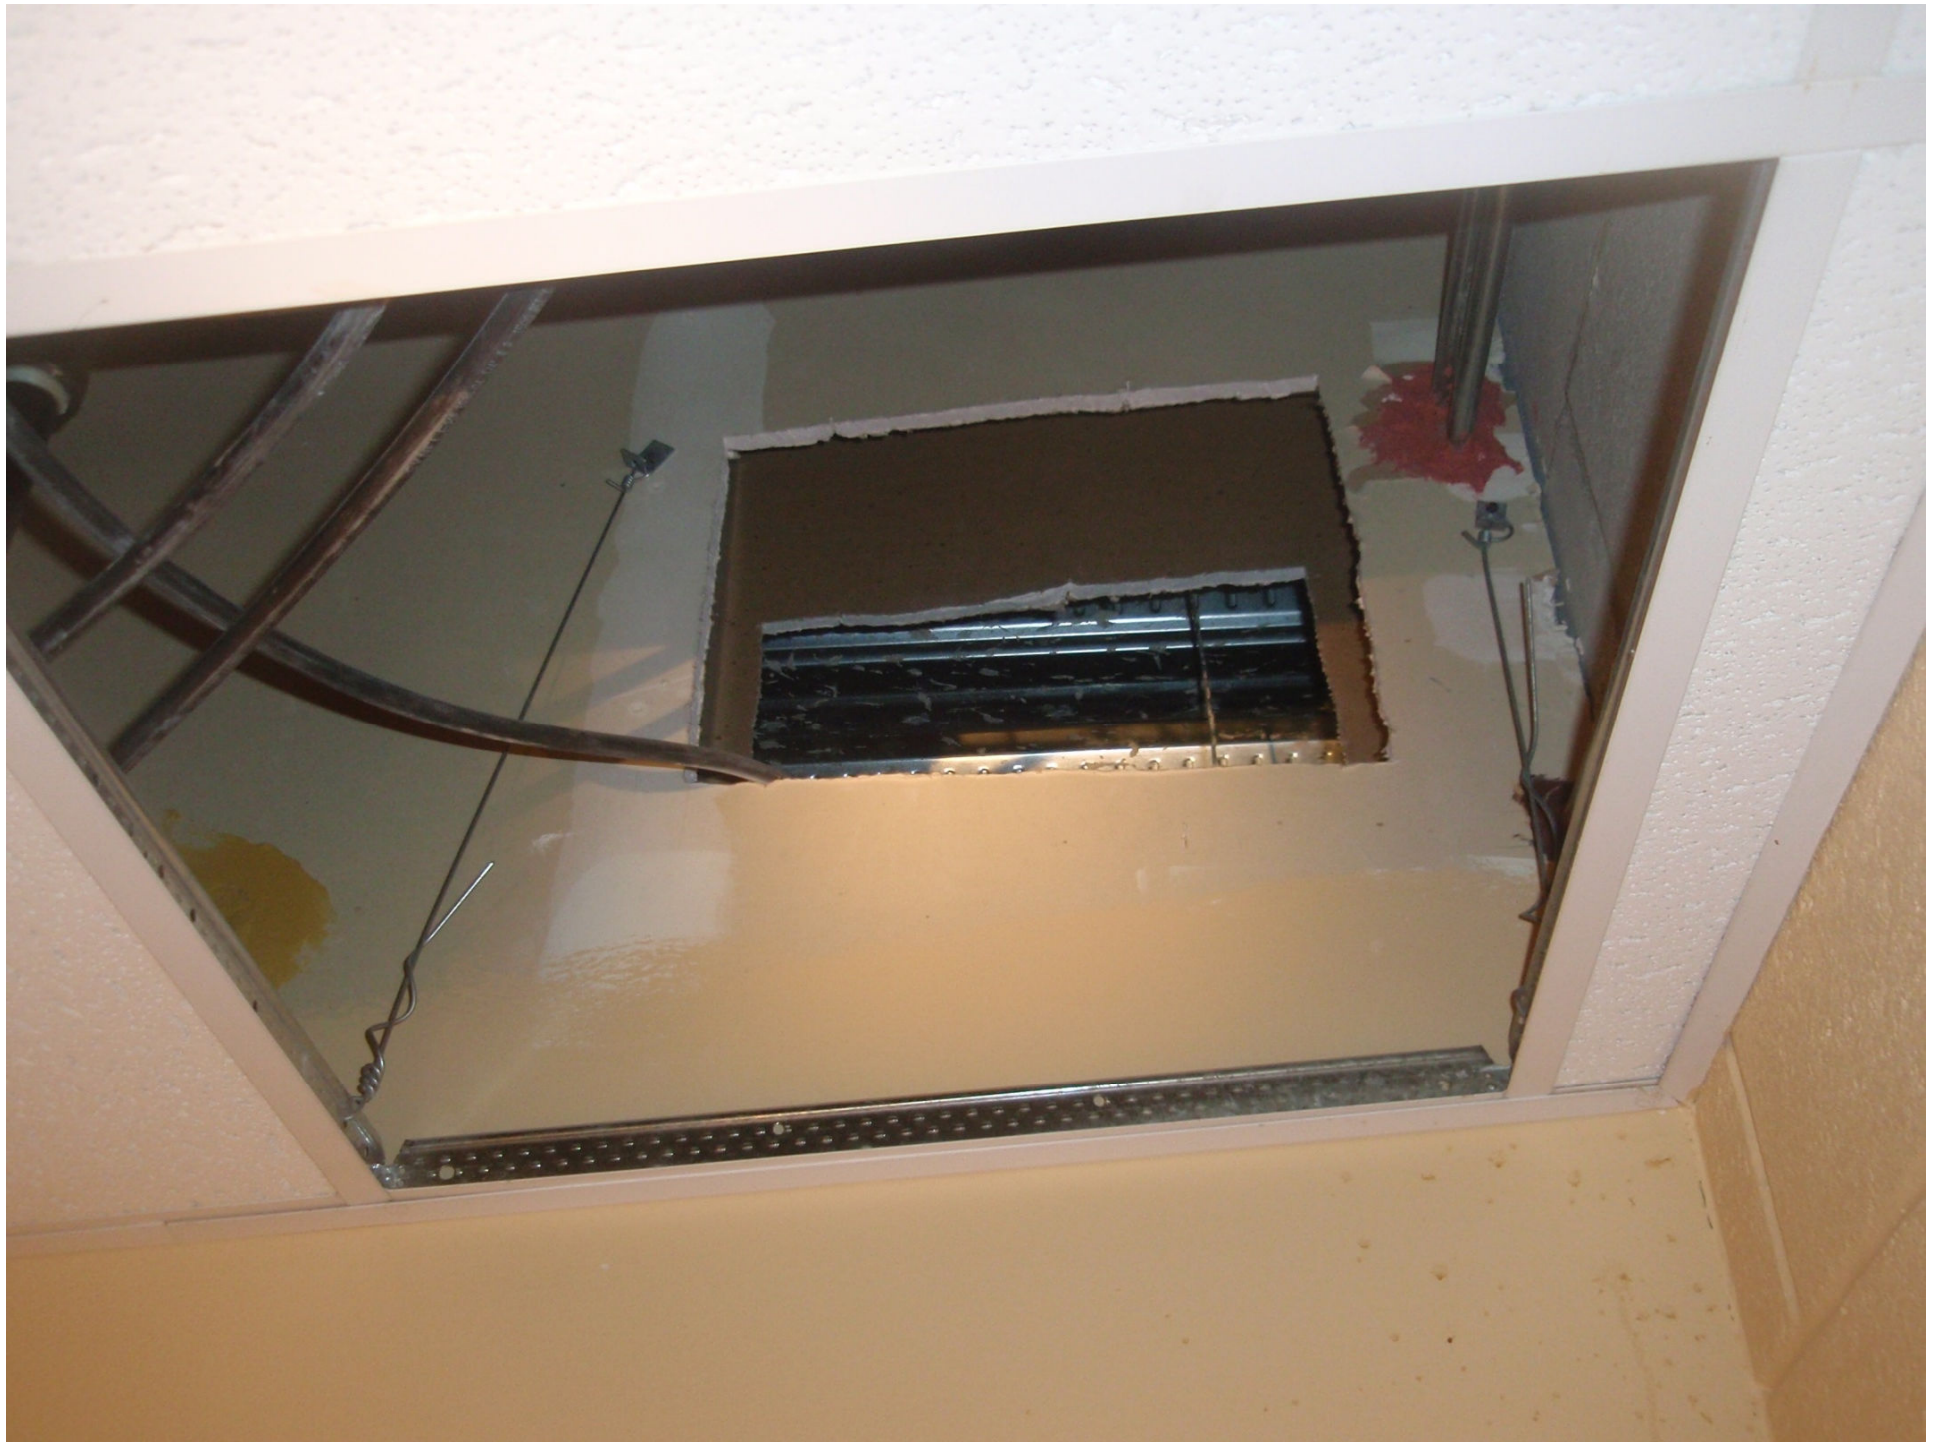
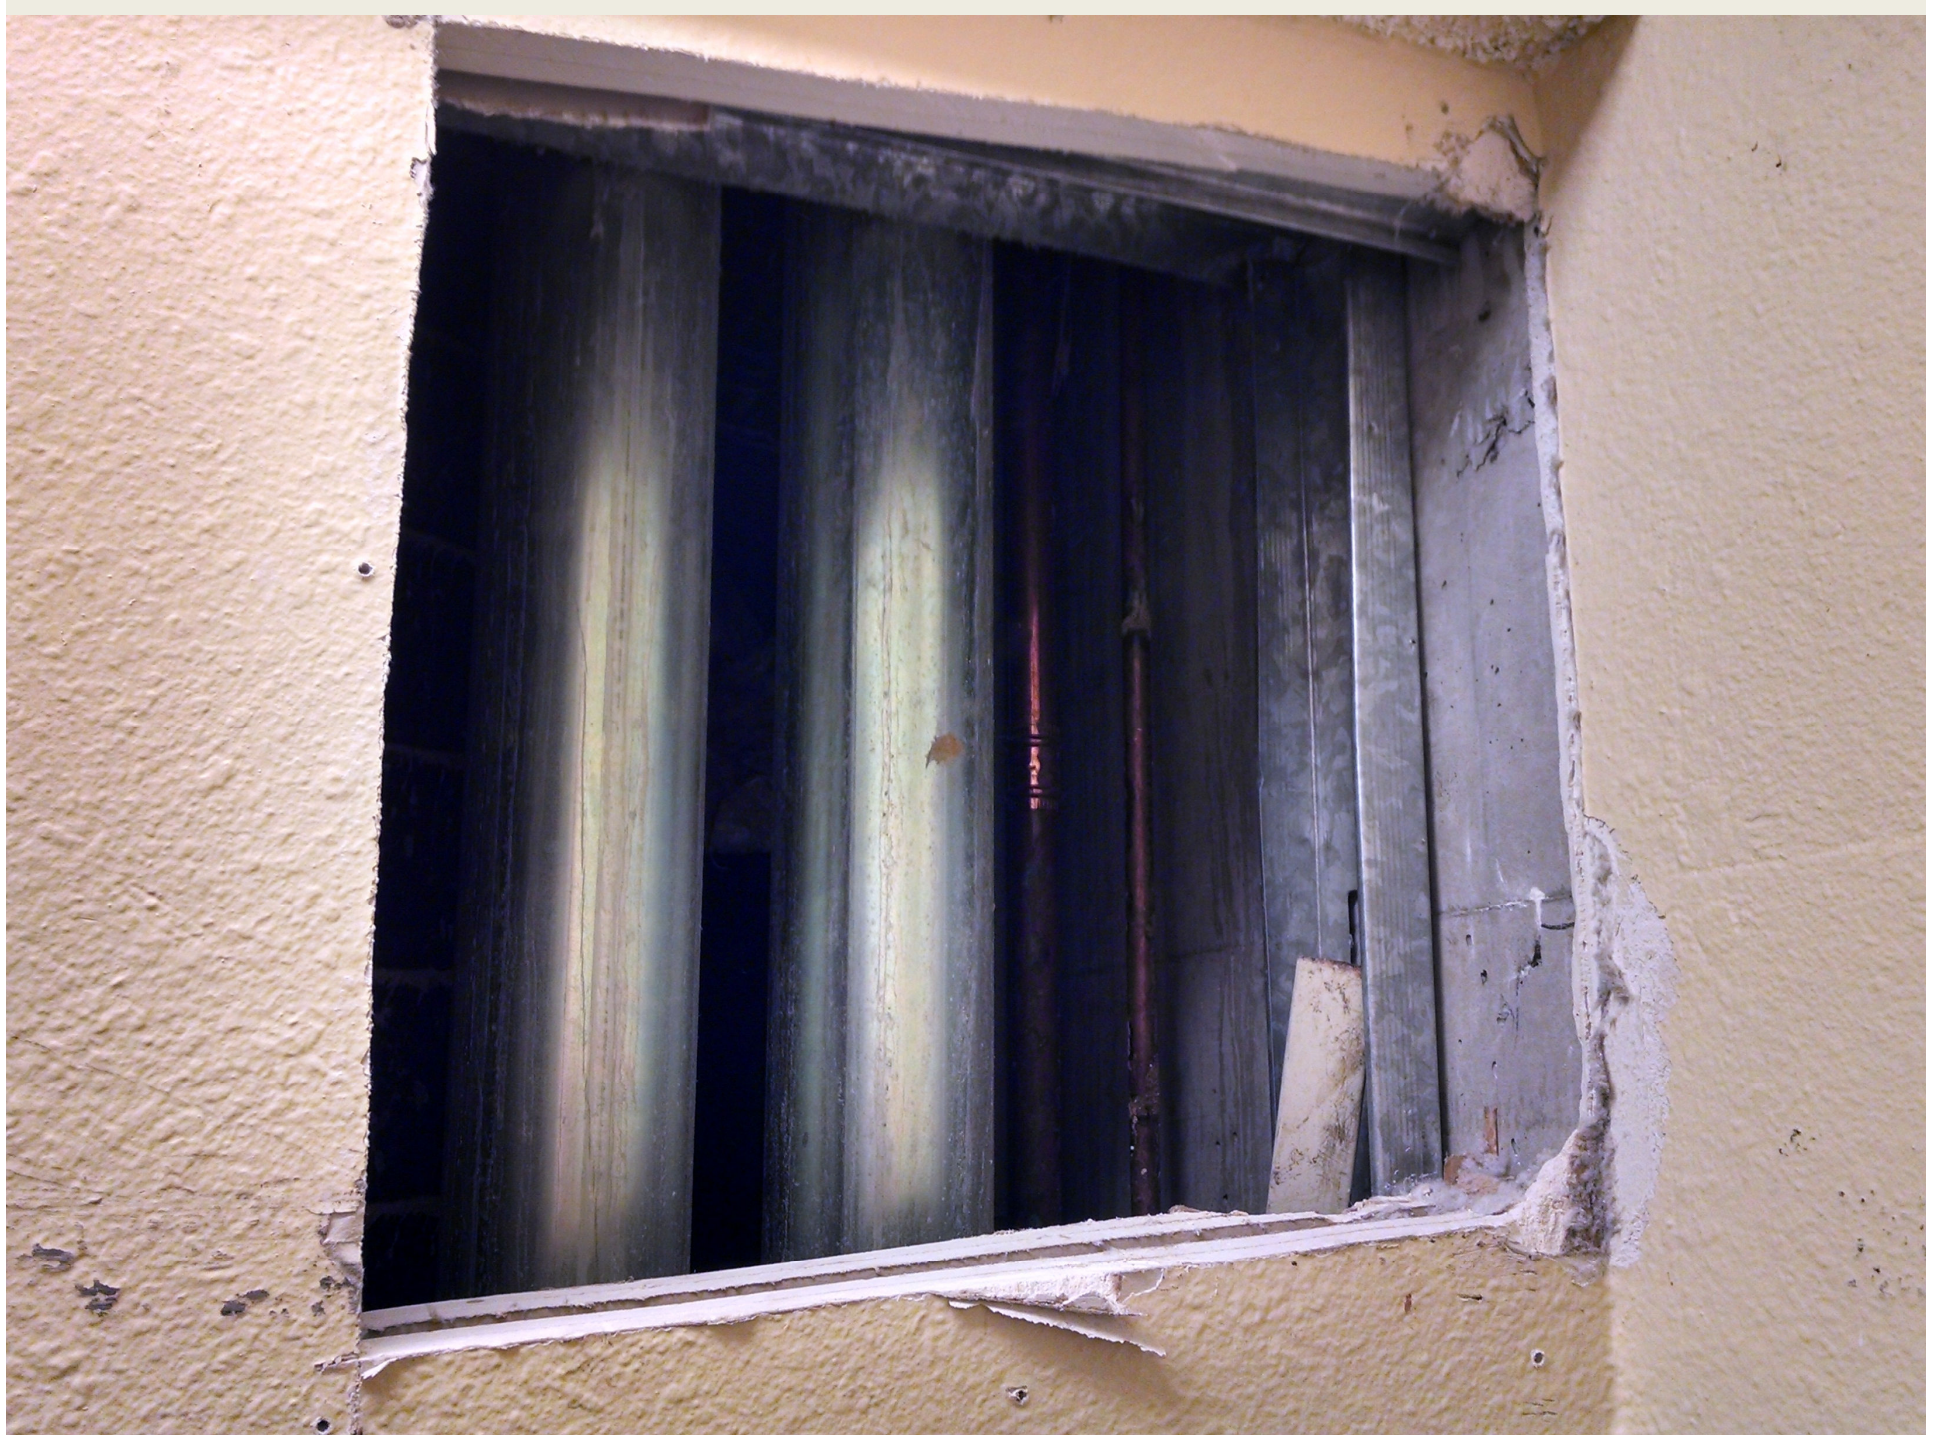
SHAFT ENCLOSURES

Required to protect openings and penetrations through floor/ceiling and roof/ceiling assemblies.
