CONSTRUCTION WITHOUT OVERSIGHT

Douglas H. Evans, P.E., FSFPE
DHE FPE LLC
Las Vegas, NV

In 2008, Clark County Building Department instituted a rigorous inspections program to uncover unreported building code violations in the existing resorts on the world-famous Las Vegas Strip. The violations discovered were primarily due to substantial work conducted without permits or inspections and inadequate or improper maintenance. An overview of the various types of violations and their extent will be discussed.

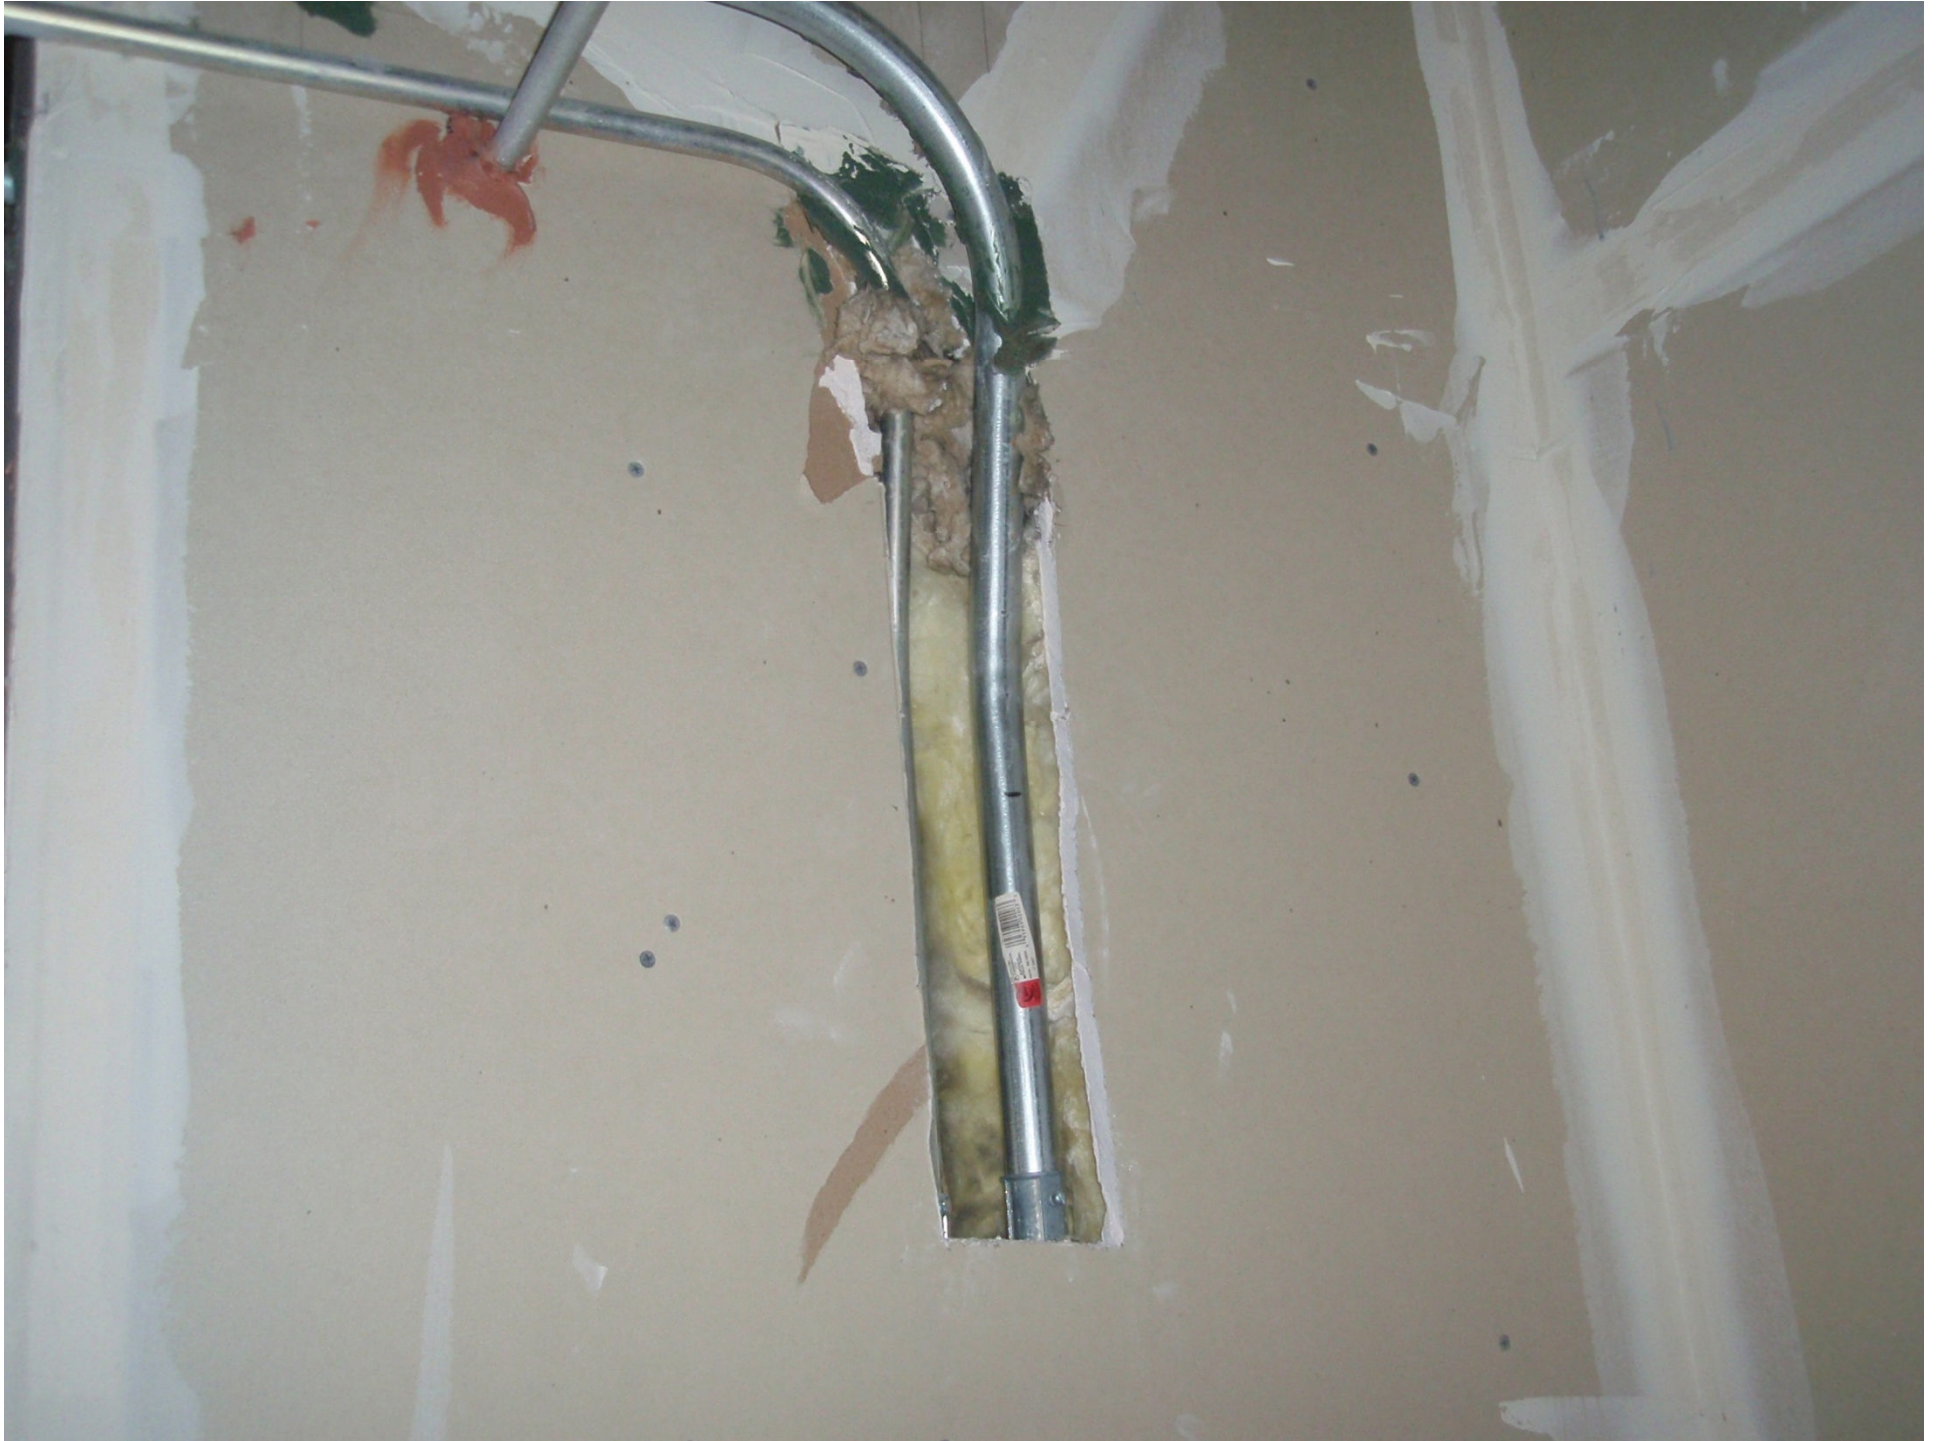
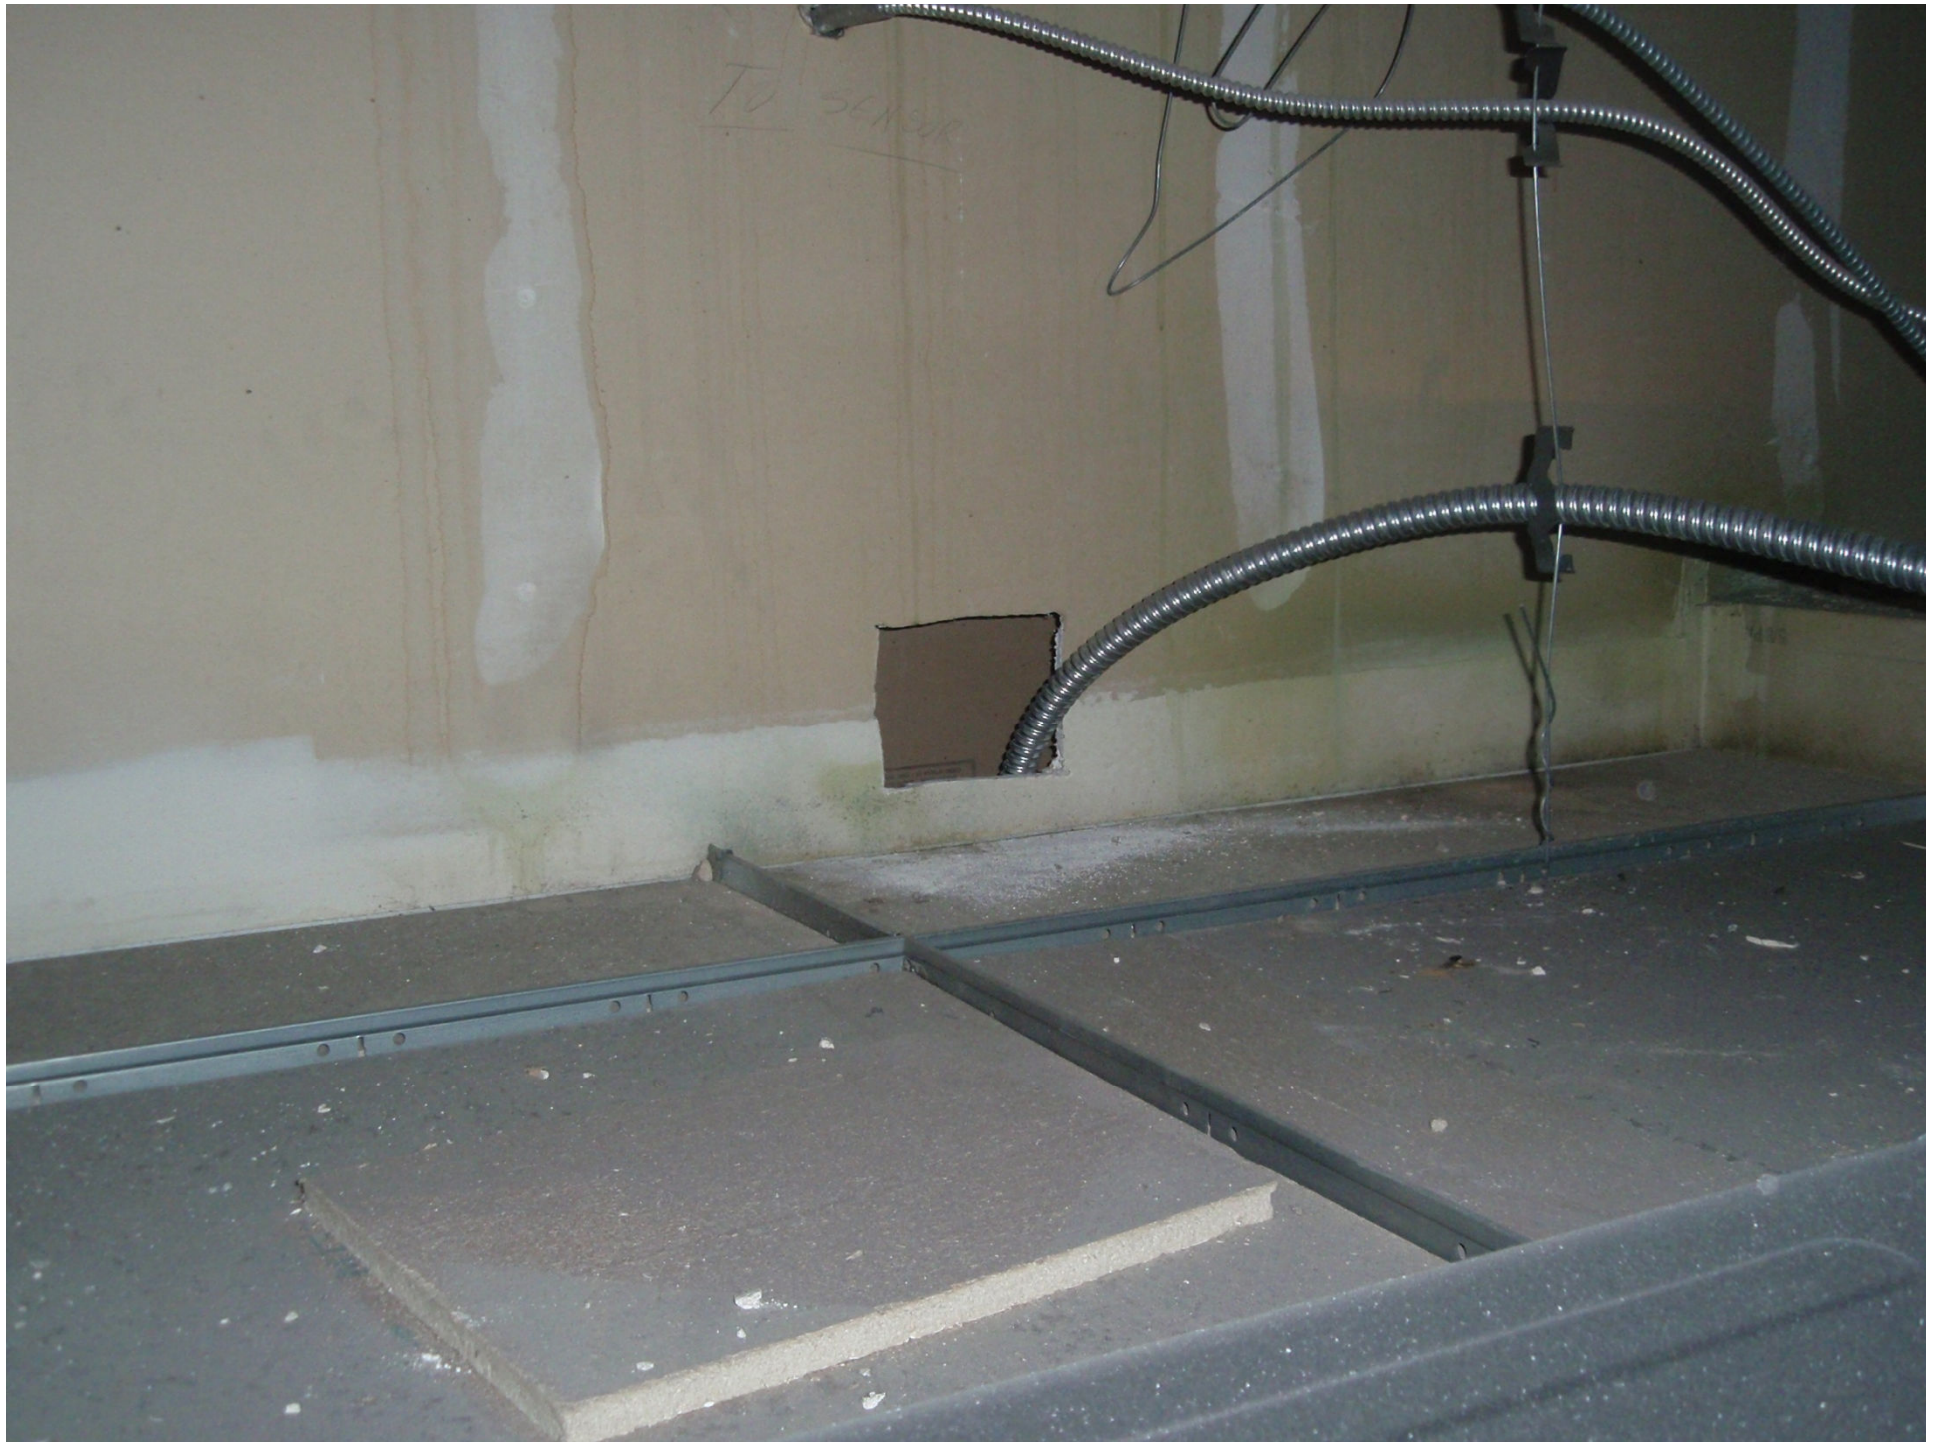
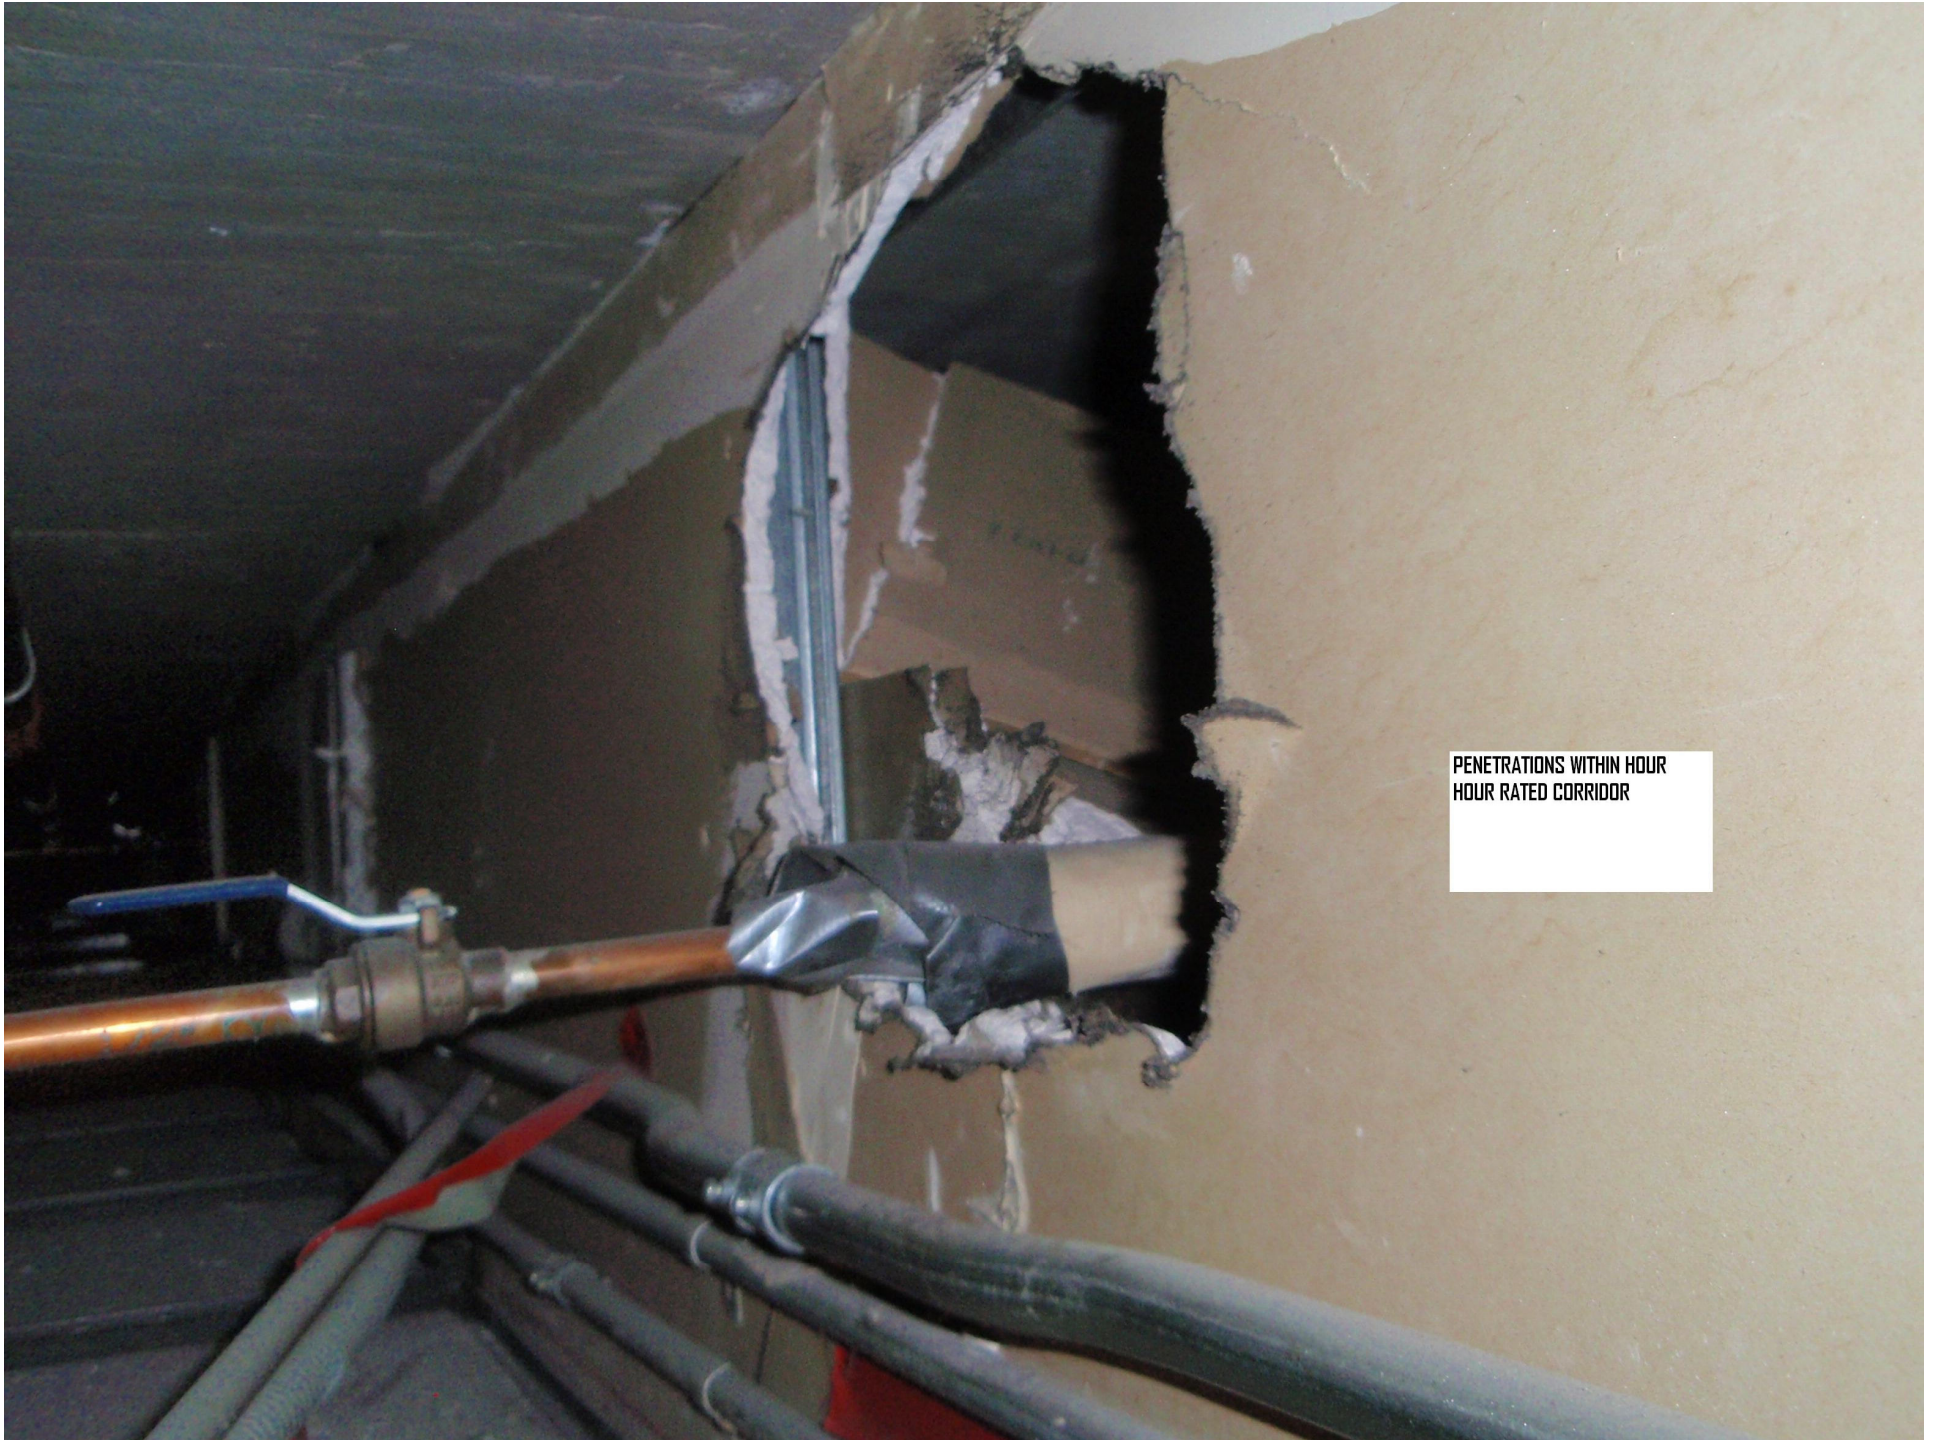
PENETRATIONS
