CONSTRUCTION WITHOUT OVERSIGHT

Douglas H. Evans, P.E., FSFPE
DHE FPE LLC
Las Vegas, NV

In 2008, Clark County Building Department instituted a rigorous inspections program to uncover unreported building code violations in the existing resorts on the world-famous Las Vegas Strip. The violations discovered were primarily due to substantial work conducted without permits or inspections and inadequate or improper maintenance. An overview of the various types of violations and their extent will be discussed.

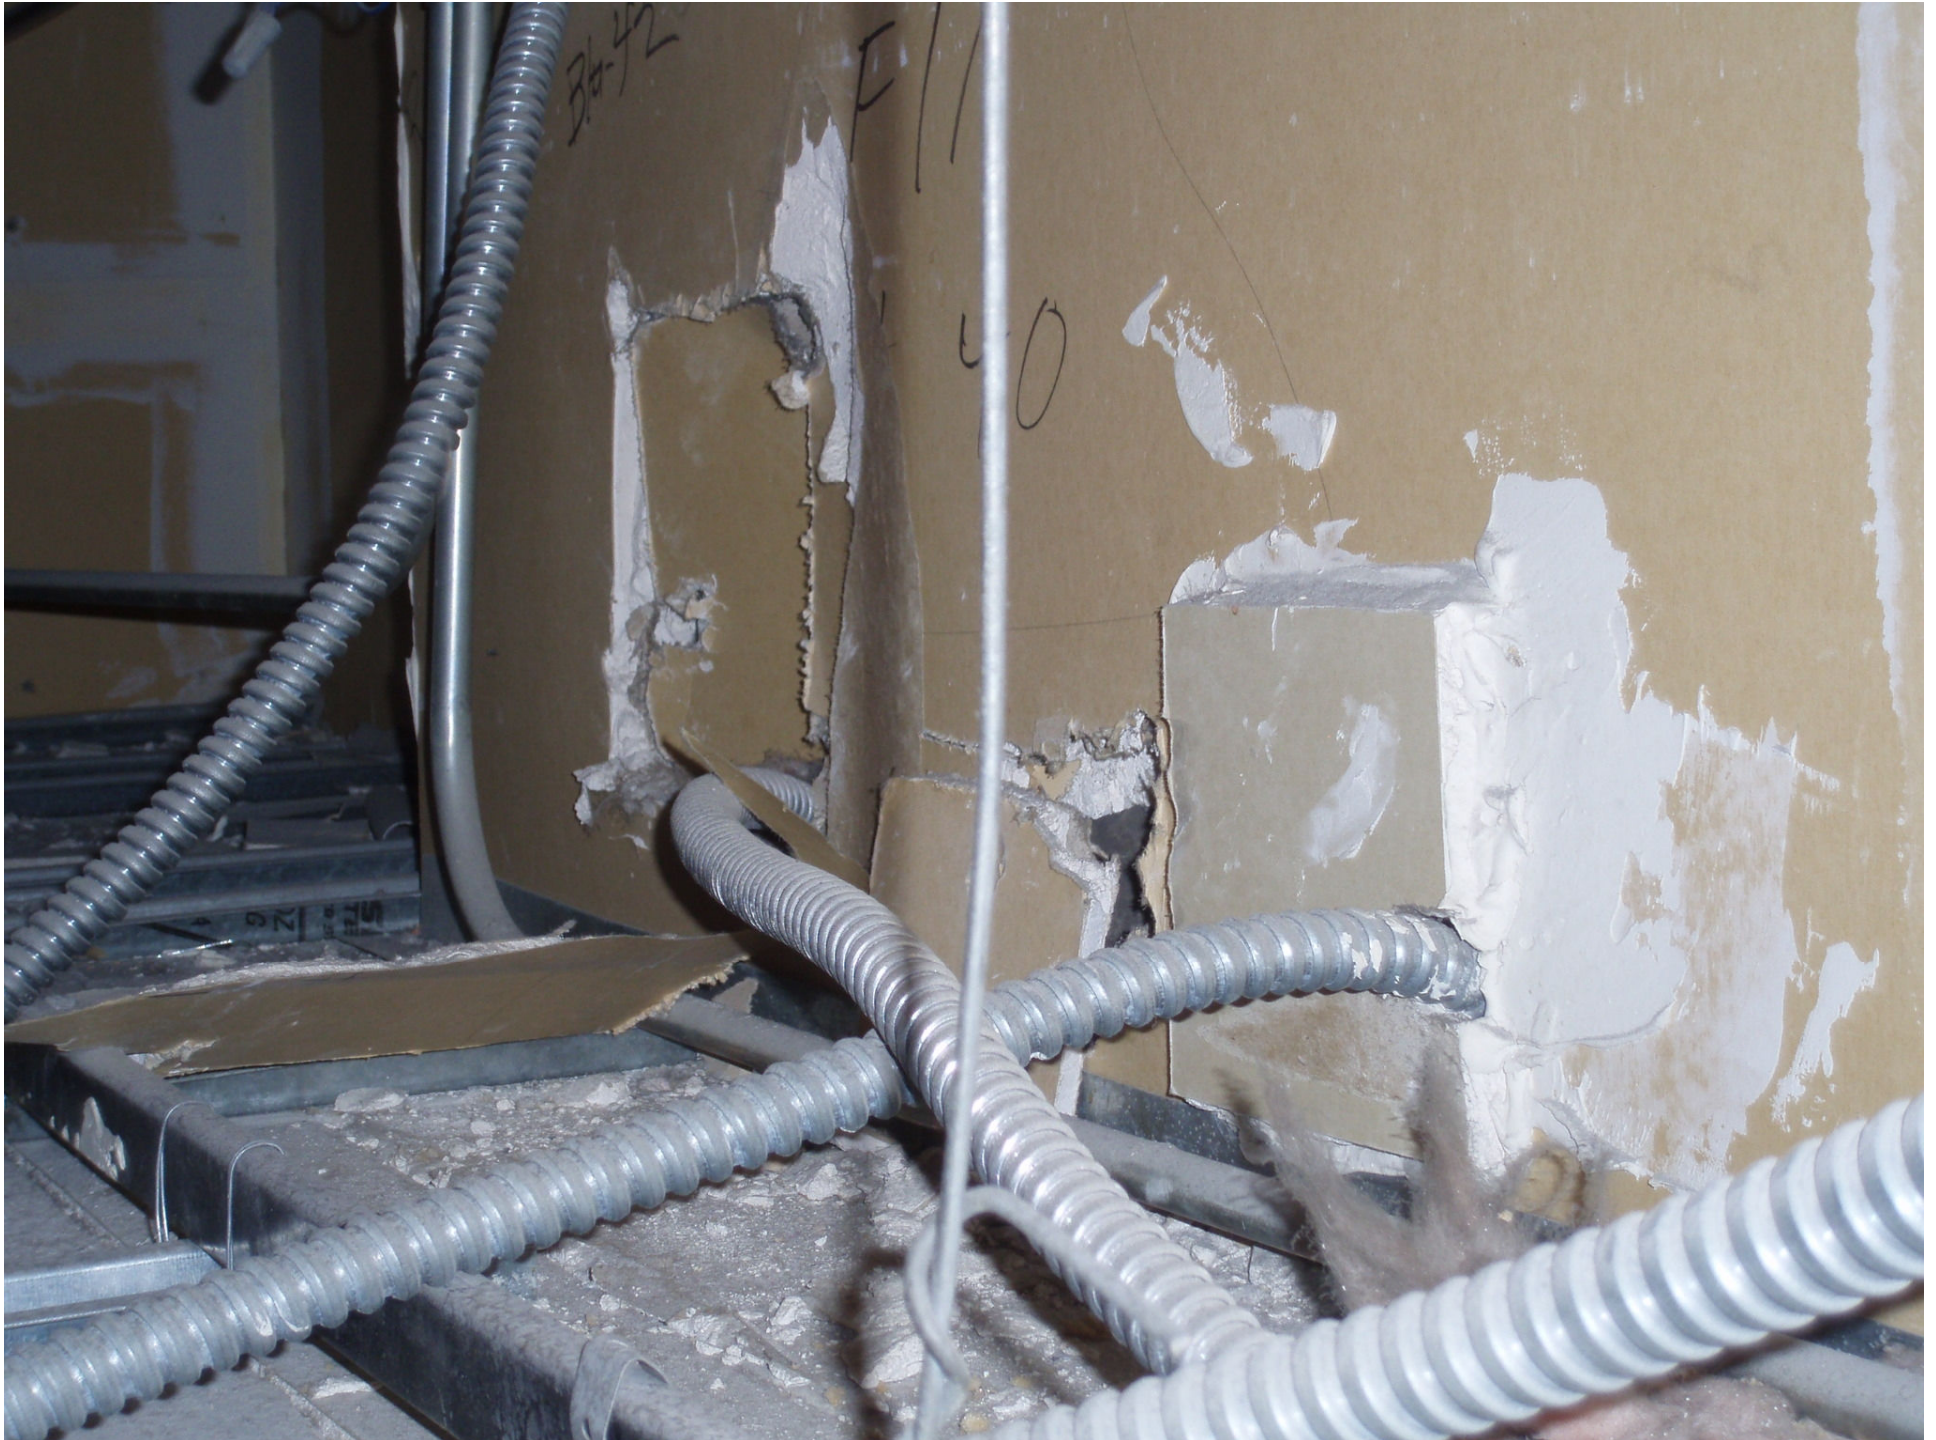
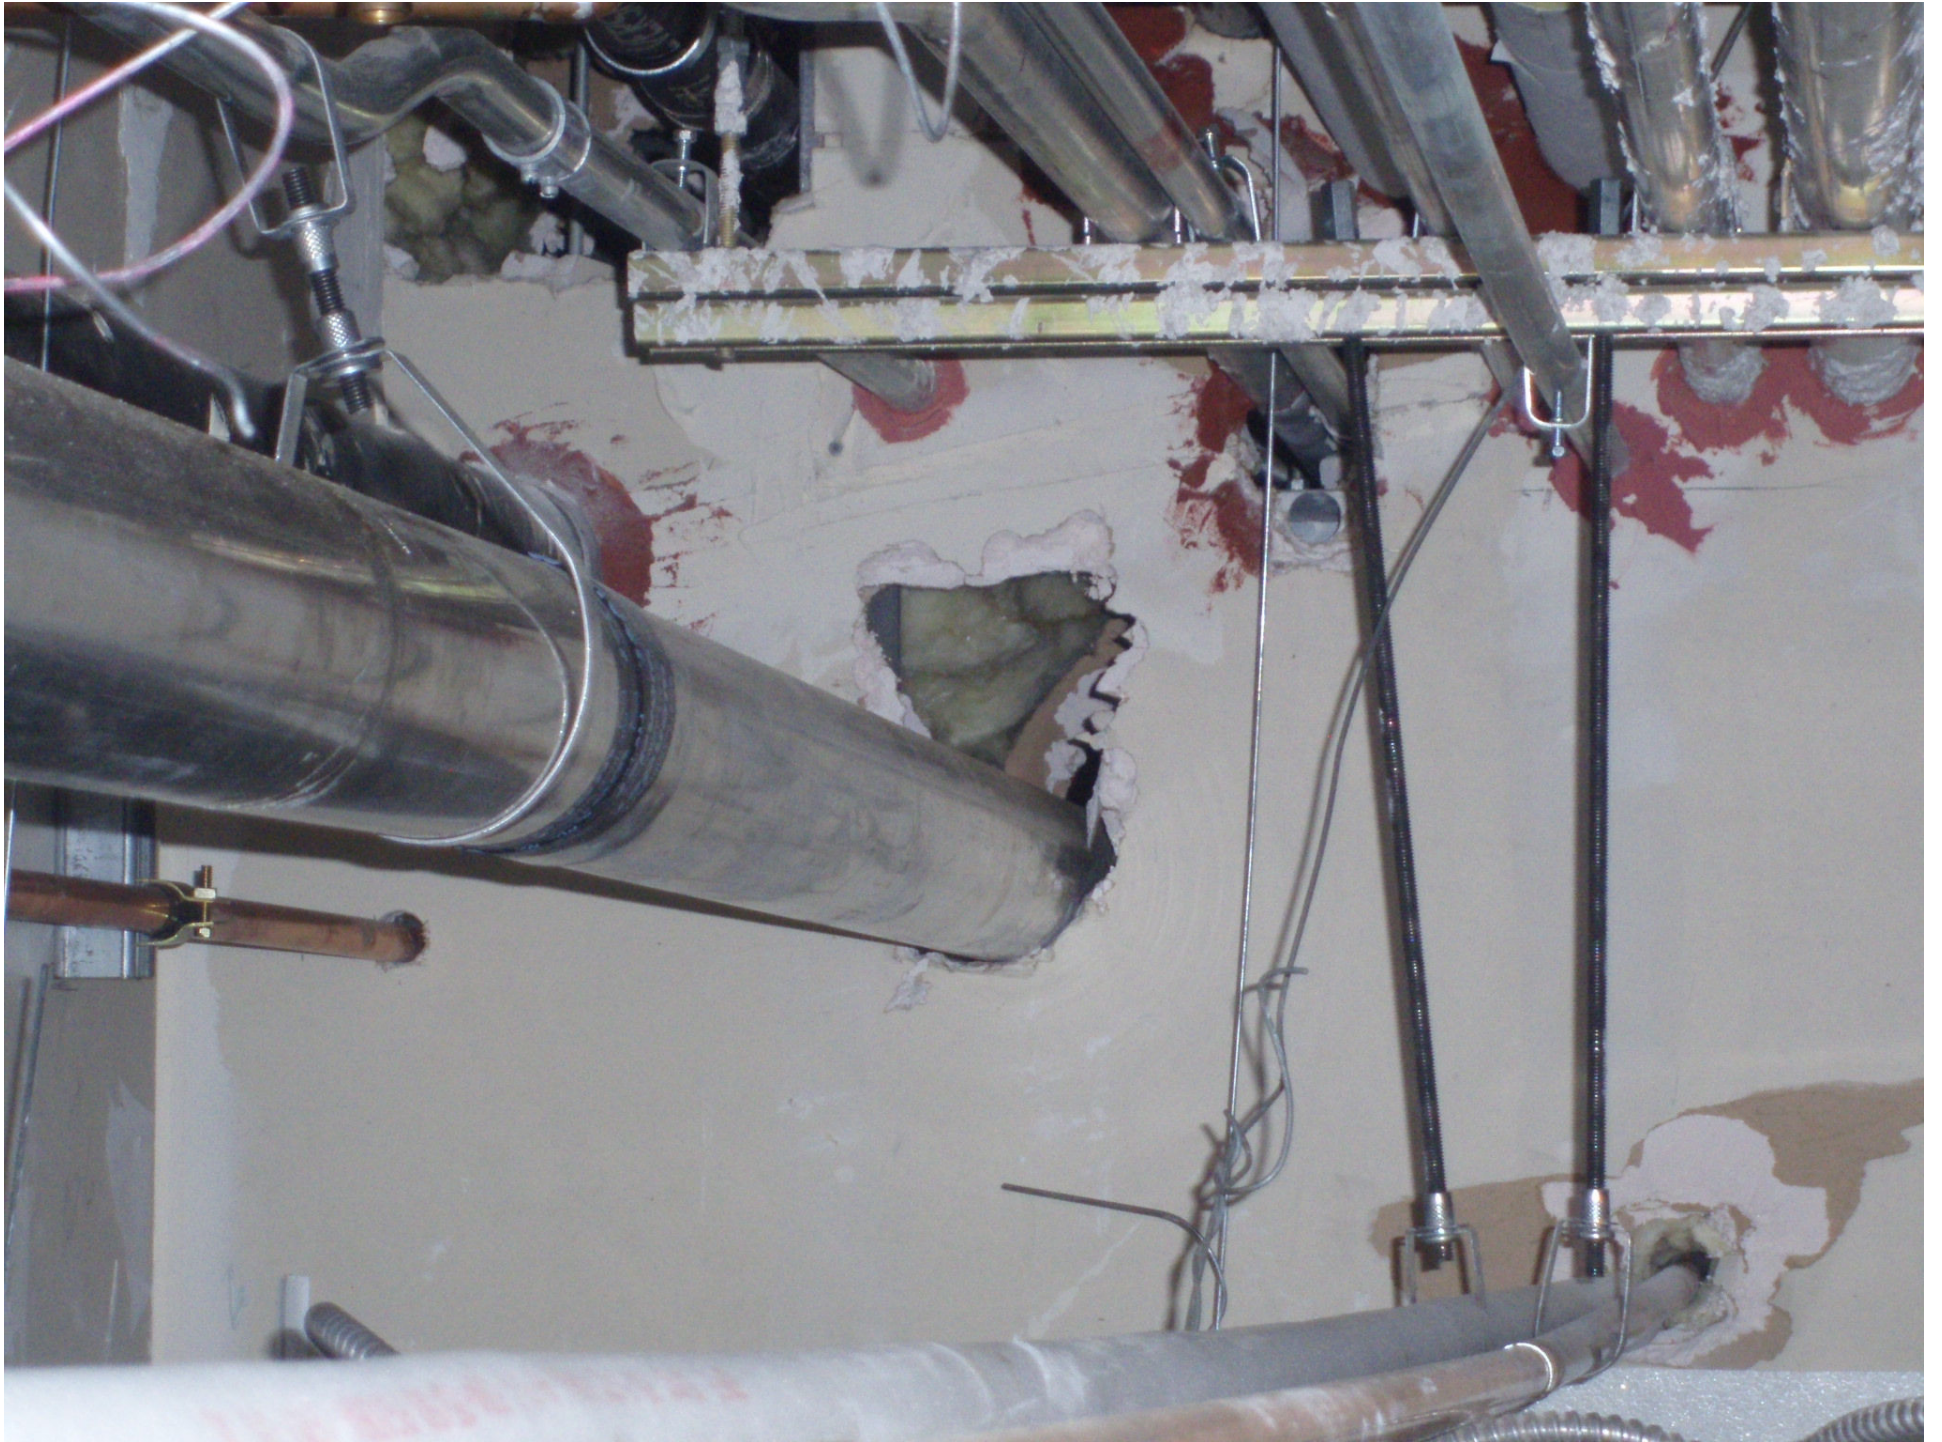
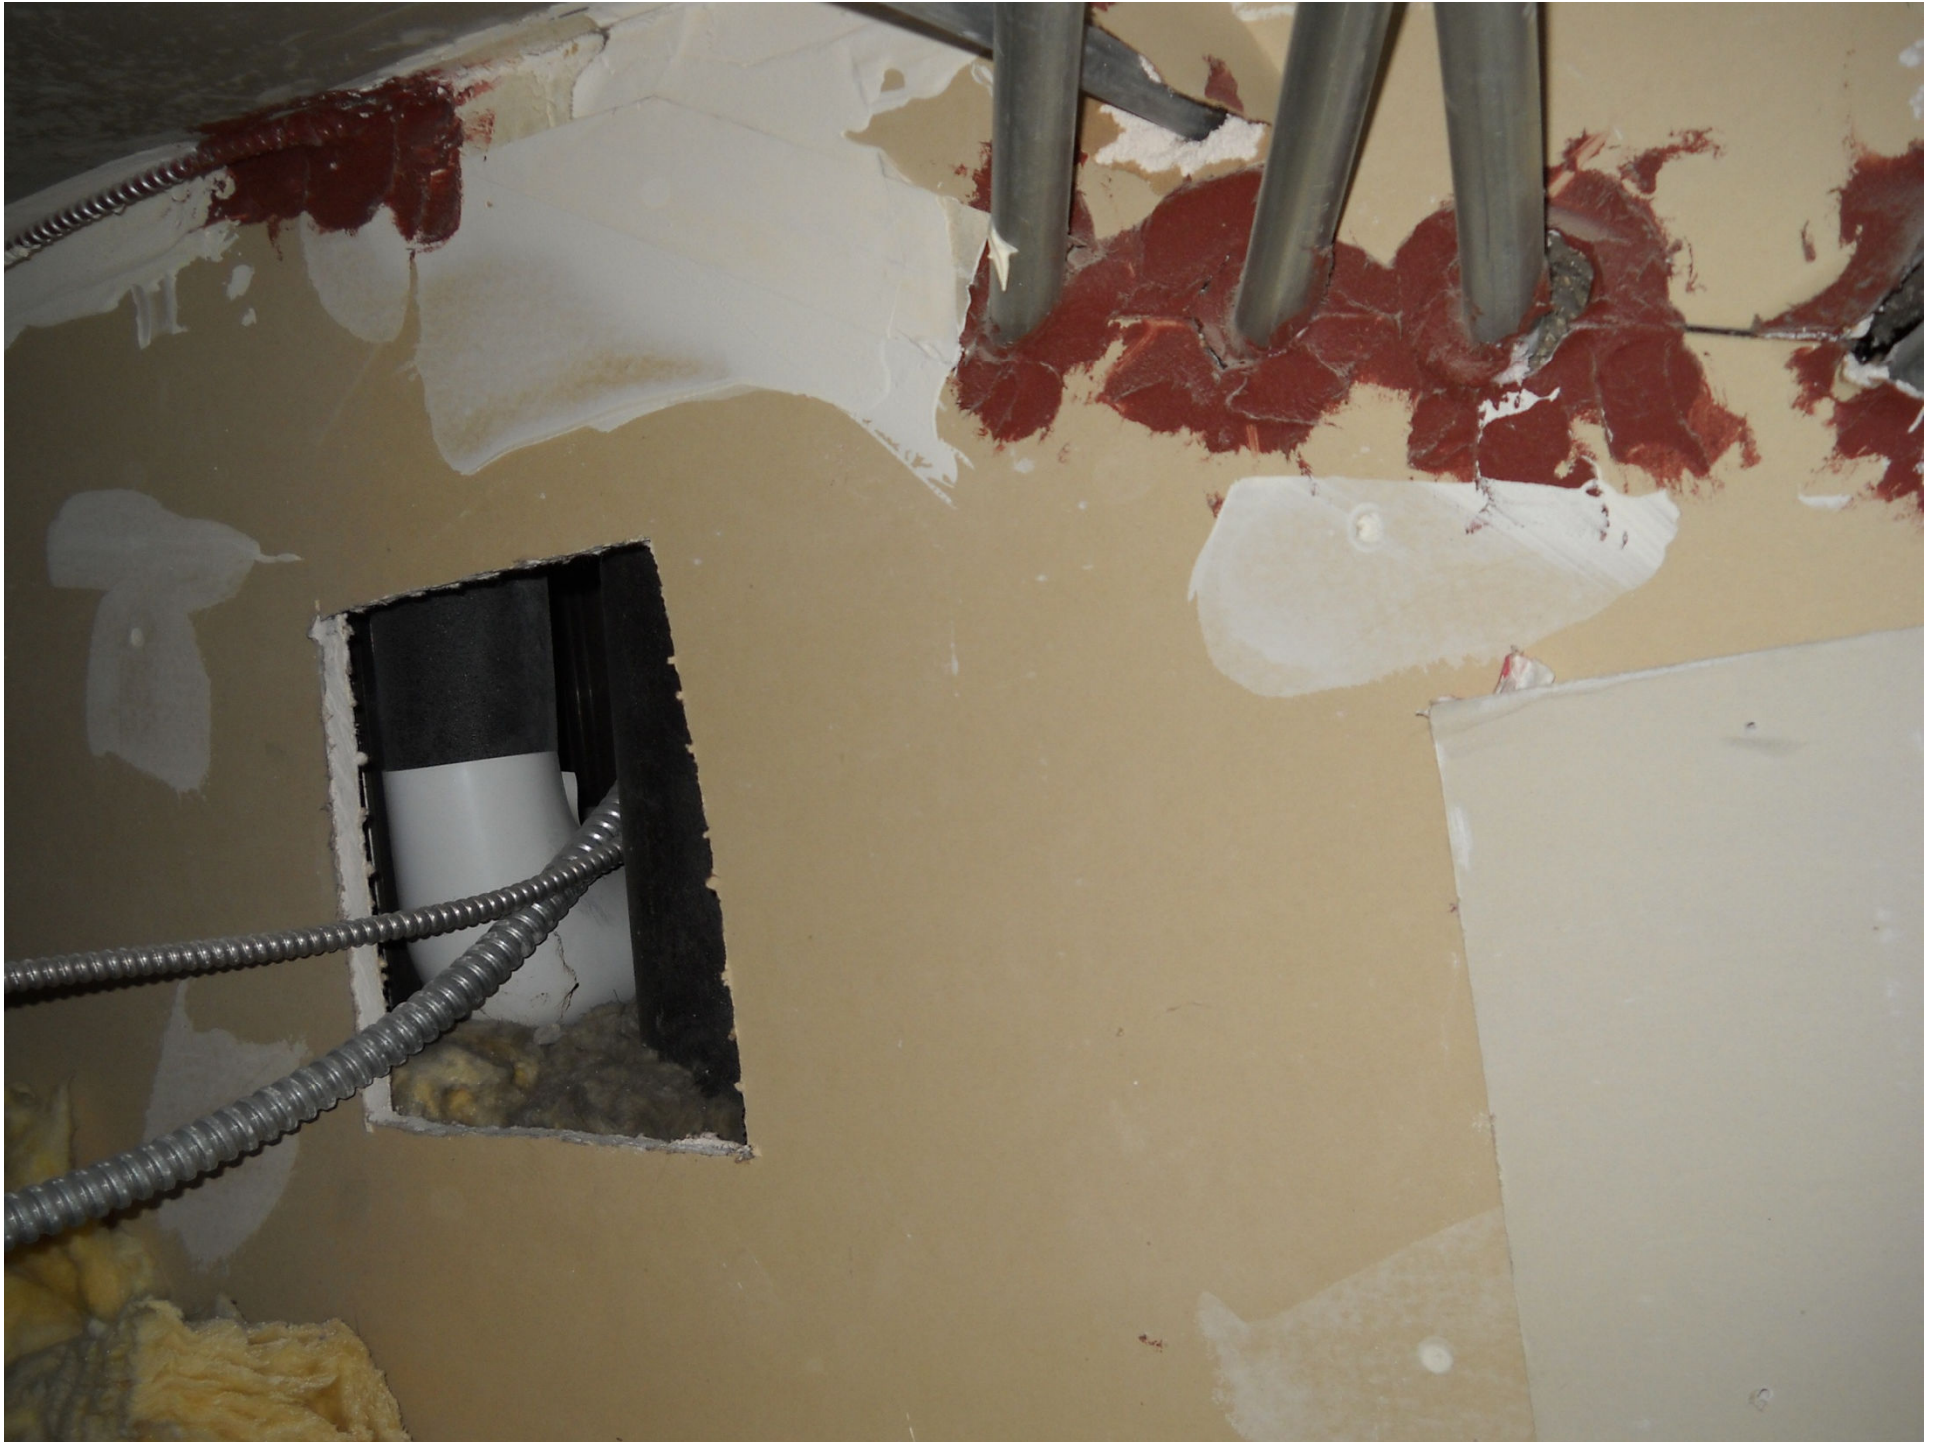
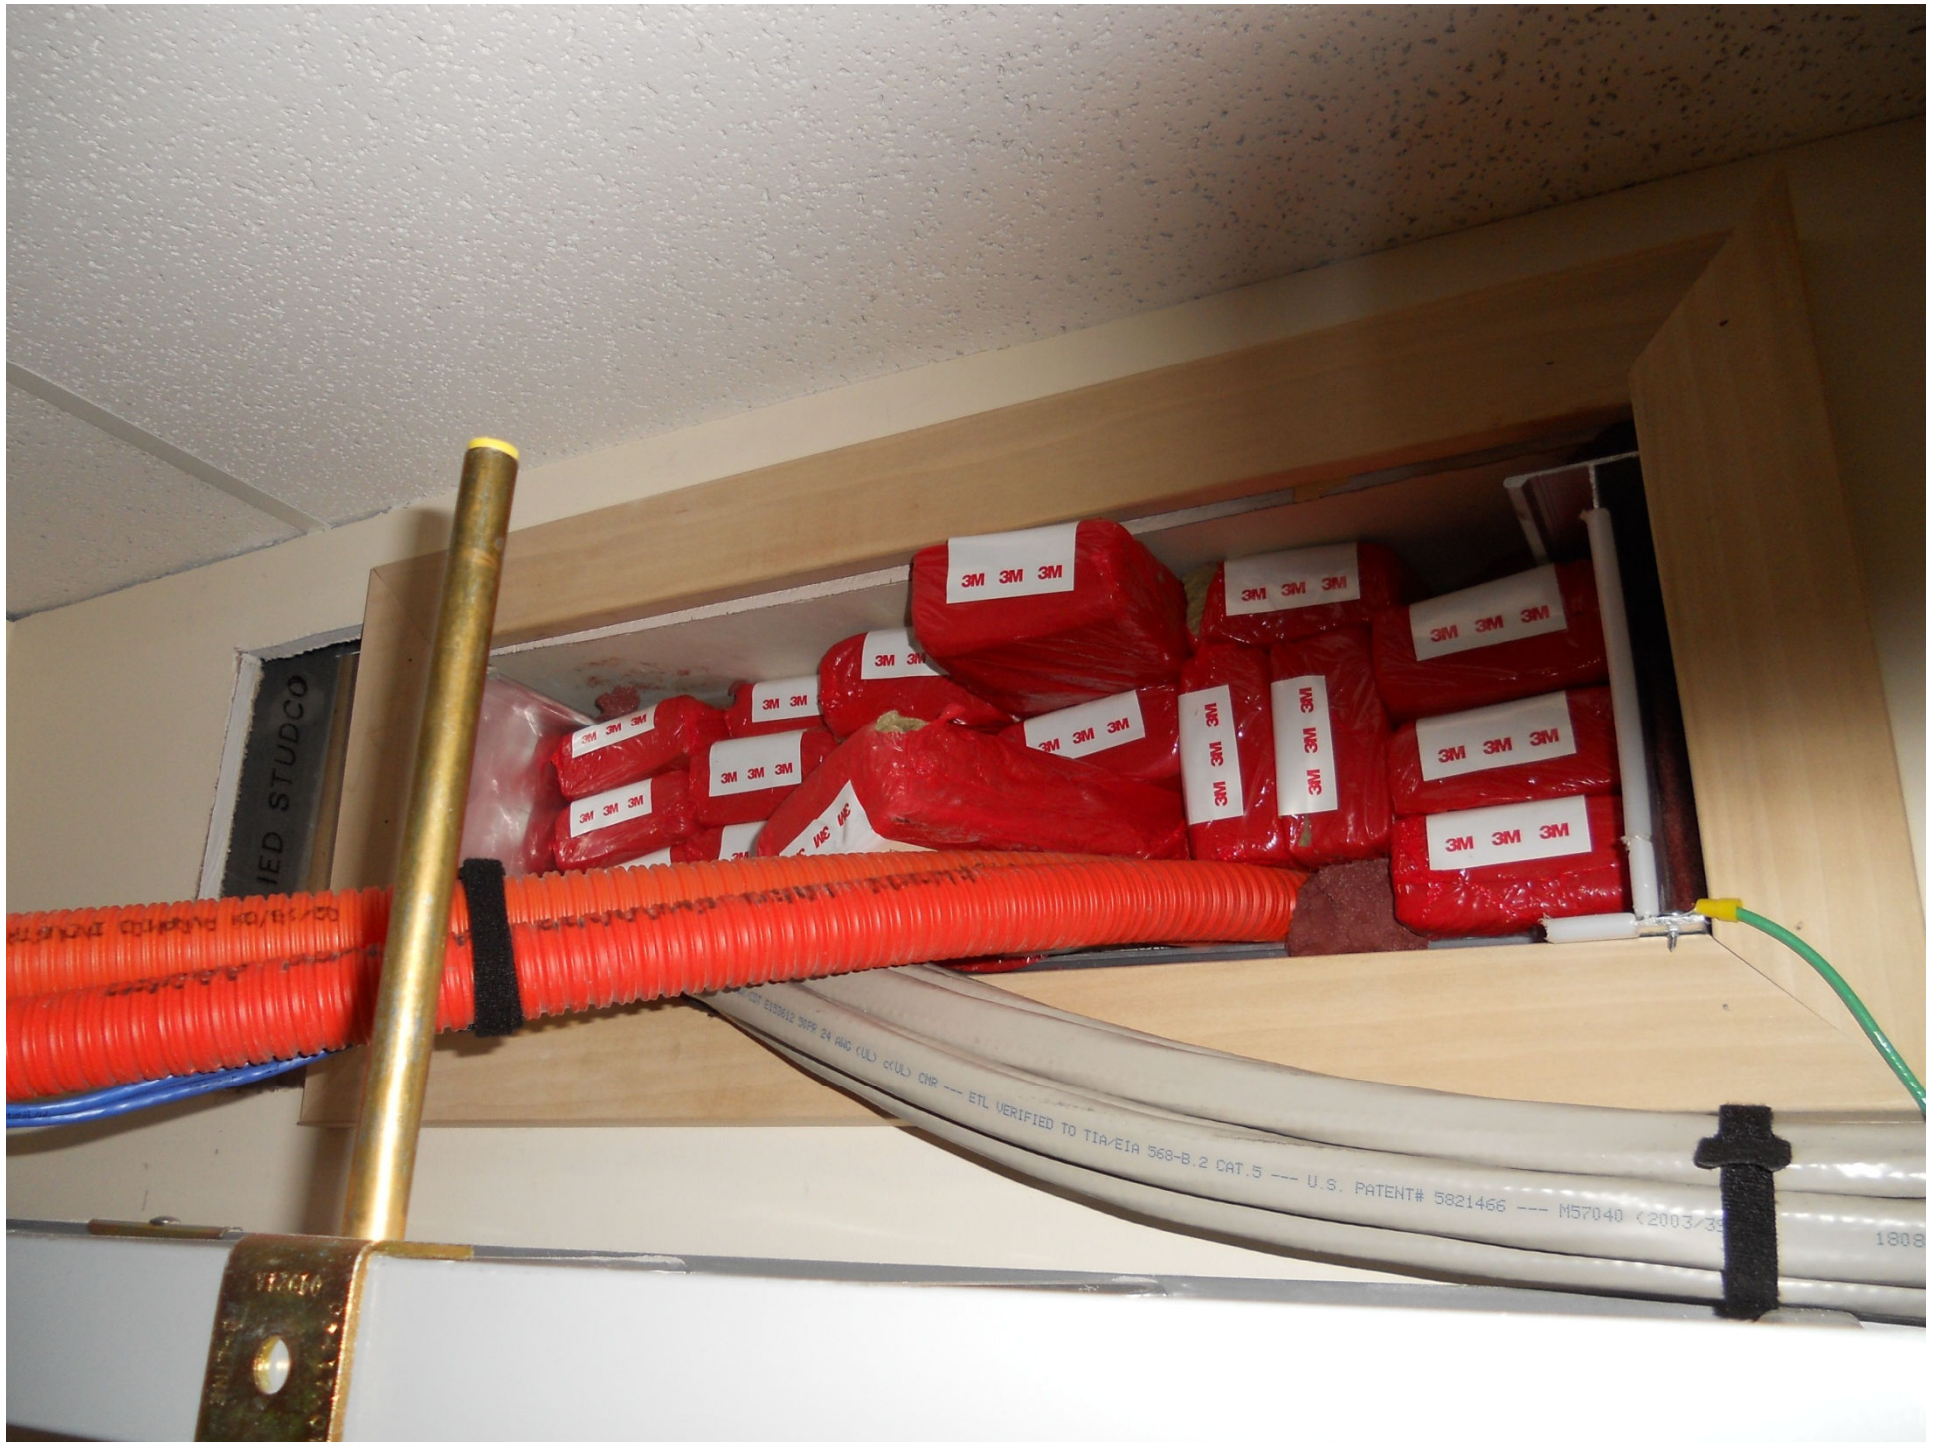
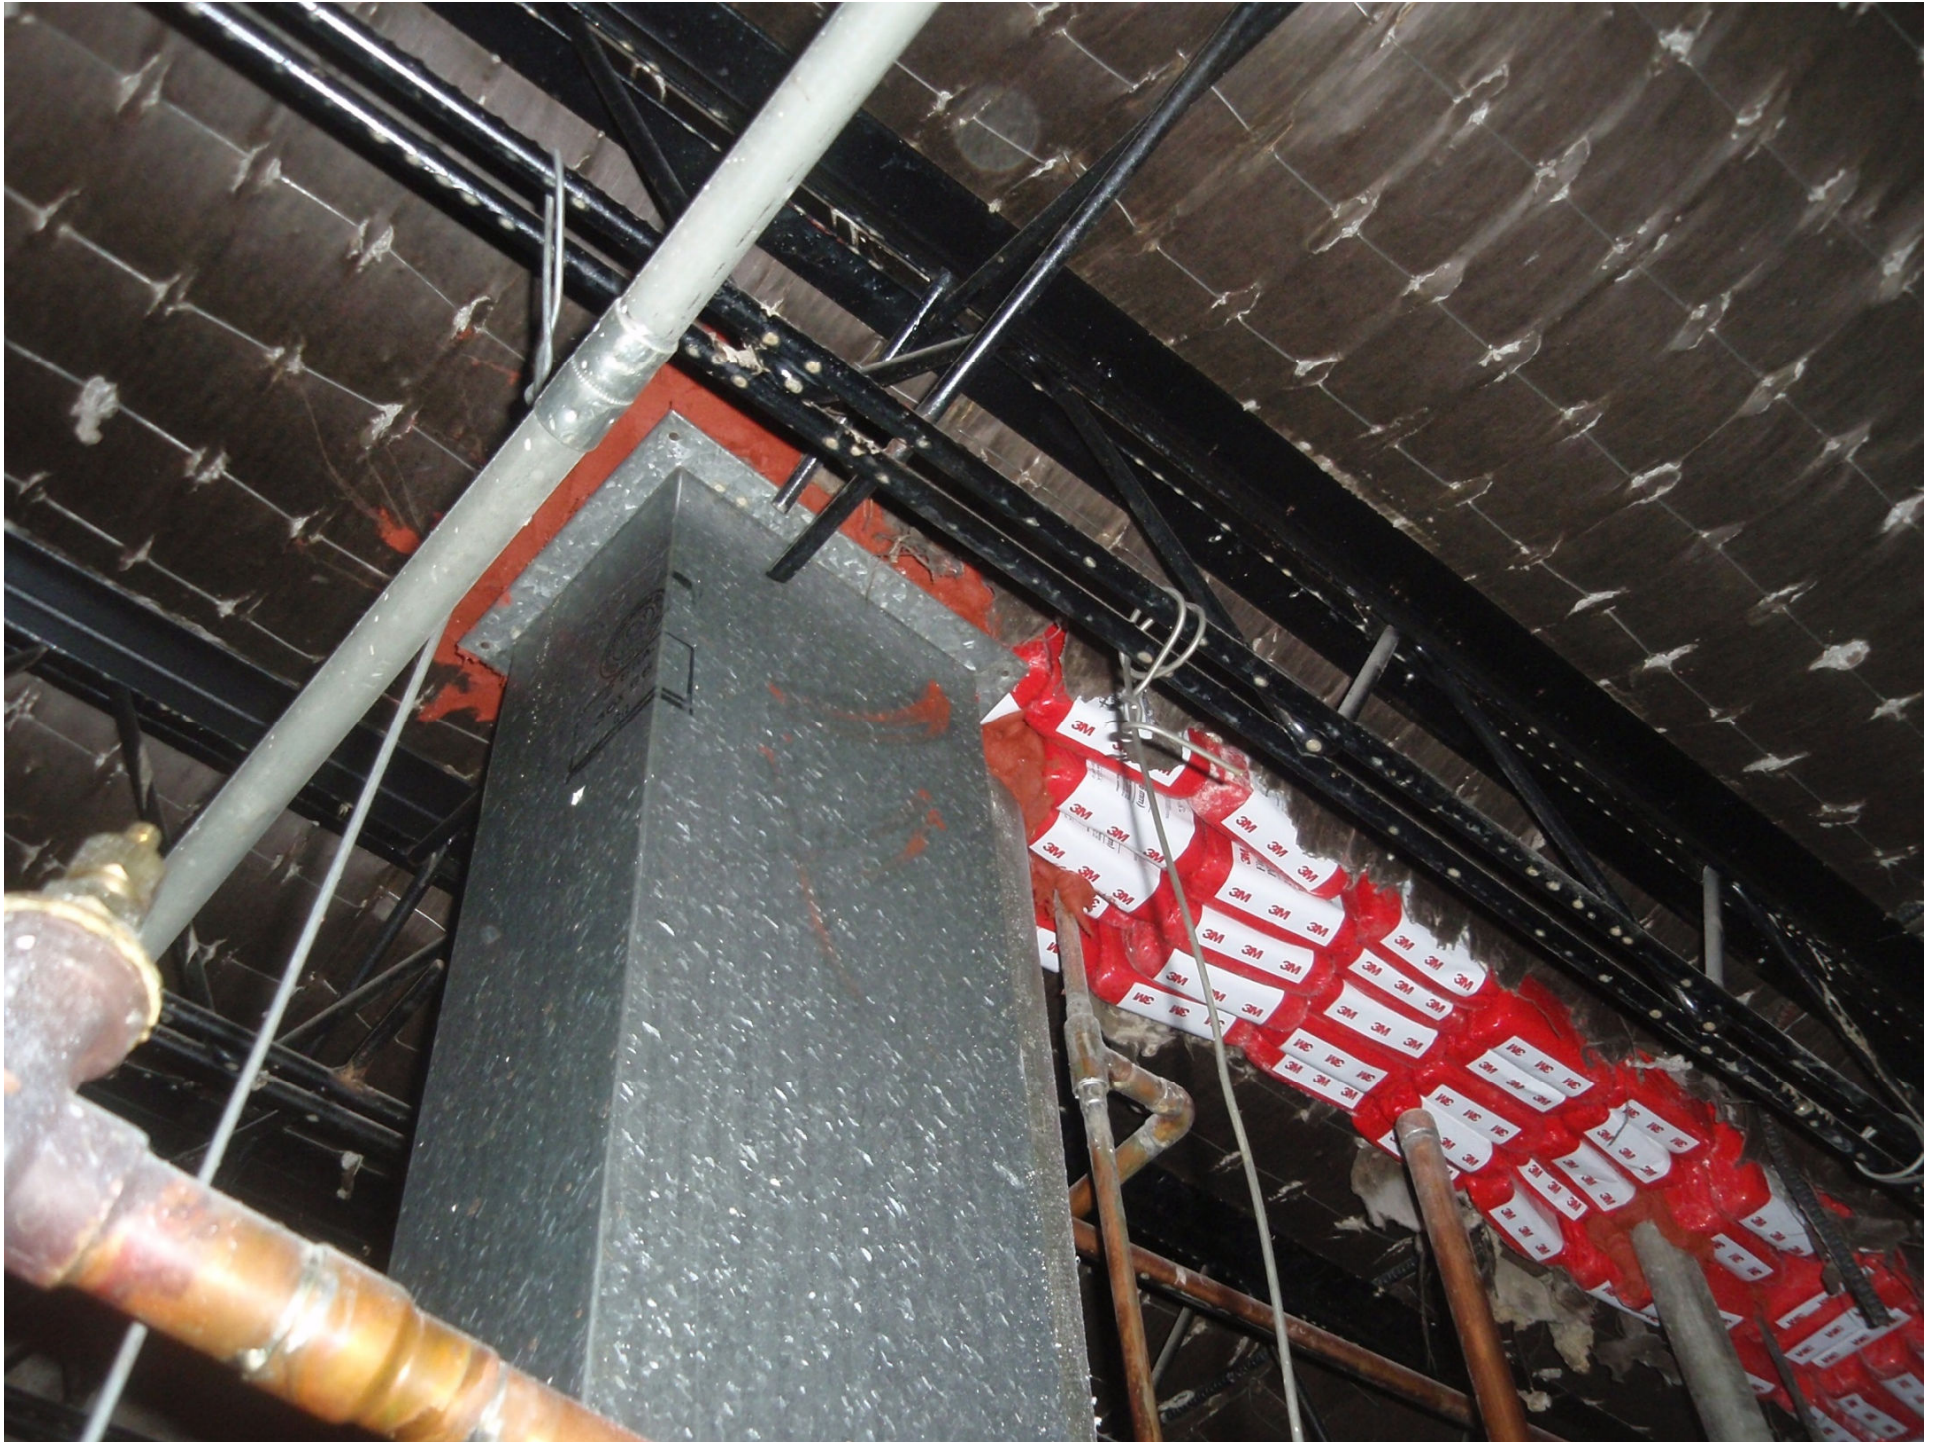
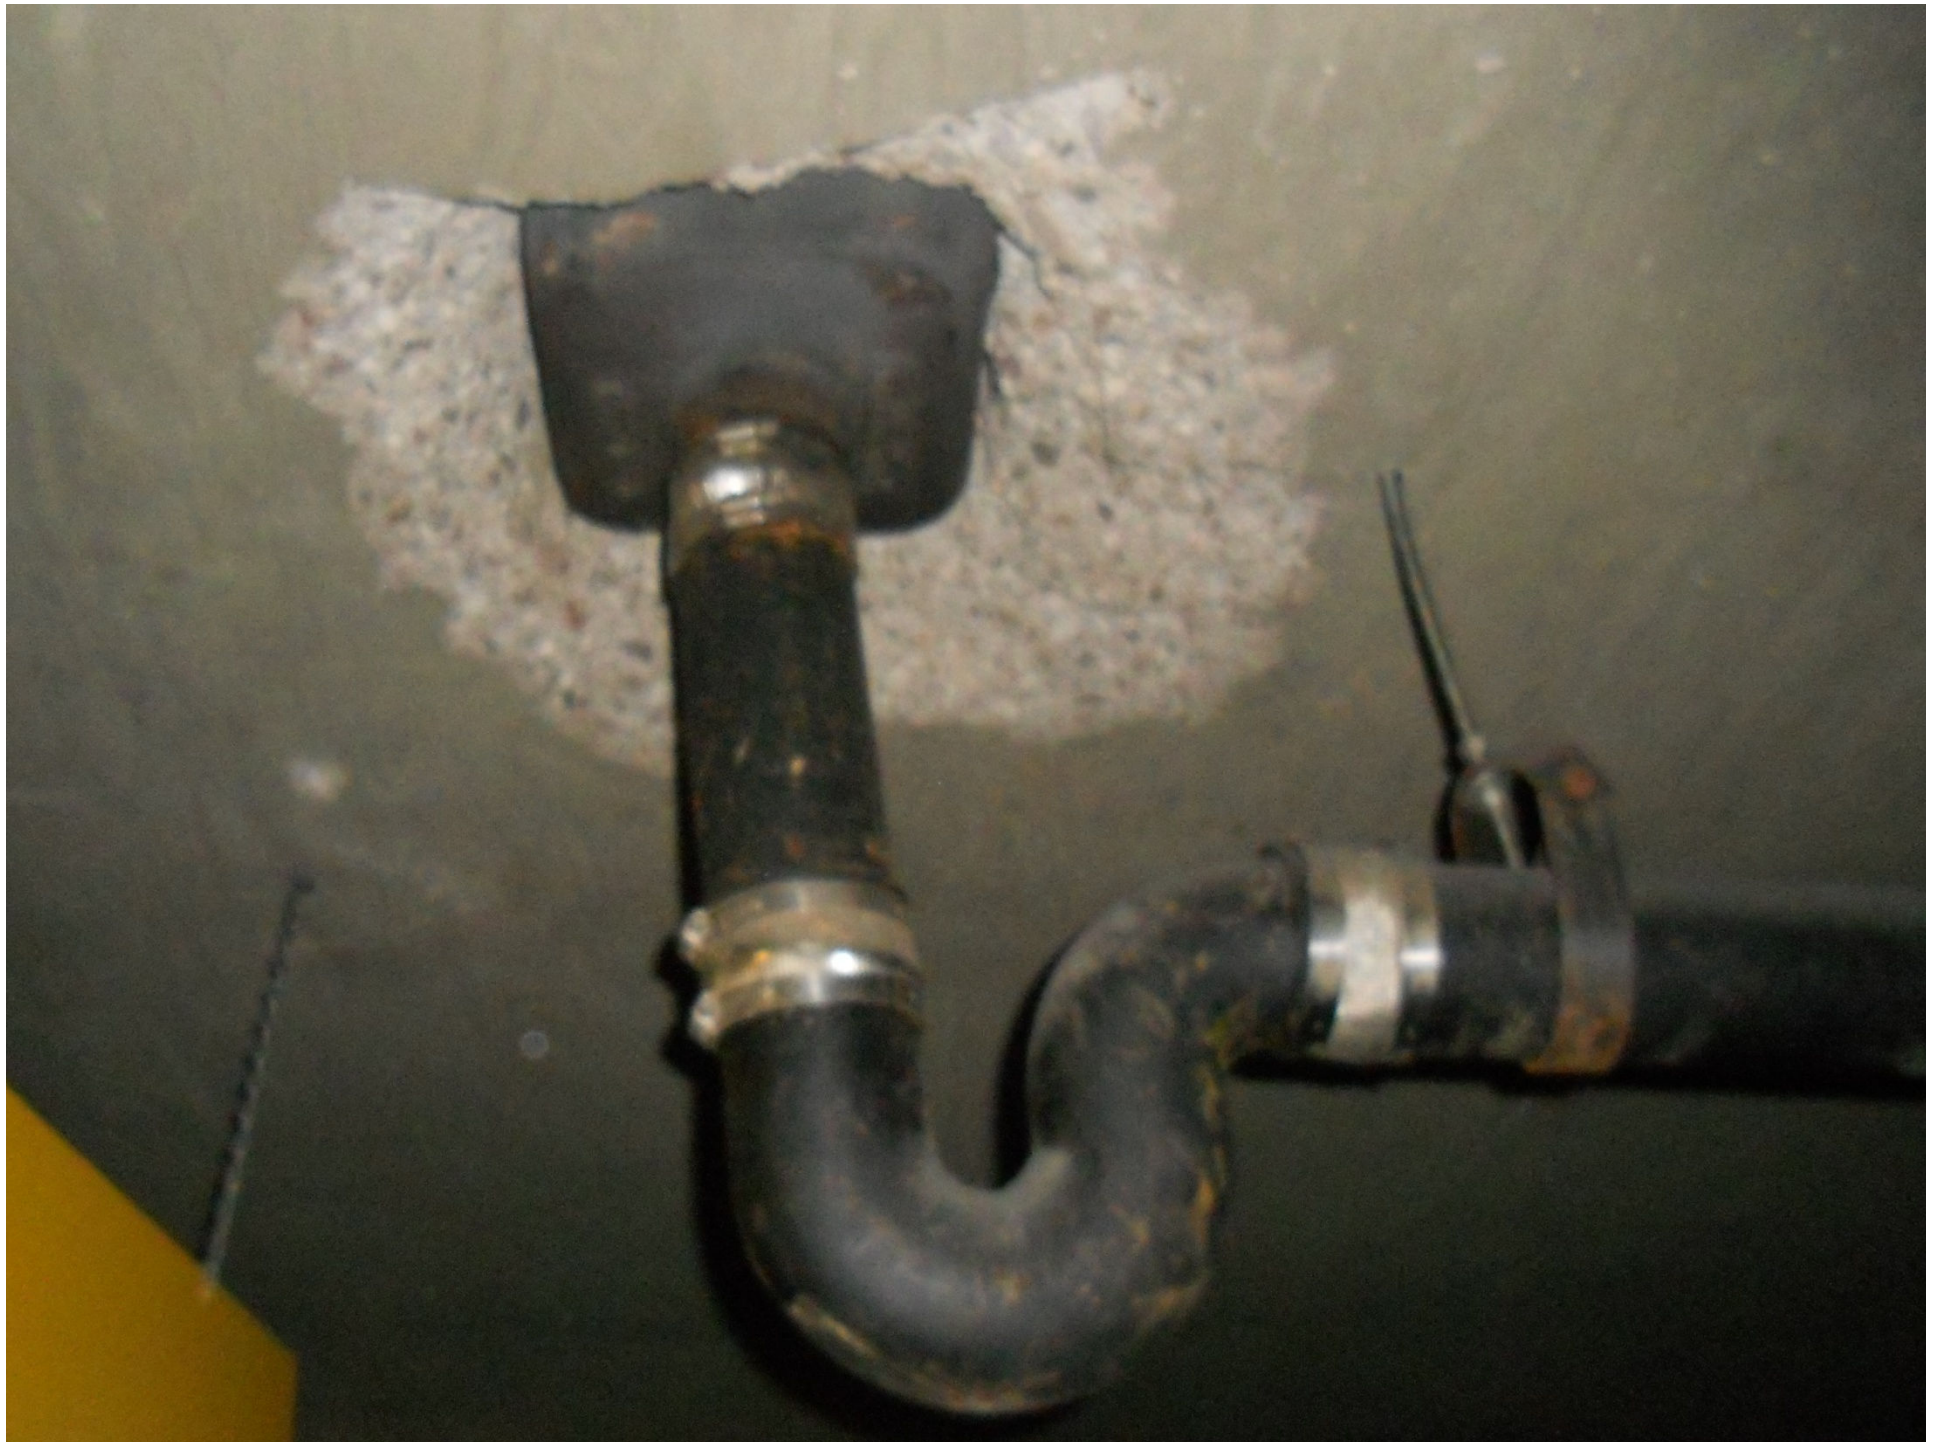
PENETRATIONS WITHIN HOUR
RATED CORRIDOR
