Evaluating Passive Fire Protection in Risk Assessment: A Holistic approach

Sourav Chatterjee-Senior Risk Engineer-Lockton(MENA) Limited

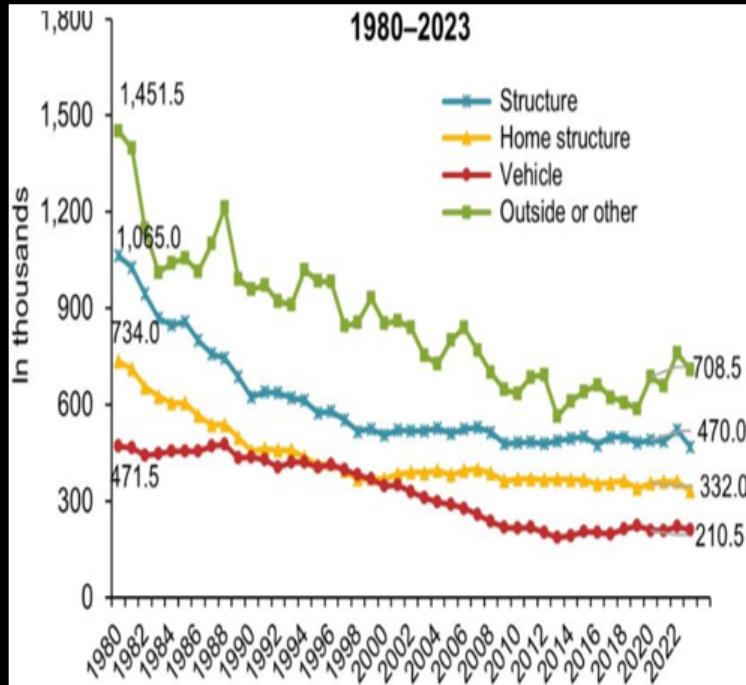
Fires by incident type-in US 1980-2023-Source-NFPA

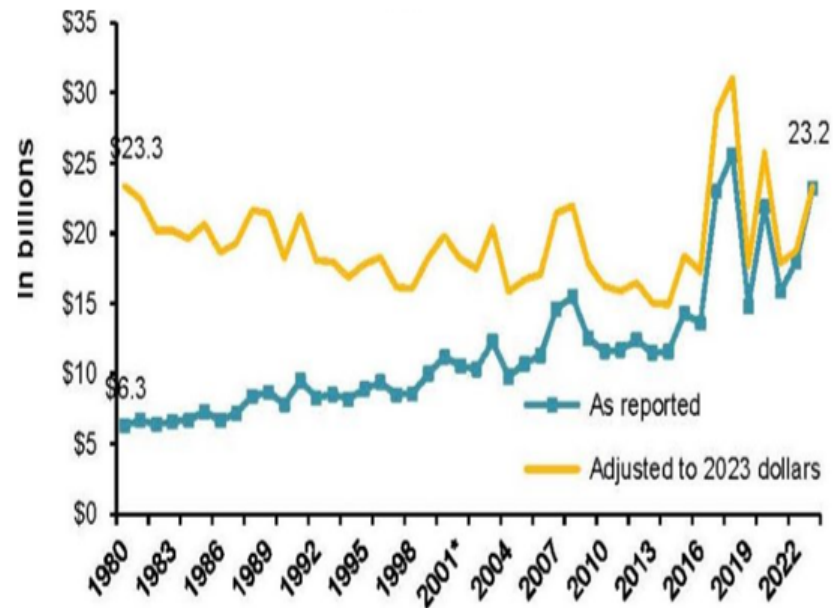
Estimated fire property loss in US-*by year excluding \$33.4 billion loss from 9/11/2001-Source-NFPA

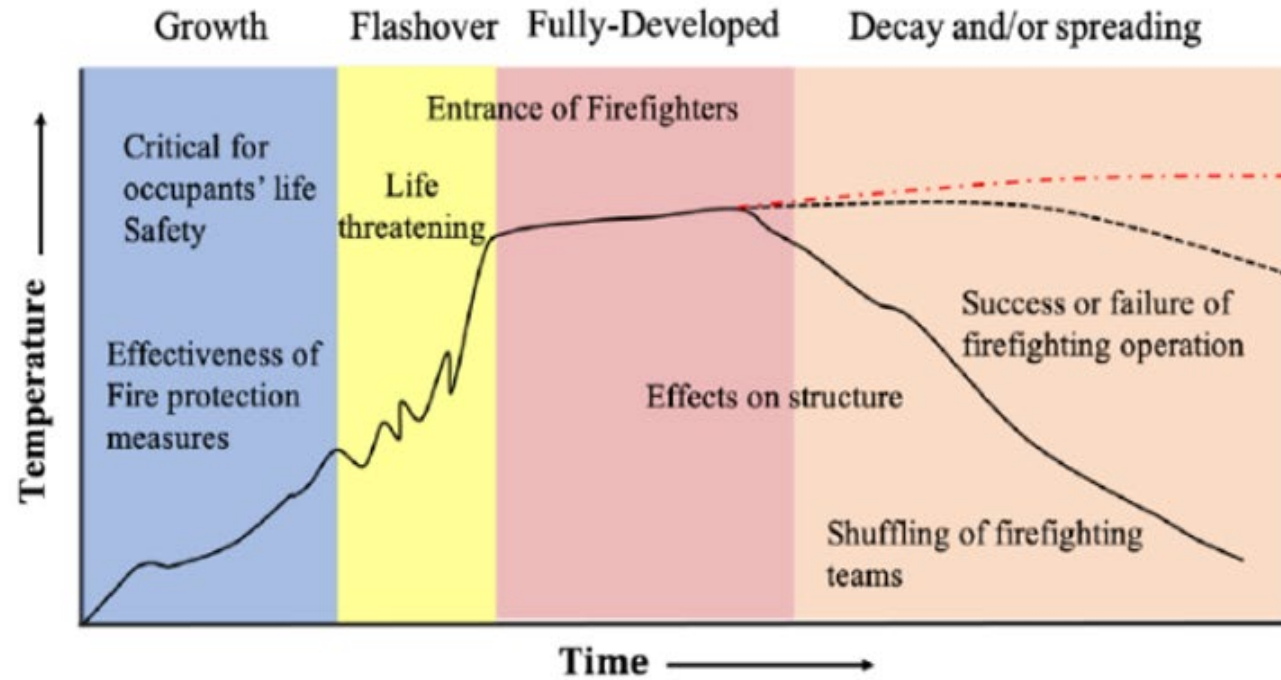
Understanding the synergy between passive and active fire protection measures in a typical building fire

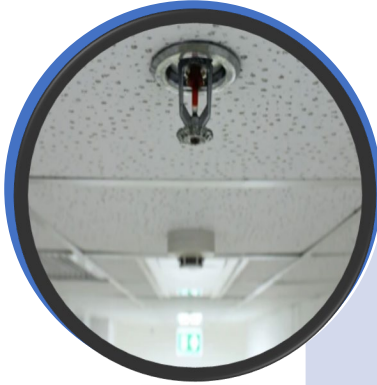
i. Relies on systems that can actively detect, suppress or mitigate fire.

ii. Critical for situations where containment alone isn't sufficient(eg high rise buildings, areas with complex layouts etc)

iii. It requires regular maintenance to ensure reliability in a fire emergency

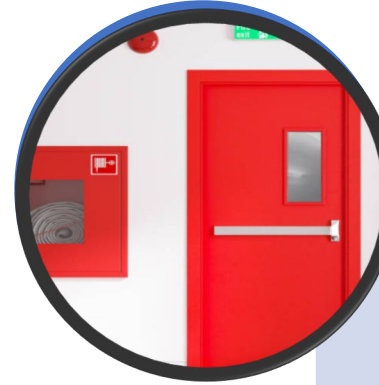
i. Prevents the spread of fire or smoke by containing it within designated compartments, thereby reducing damage and providing valuable time for evacuation and response.

ii. A more resilient approach for preventing fire spread, as it functions continuously, regardless of the fire's stage.

iii. It's a long-term solution embedded within the building structure, while active systems depend on external factors like power or activation.

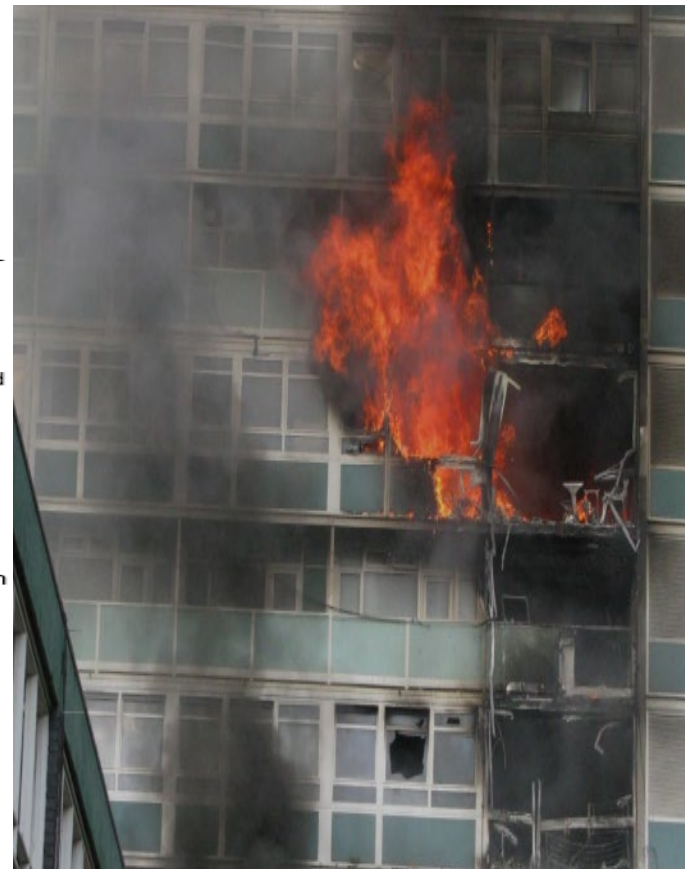
Case study 1- The Lakanal house fire(London, 2009)

The Lakanal House fire killed six people and injured 20 others. The fire spread quickly through the building, exacerbating the situation. The building had been designed with compartmentation to contain fires in individual flats, but the fire spread through open windows and gaps in the building's fire-resisting walls.

- **Failure in Compartmentation:** While the building had been designed with fire-resistant walls, there were significant failures in maintaining these barriers. Fire-resistant doors were often left open or obstructed, and gaps around window frames were not properly sealed.
- **Lack of Firestopping:** Penetrations around services like electrical wiring and pipes were not properly sealed with fire-resistant materials, allowing smoke and fire to spread across floors.
- **Windows and External Spread:** The fire spread rapidly between flats via windows, due to the use of inadequate fire-resistant glazing or lack of fire barriers between windows in the facade.

- A fire risk assessor could have identified that fire doors and compartmentation barriers were not properly maintained or had been compromised by open or obstructed doors. They could have recommended a more rigorous inspection and maintenance routine for these elements.
- They would also have noticed the failure in firestopping around service penetrations, ensuring that these gaps were sealed properly to prevent the spread of fire and smoke.
- A proper assessment could have identified the need for better window fire-resistance measures or fire barriers to prevent fire from spreading across the building externally.

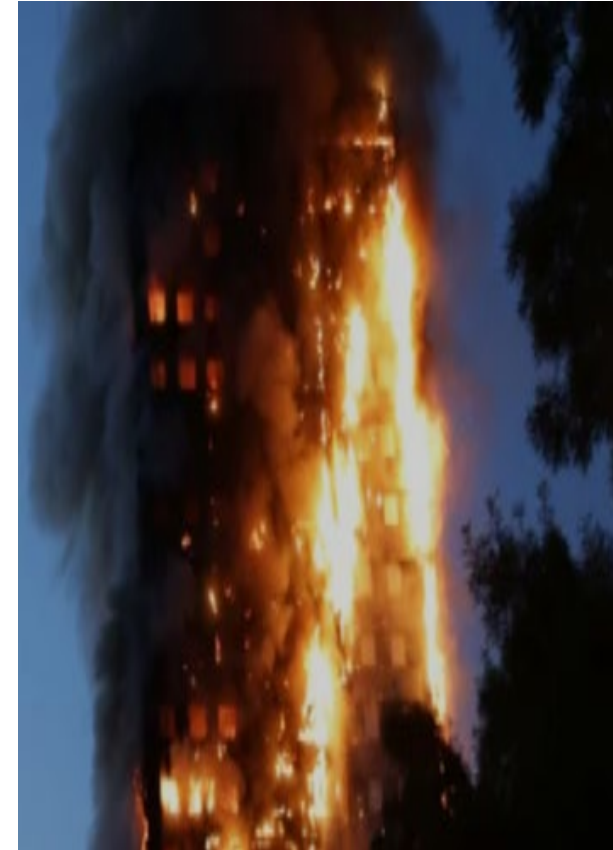
Case study 2-The Melbourne Lacrosse Tower Fire (Australia, 2014)

In Melbourne, a fire broke out on the 21st floor of the Lacrosse Tower, which spread quickly up the building's facade. Thankfully, there were no fatalities, but the fire caused significant property damage and raised concerns about building safety.

- **Flammable Cladding:** The building's exterior was clad with highly flammable aluminium composite panels. The fire spread along the facade because the cladding material did not have adequate fire resistance.
- **Lack of Fire-Resistant Barriers on the Facade:** The fire spread vertically between the floors along the exterior of the building, bypassing internal fire barriers.

- A fire risk assessor should have identified that the choice of cladding material was not compliant with fire safety regulations and that it posed a significant fire risk.
- They could have recommended replacing the cladding with fire-resistant materials to prevent external fire spread.
- Assessors could have also ensured that the building design incorporated adequate fire barriers along the facade to contain fire within each floor and prevent it from spreading up the building's exterior.

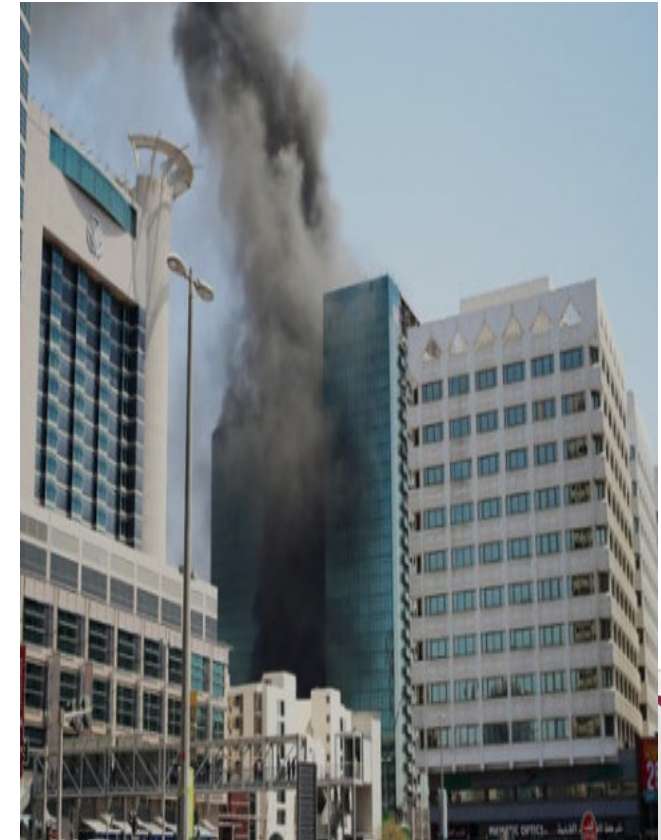
Case study 3-Al Shams tower (Abu Dhabi, 2016)

A significant fire broke out in the Al Shams Tower, a high-rise building in Abu Dhabi, in 2016. The fire, which started on the upper floors, caused considerable damage but fortunately did not result in any fatalities.

- **Flammable External Materials:** Like other high-rise fires, the fire spread quickly along the external facade, which was clad with aluminum composite panels (ACP) that were highly flammable.
- **Failure of Firestopping Measures:** The building had gaps in firestopping around services such as electrical cables and pipes, which allowed fire and smoke to spread between floors, bypassing the compartmentation system.
- **Lack of Maintenance of Fire Doors and Barriers:** There were reports that fire doors were either blocked or left open, which meant that fire and smoke could migrate from one apartment to another, exacerbating the fire's spread.

- A fire risk assessor would have identified the fire risk posed by the use of combustible cladding and recommended replacing it with fire-resistant alternatives to prevent external fire spread.
- They would have conducted thorough inspections of the building's firestopping systems, ensuring that service penetrations were sealed and that there were no gaps through which fire and smoke could pass.
- The assessor would have also ensured that all fire doors were operational, well-maintained, and not obstructed, and that compartmentation was intact to contain the fire within the affected area.
