Understanding the synergy between passive and active fire protection measures in a typical building fire

Essential principles-passive fire protection by design

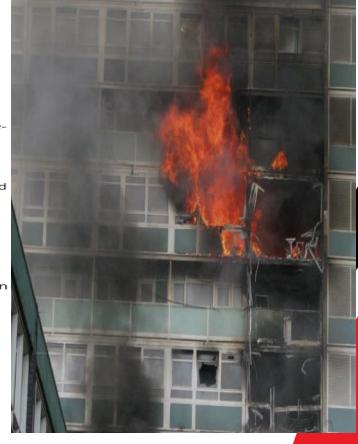
Case study 2-The Melbourne Lacrosse Tower Fire (Australia, 2014)

In Melbourne, a fire broke out on the 21st floor of the Lacrosse Tower, which spread quickly up the building's facade. Thankfully, there were no fatalities, but the fire caused significant property damage and raised concerns about building safety.

- Flammable Cladding: The building's exterior was clad with highly flammable aluminium composite panels. The fire spread along the facade because the cladding material did not have adequate fire resistance.
- Lack of Fire-Resistant Barriers on the Facade: The fire spread vertically between the floors along the exterior of the building, bypassing internal fire barriers.

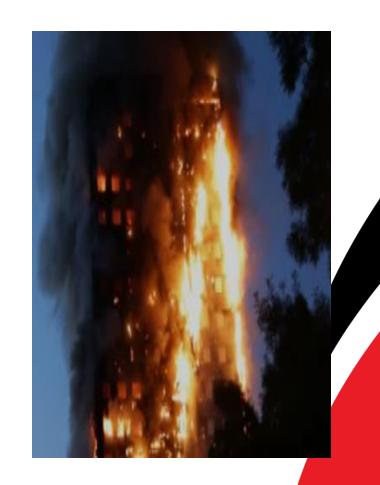
Case study 3-Al Shams tower (Abu Dhabi, 2016)

A significant fire broke out in the Al Shams Tower, a high-rise building in Abu Dhabi, in 2016. The fire, which started on the upper floors, caused considerable damage but fortunately did not result in any fatalities.

Flammable External Materials: Like other high-rise fires, the fire spread quickly along the external facade, which was clad with aluminum composite panels (ACP) that were highly flammable.

Failure of Firestopping Measures: The building had gaps in firestopping around services such as electrical cables and pipes, which allowed fire and smoke to spread between floors, bypassing the compartmentation system.

Lack of Maintenance of Fire Doors and Barriers: There were reports that fire
doors were either blocked or left open, which meant that fire and smoke could
migrate from one apartment to another, exacerbating the fire's spread.
