# The role of Passive F Protection

Dr Gabrielle Peck, BSc (Hons), Ph.D., MRSC,  
Technical Director

# Smoke toxicity is the leading cause of death in fire.

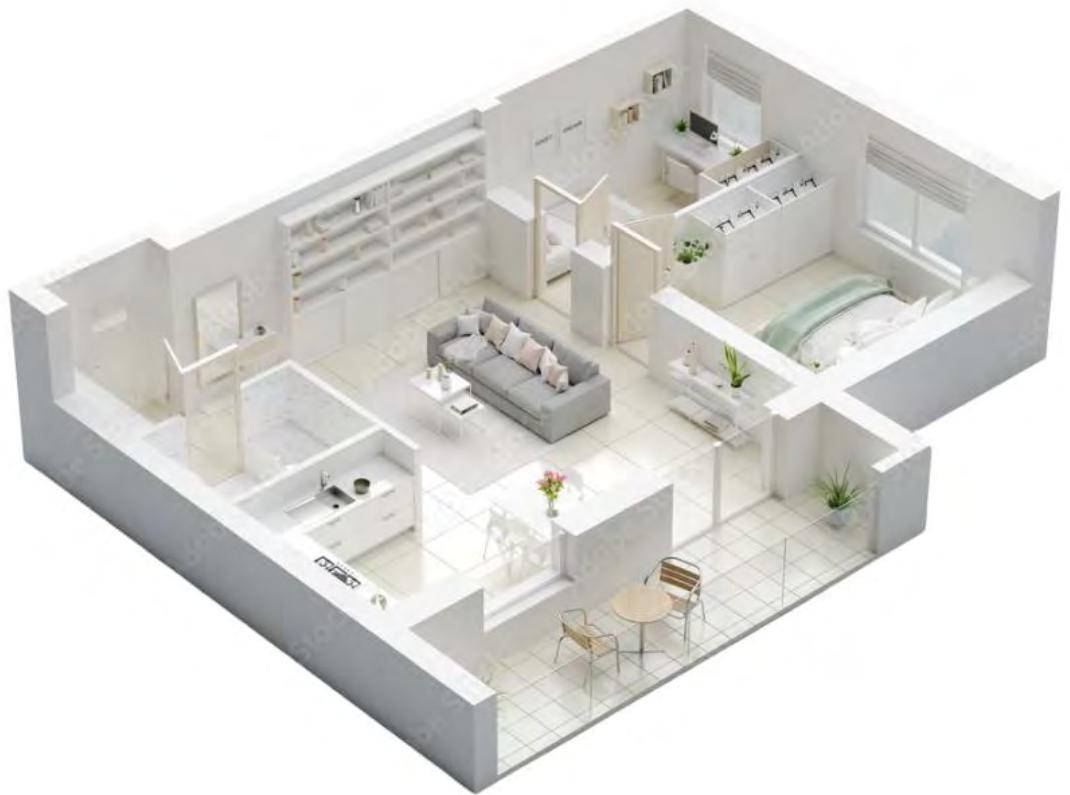
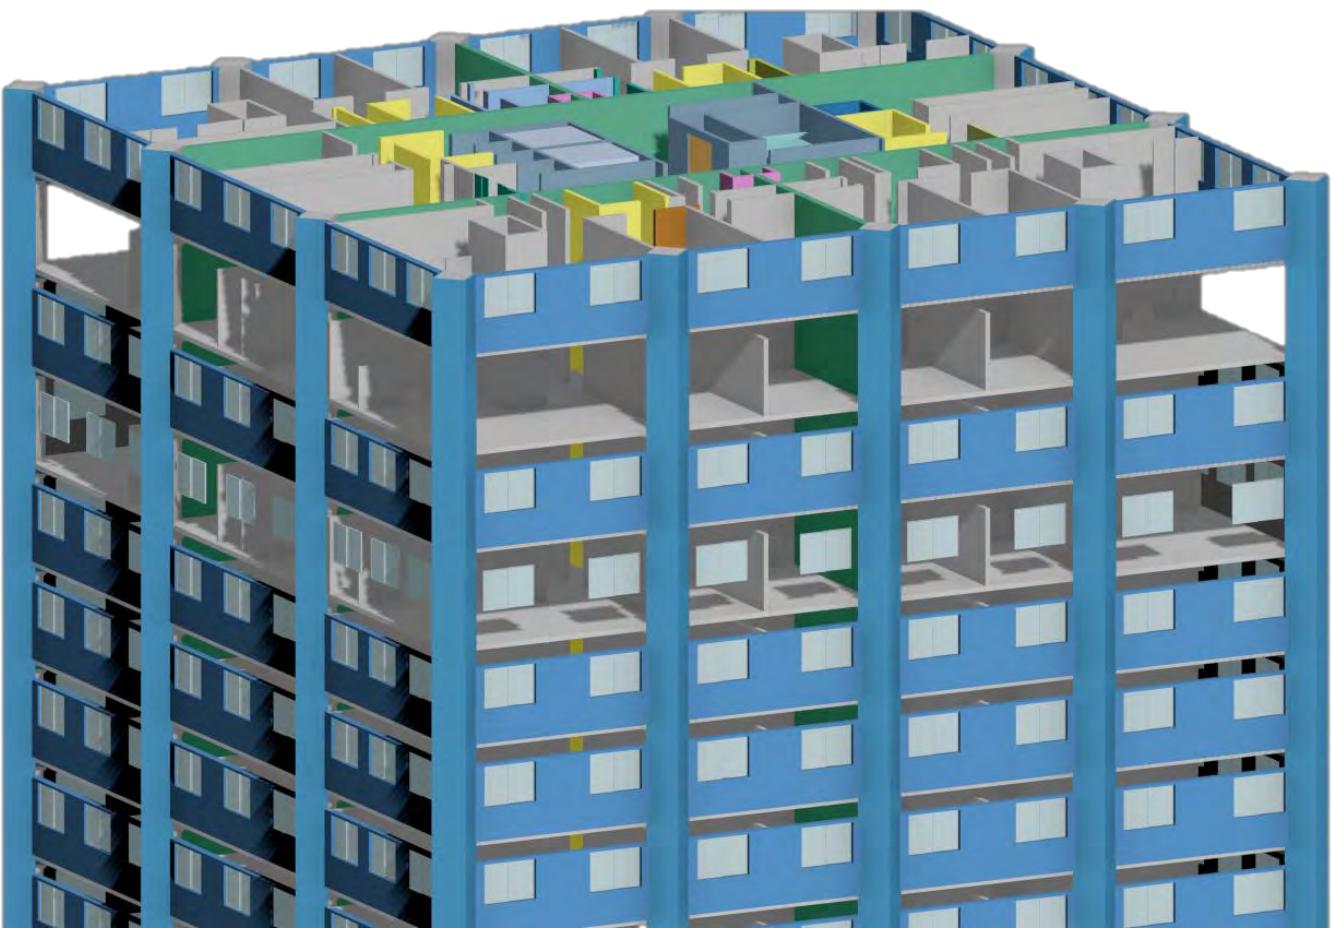
- Flashover is the rapid transition in a fire where all combustible materials in an enclosed space ignite nearly simultaneously due to intense heat, typically occurring when temperatures reach 500–600°C (932–1112°F), causing a sudden spread of flames and extreme danger.

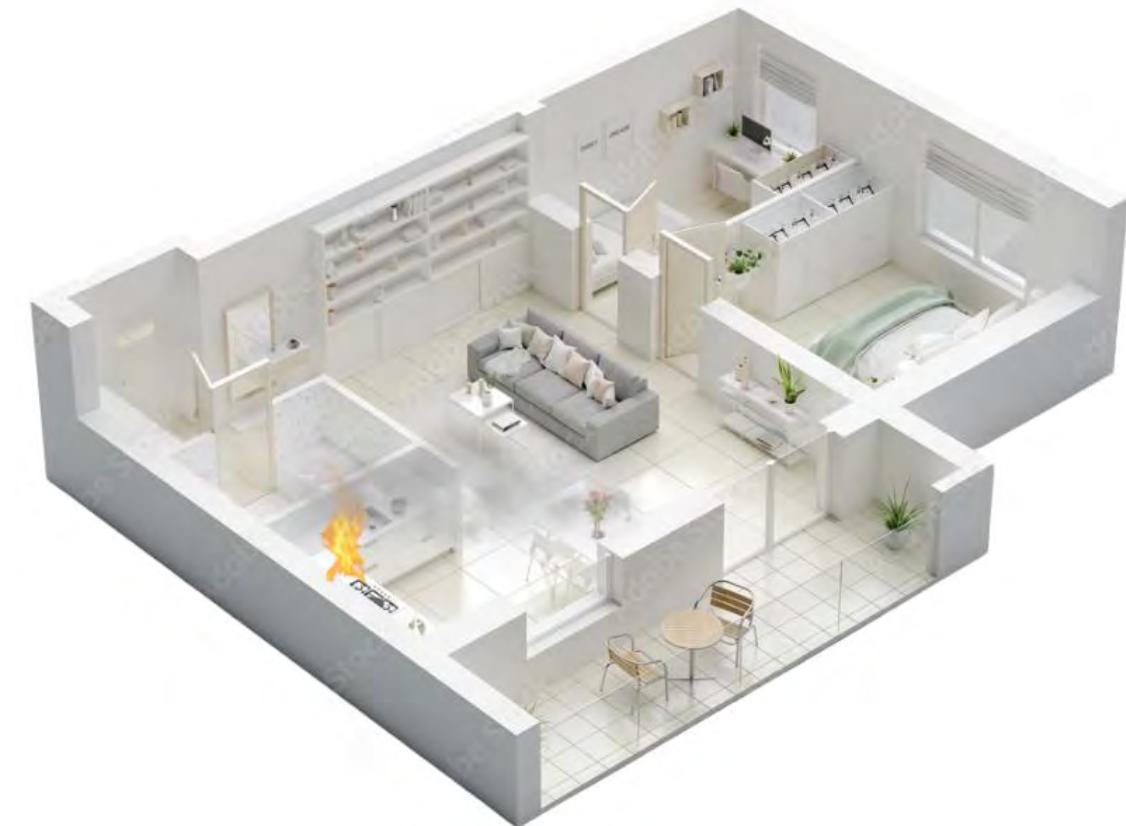
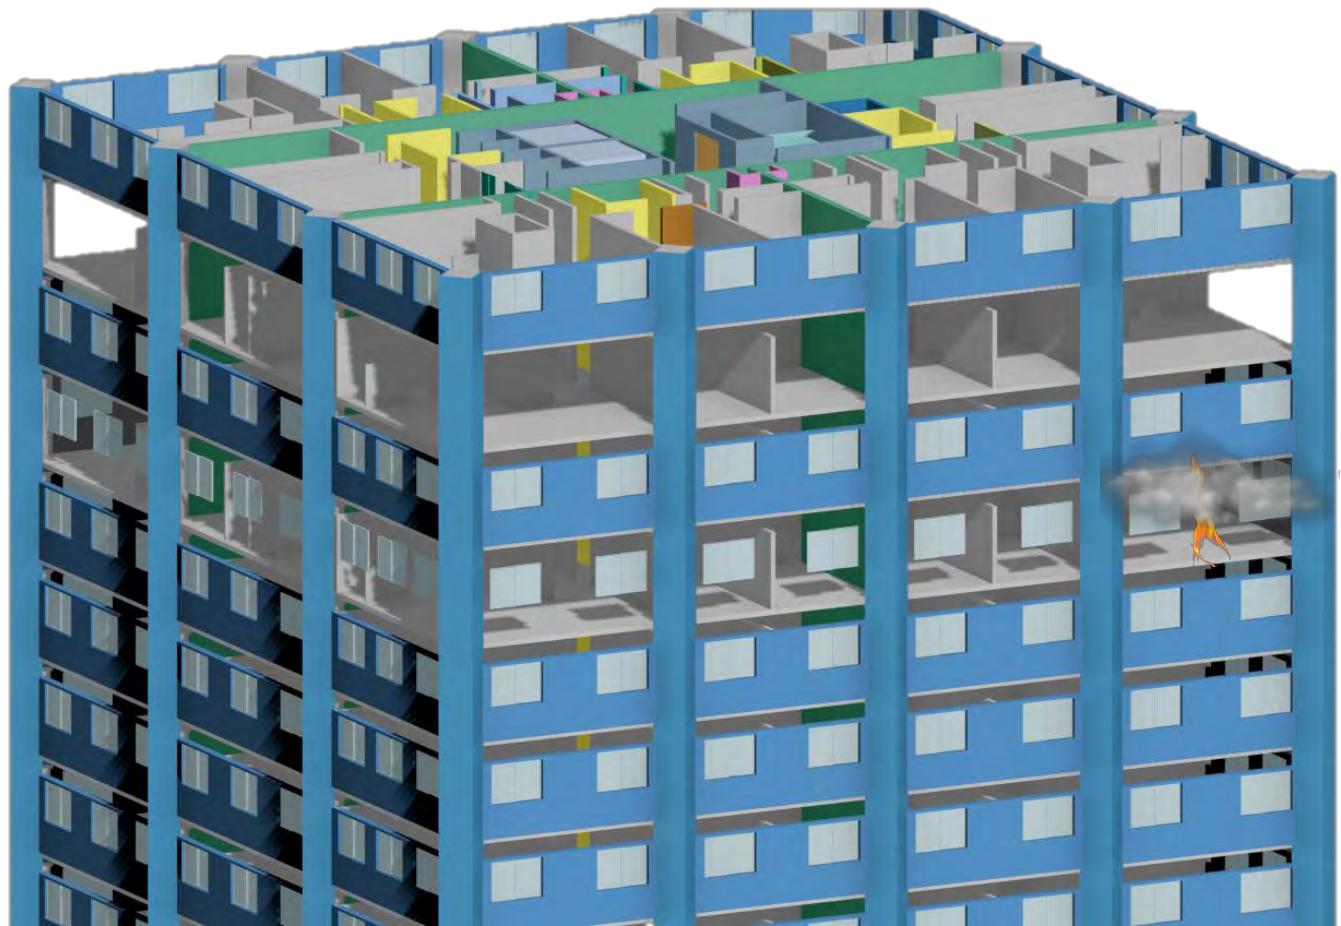
# 0 to 5 mins

A small fire in a room begins.

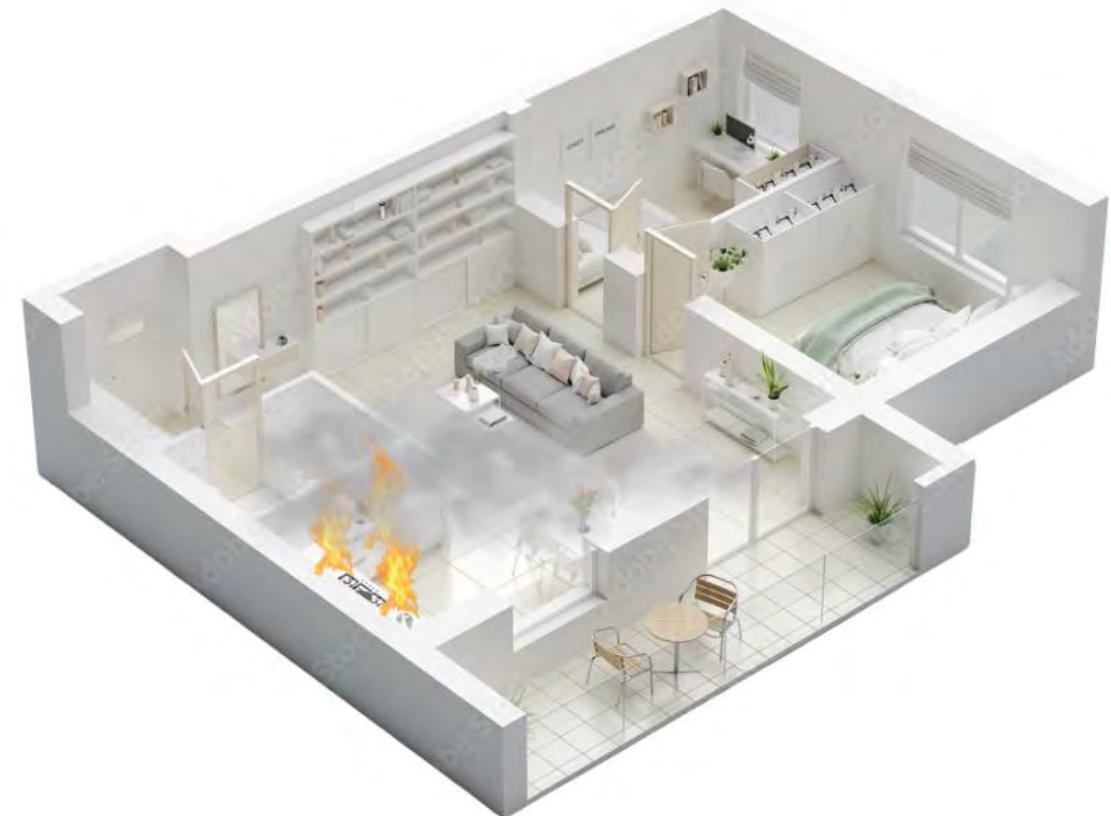
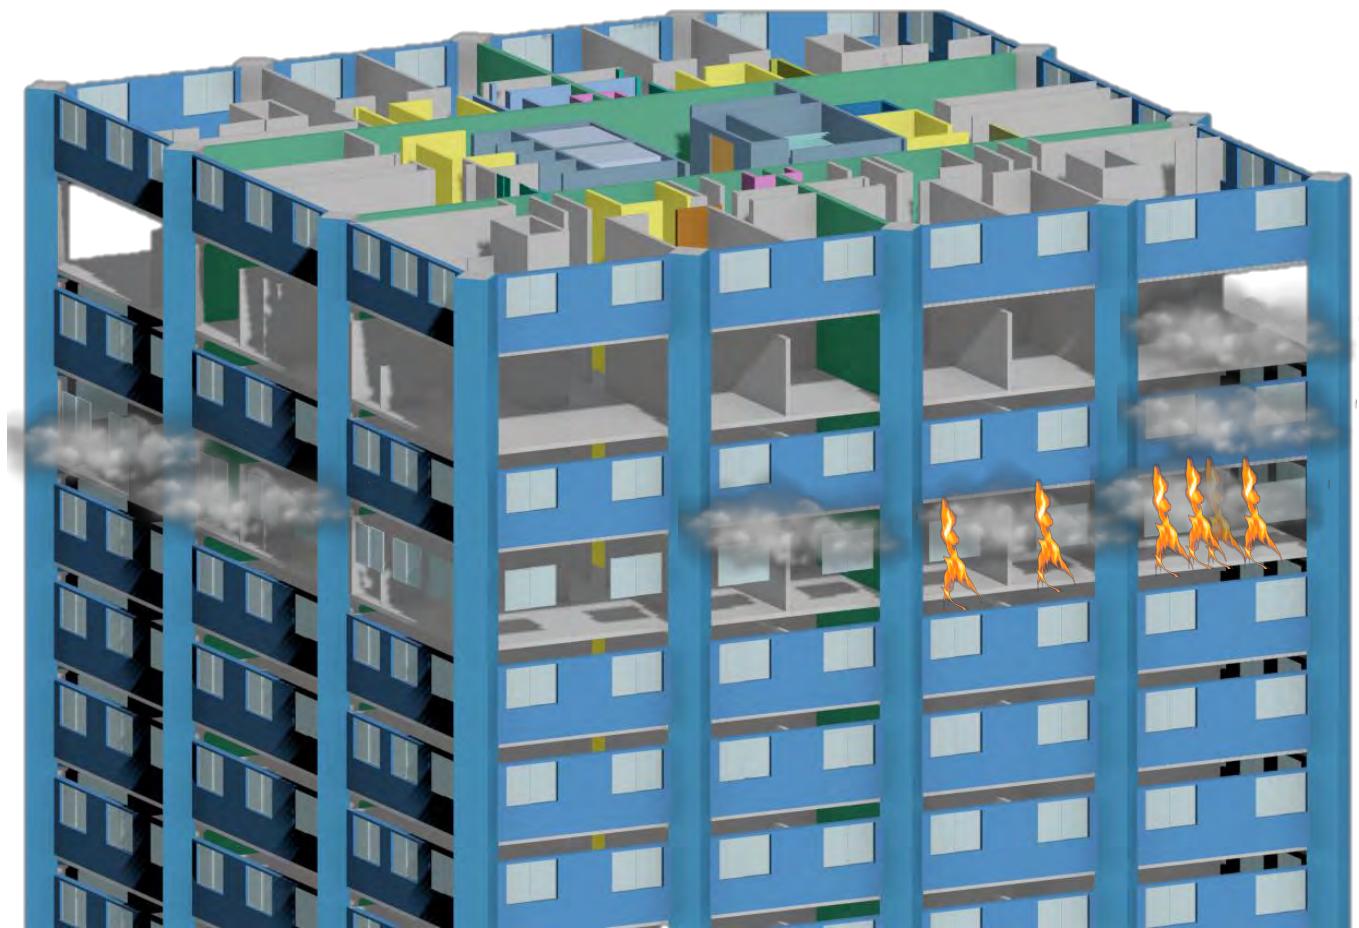
5-15 mins

The fire will  
continue to grow...

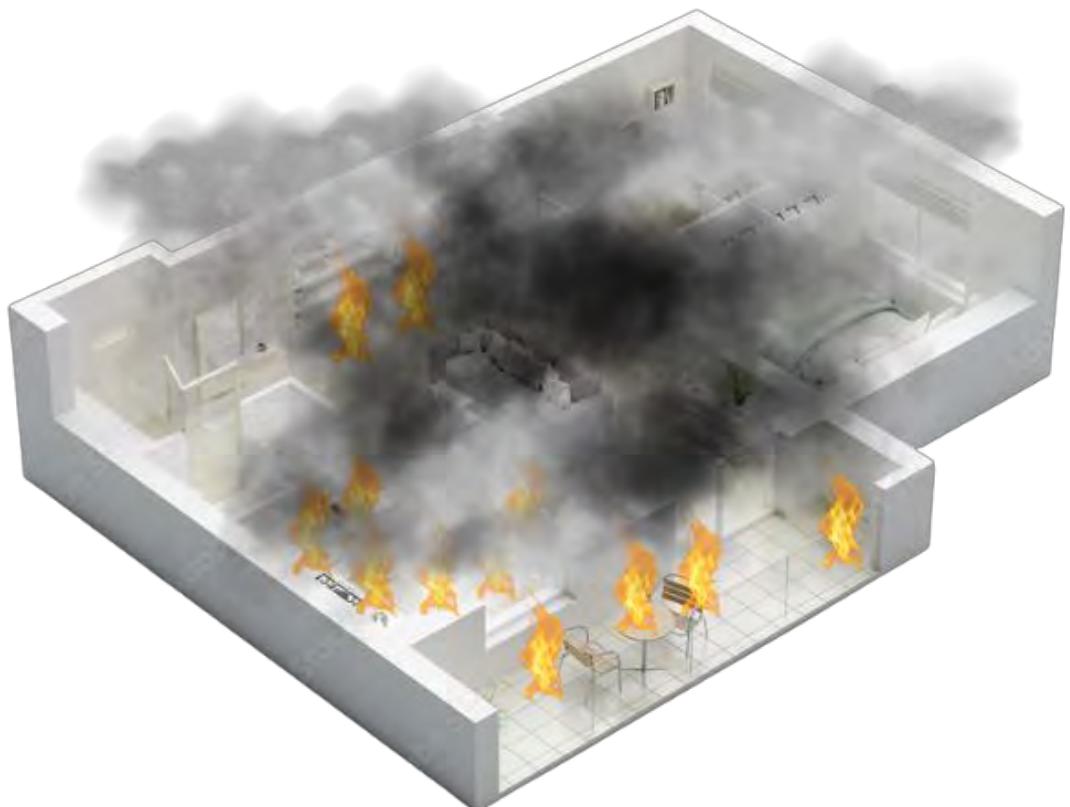
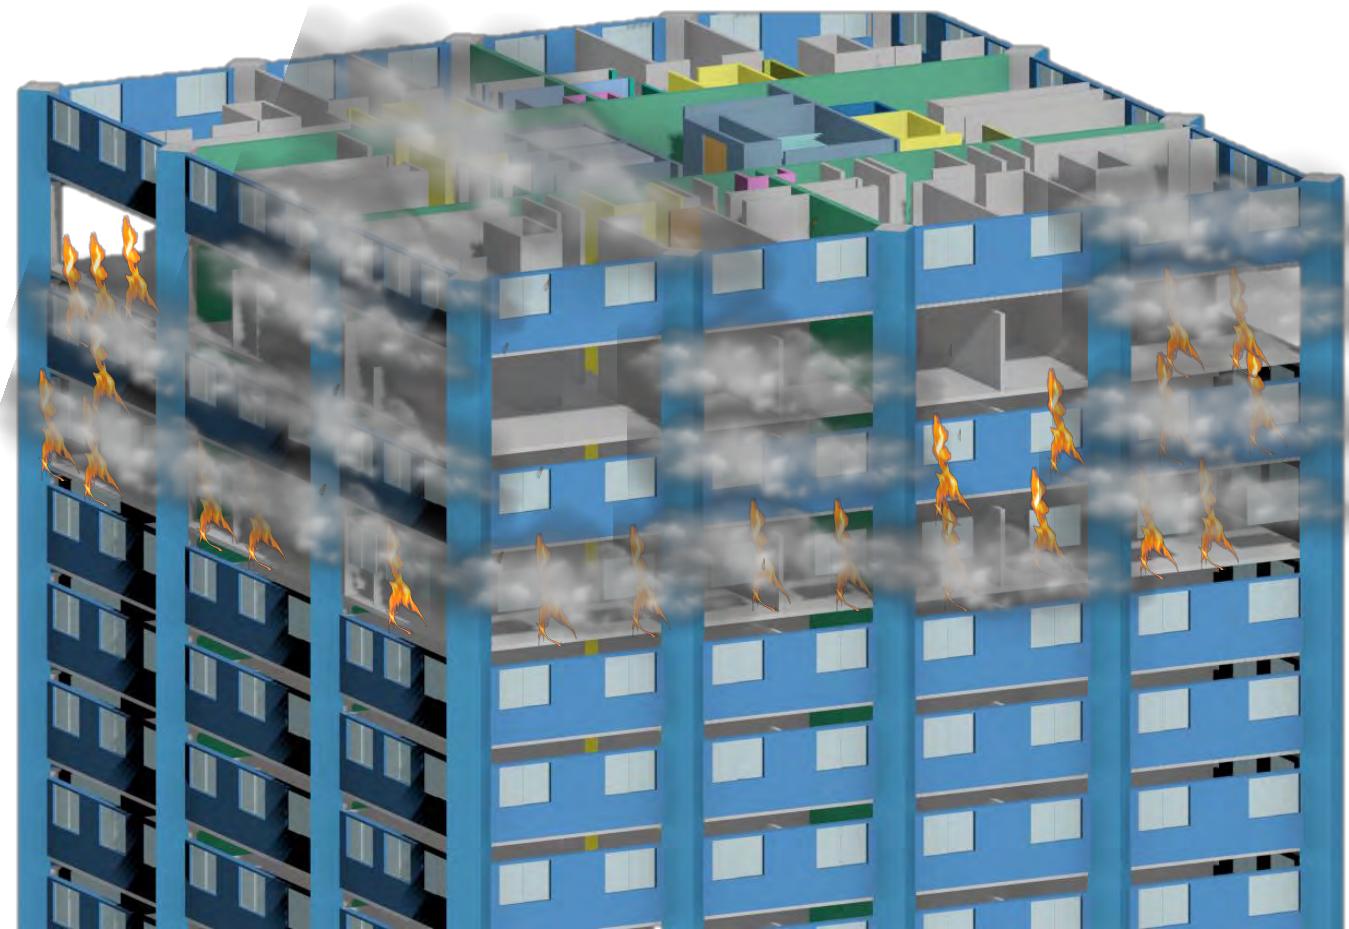
**Structural Instability begins  
(20-30 min).**

Localized to origin room, **heat begins to warp steel columns (concrete may spall)**.

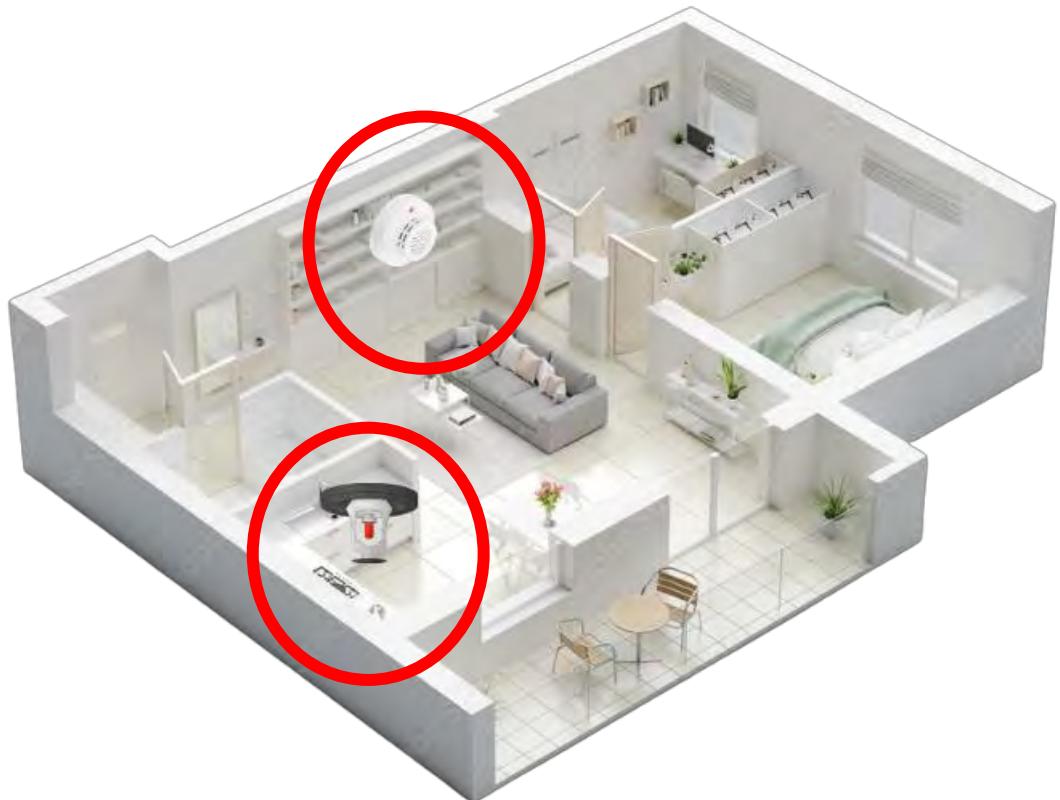
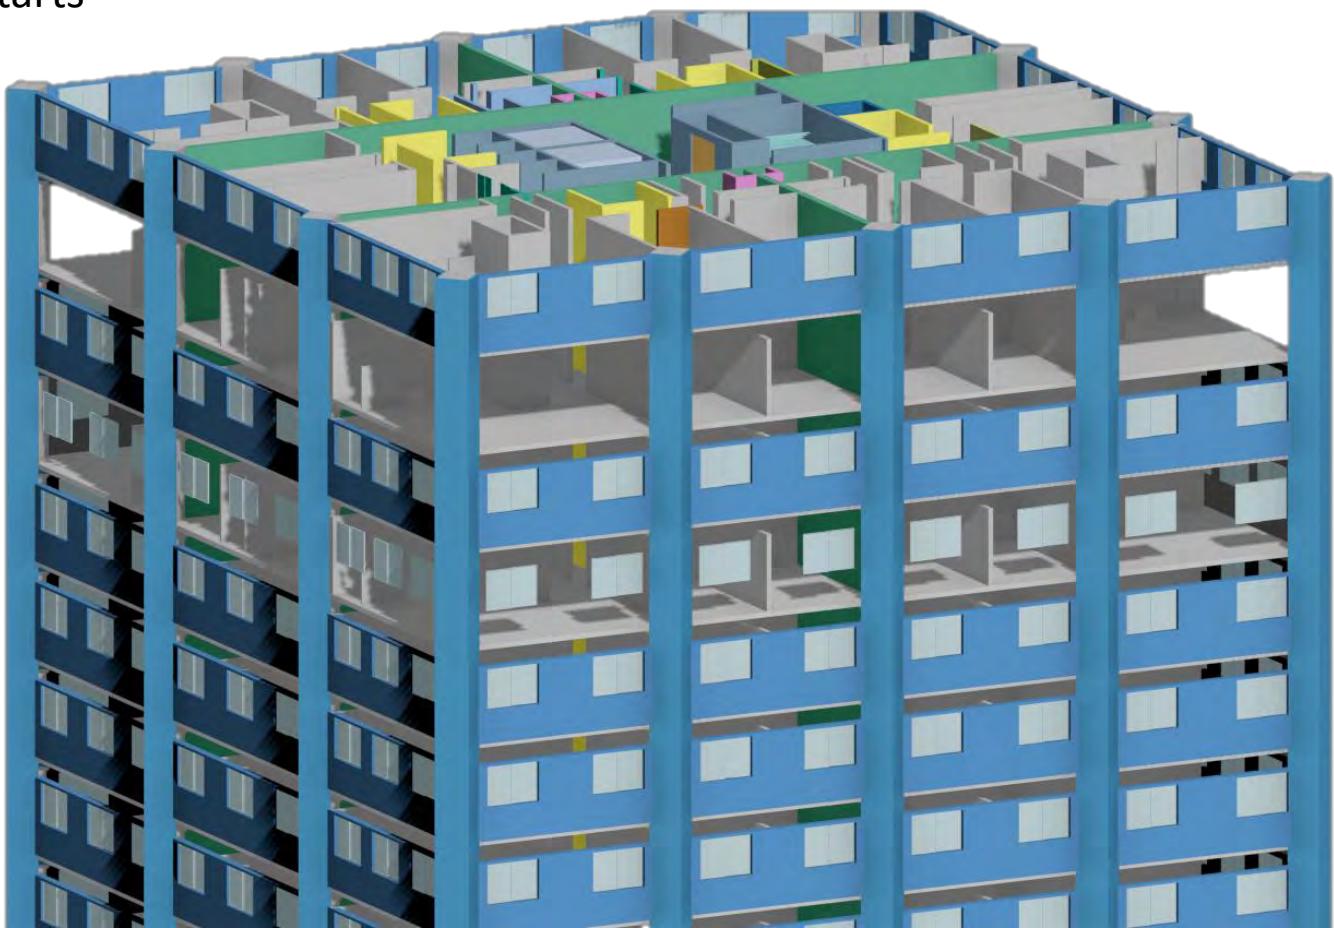
Ignition (0-5 min): Flame sparks and a small fire starts

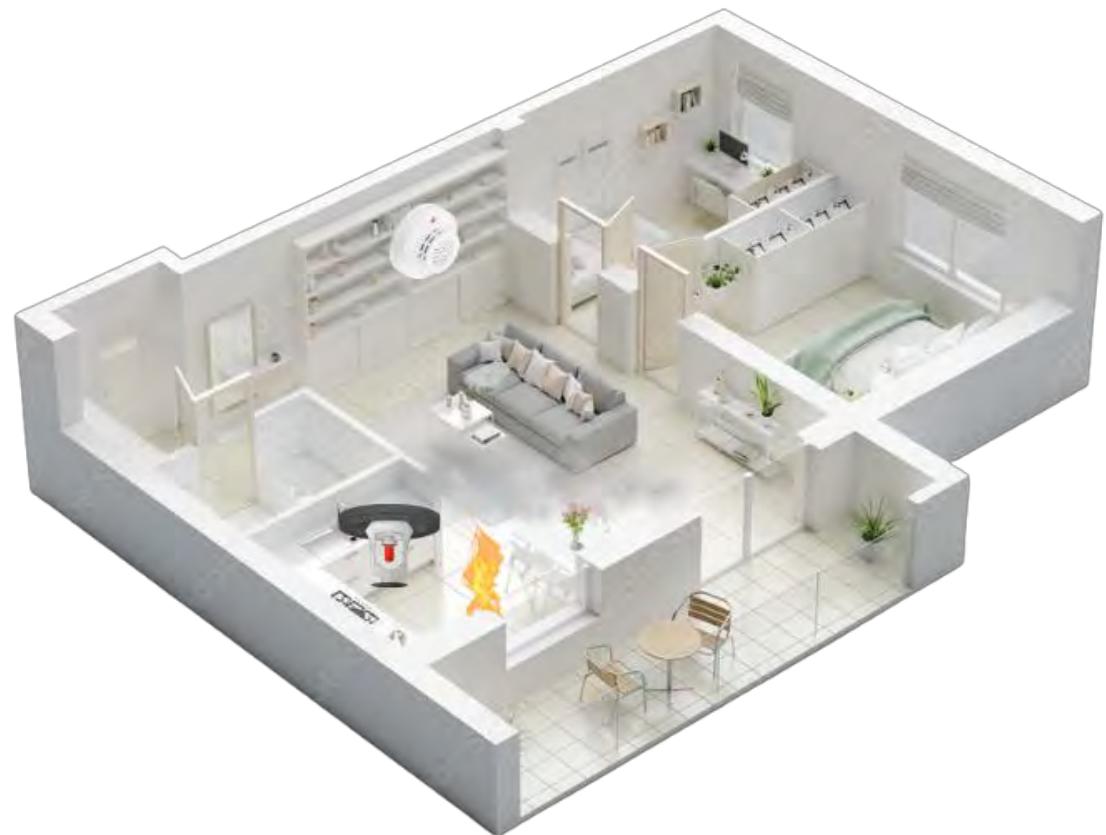
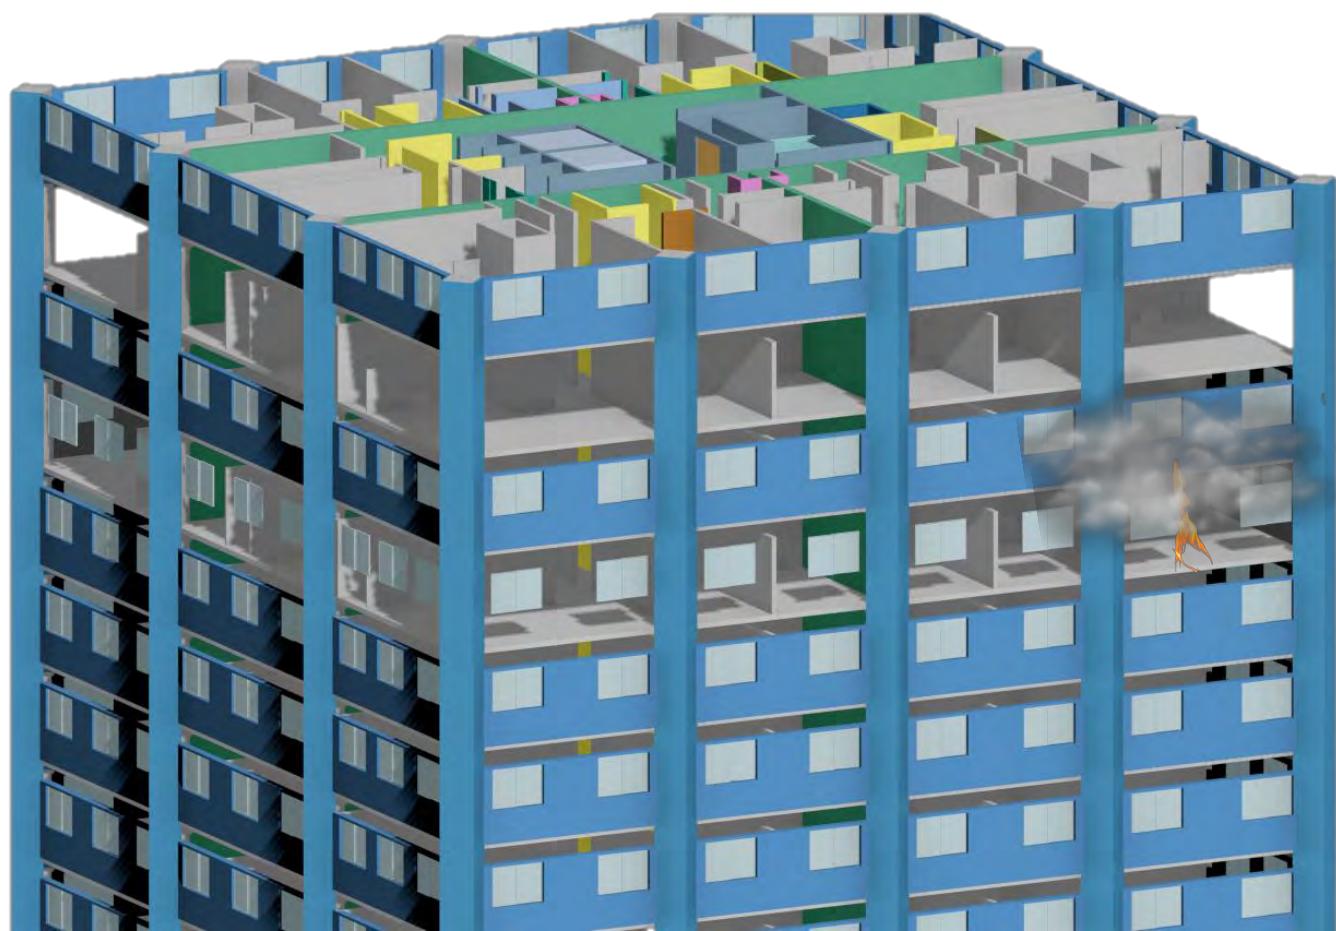
Detectors sense 68°C rise and the alarms start. Evacuation begins, but smoke still spreads and rises.

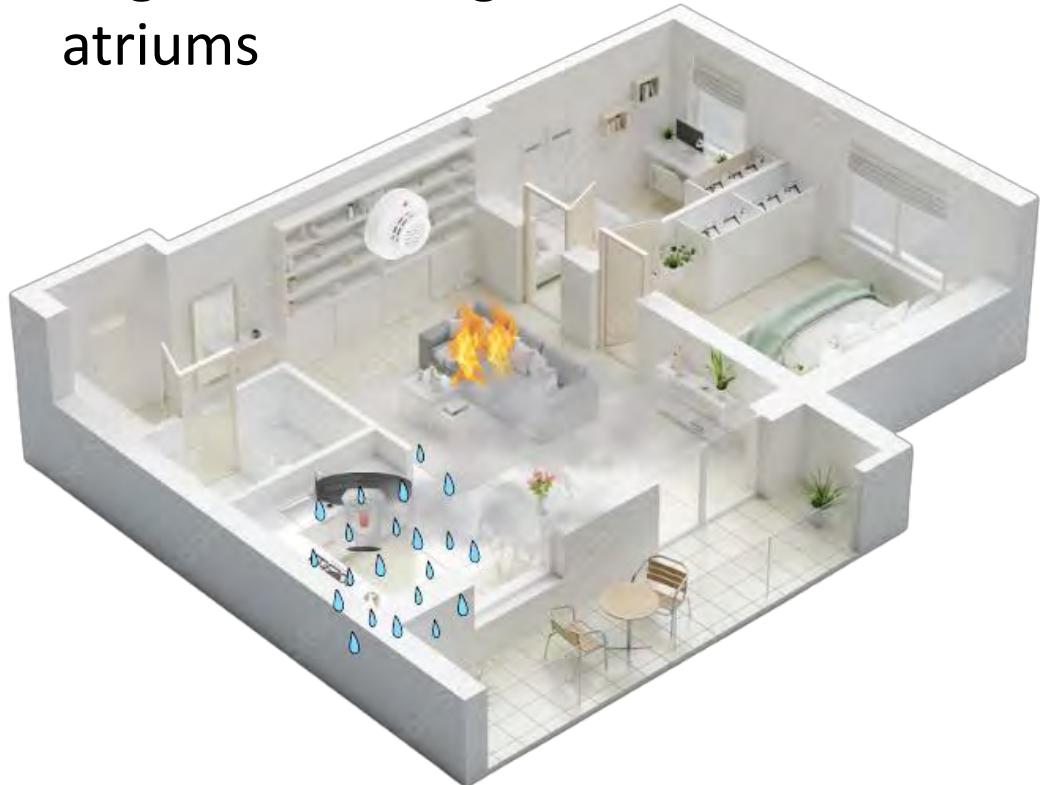
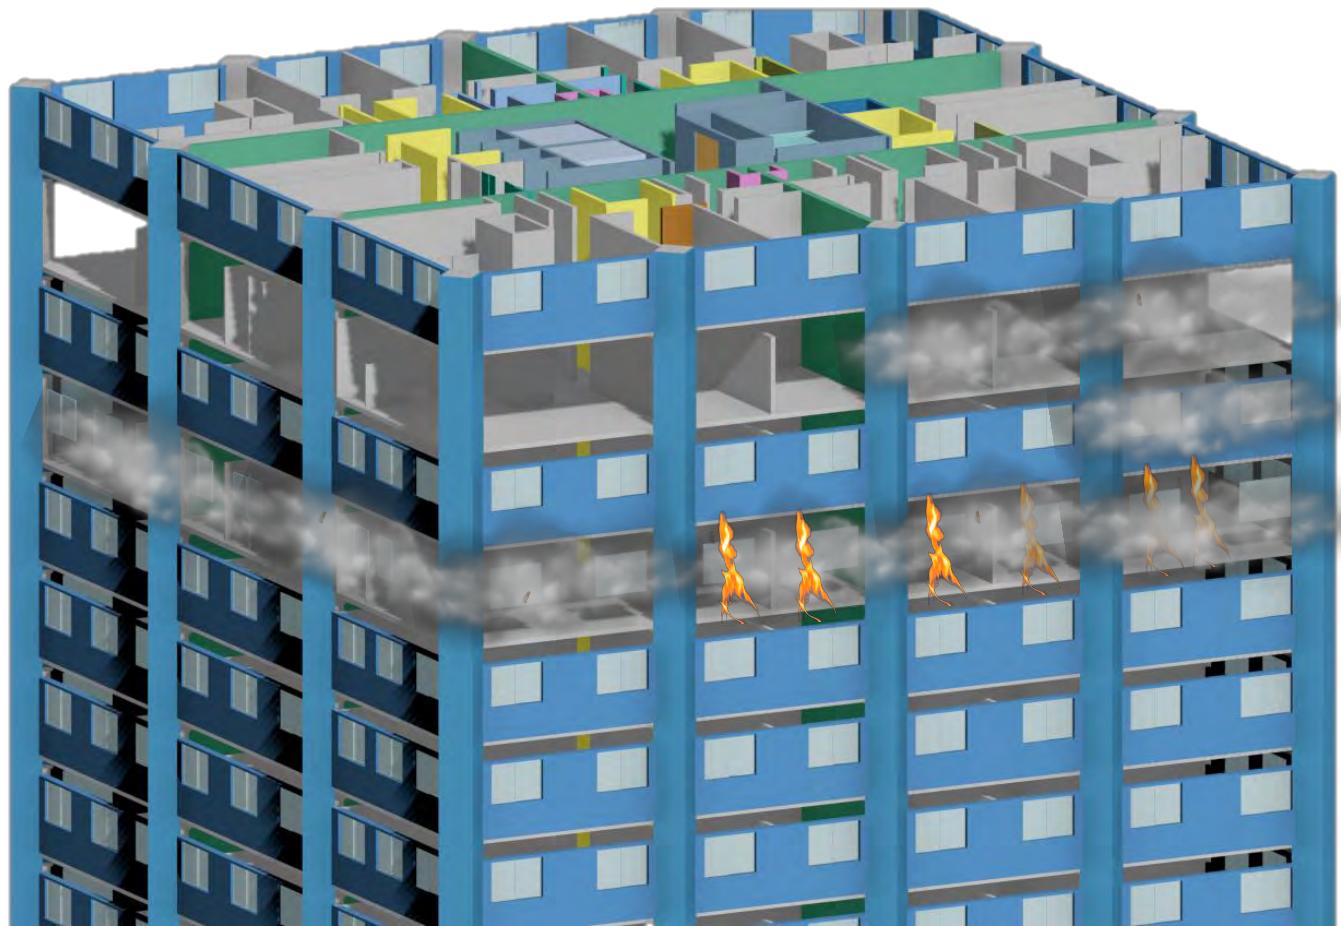
# 5–15 mins

sprinklers activate at 68°C, discharging water, capping fire growth. Flames recede, but water mist aerosolizes smoke, **aiding spread**. Horizontal smoke migration through unsealed doors fills atriums

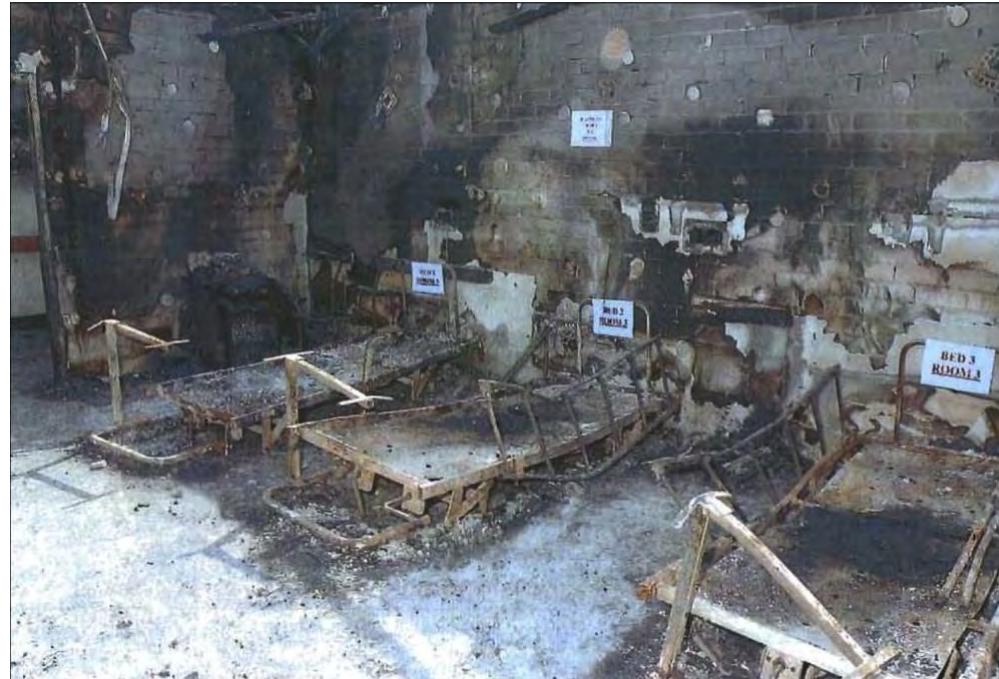
# Quakers Hill Nursing Home Fire, Sydney, Australia

Cause: Arson  
by a nurse  
using  
accelerant in  
two spots.

Early-morning  
fires **spread**  
**smoke across**  
**wards;**  
victims in  
**distant areas**  
**died** from  
inhalation  
while asleep  
or  
evacuating,  
**despite**  
**sprinklers**  
**activating.**

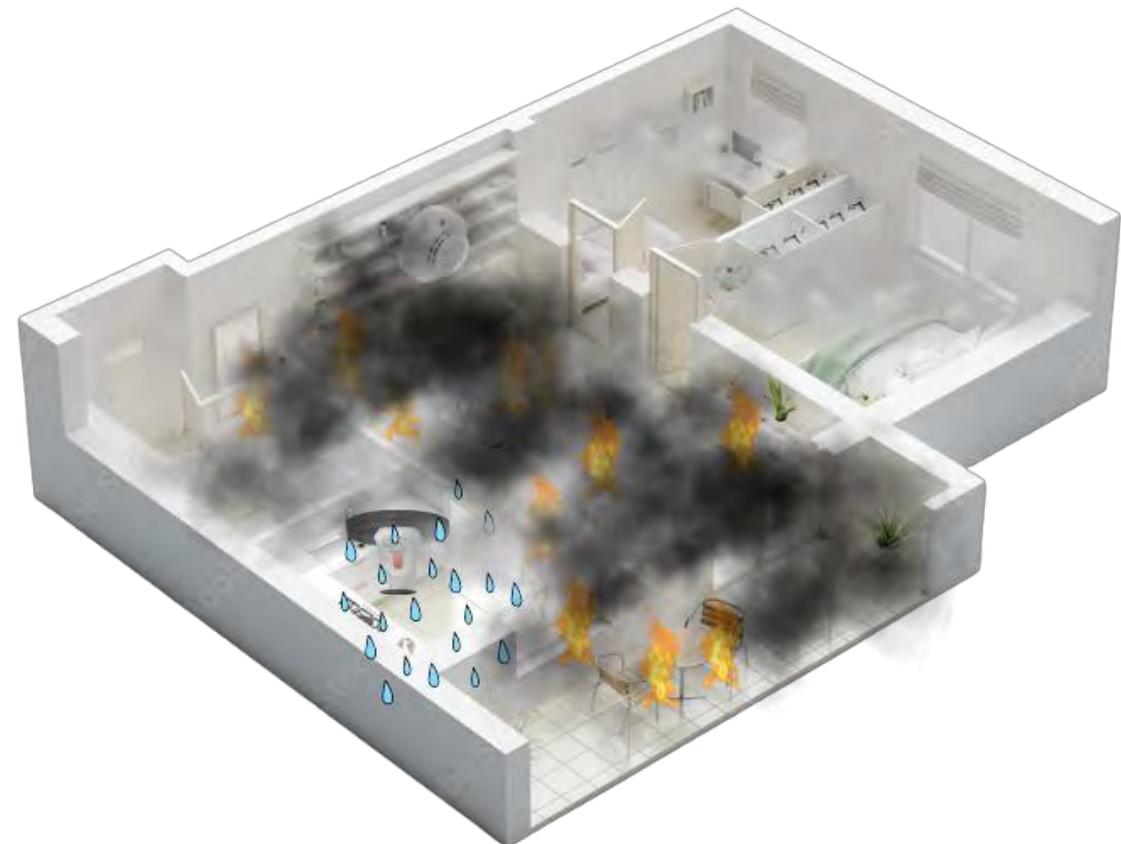
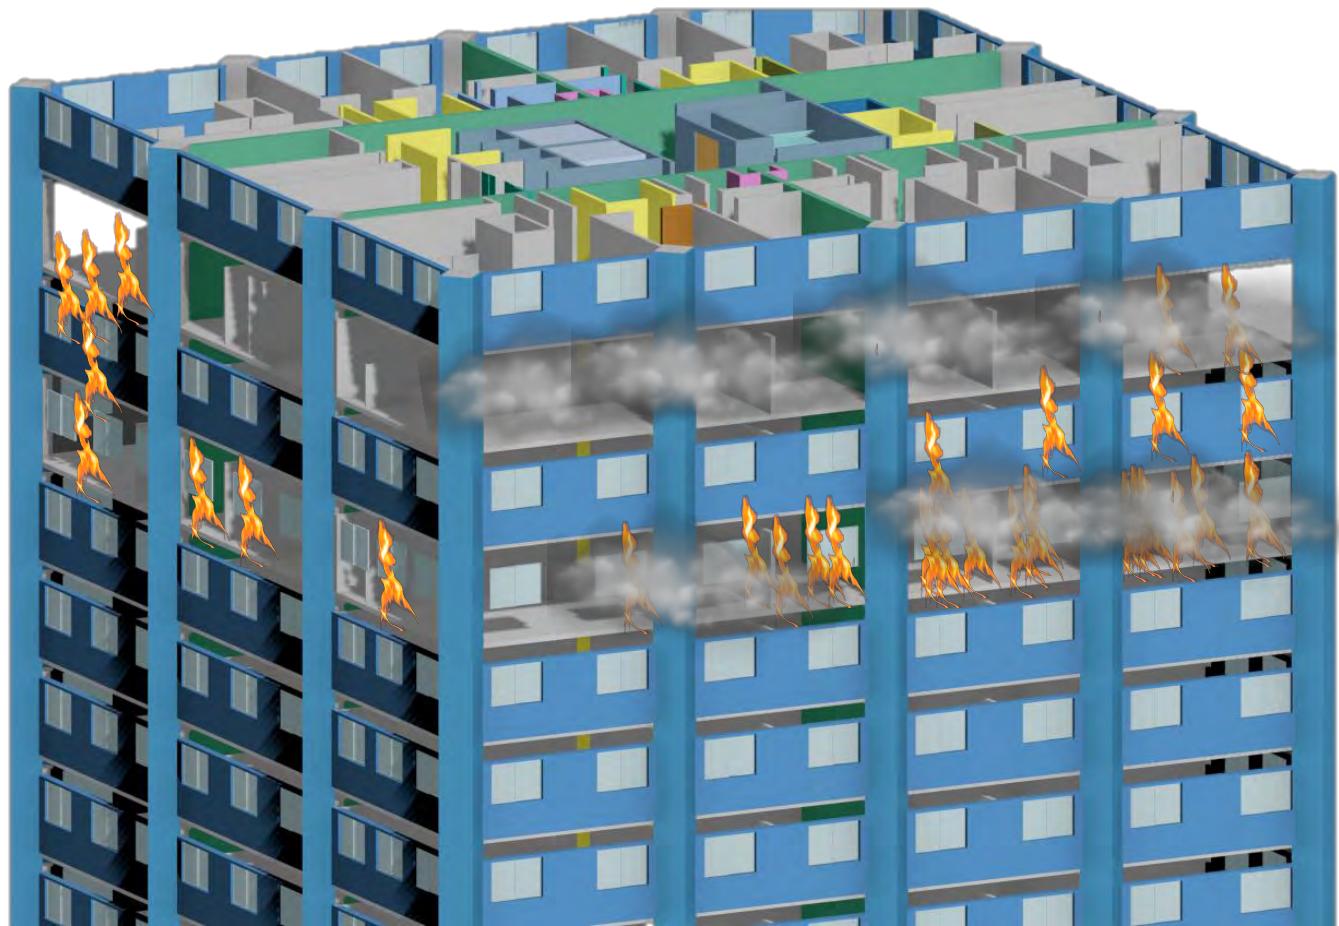
## Fully Developed (20-45 min)

No collapse imminent, but smoke permeates floors of the building and oxygen dips to 12%. Sprinklers wet distant areas, BUT occupants ARE STILL AT RISK from inhalation.

Smoke flood exit ways, making escape difficult.

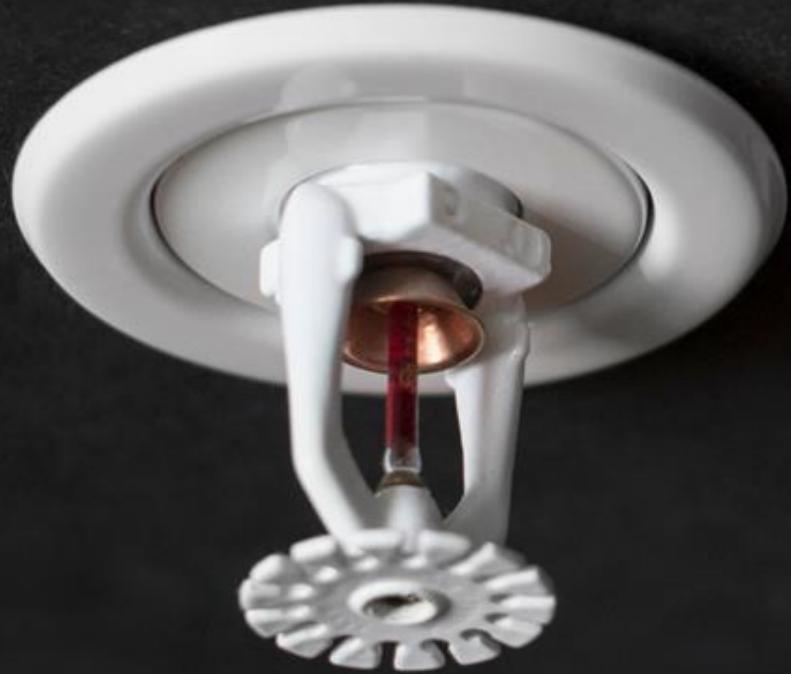
# Sprinklers

**Sprinklers are effective 89% of the time**

Key cause of failure:  
-Delayed onset/non-operation  
-Fire grew too large too fast, and the  
sprinklers **failed to contain fire**

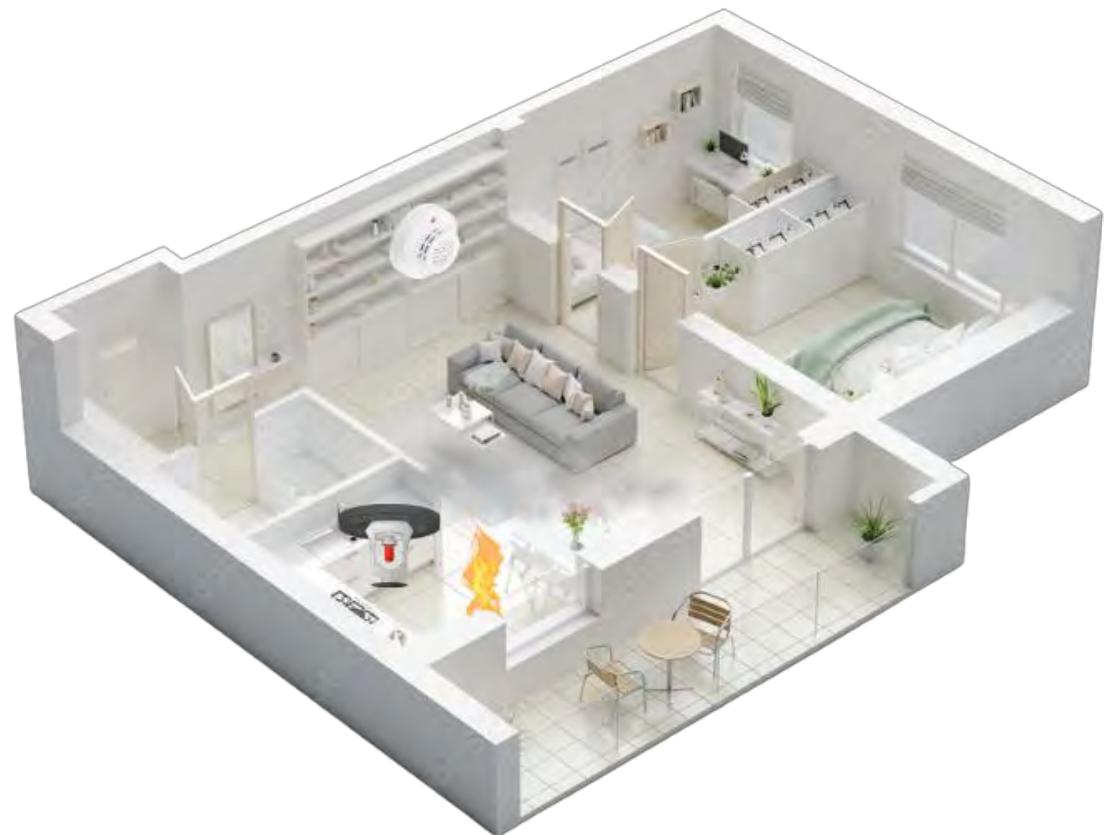
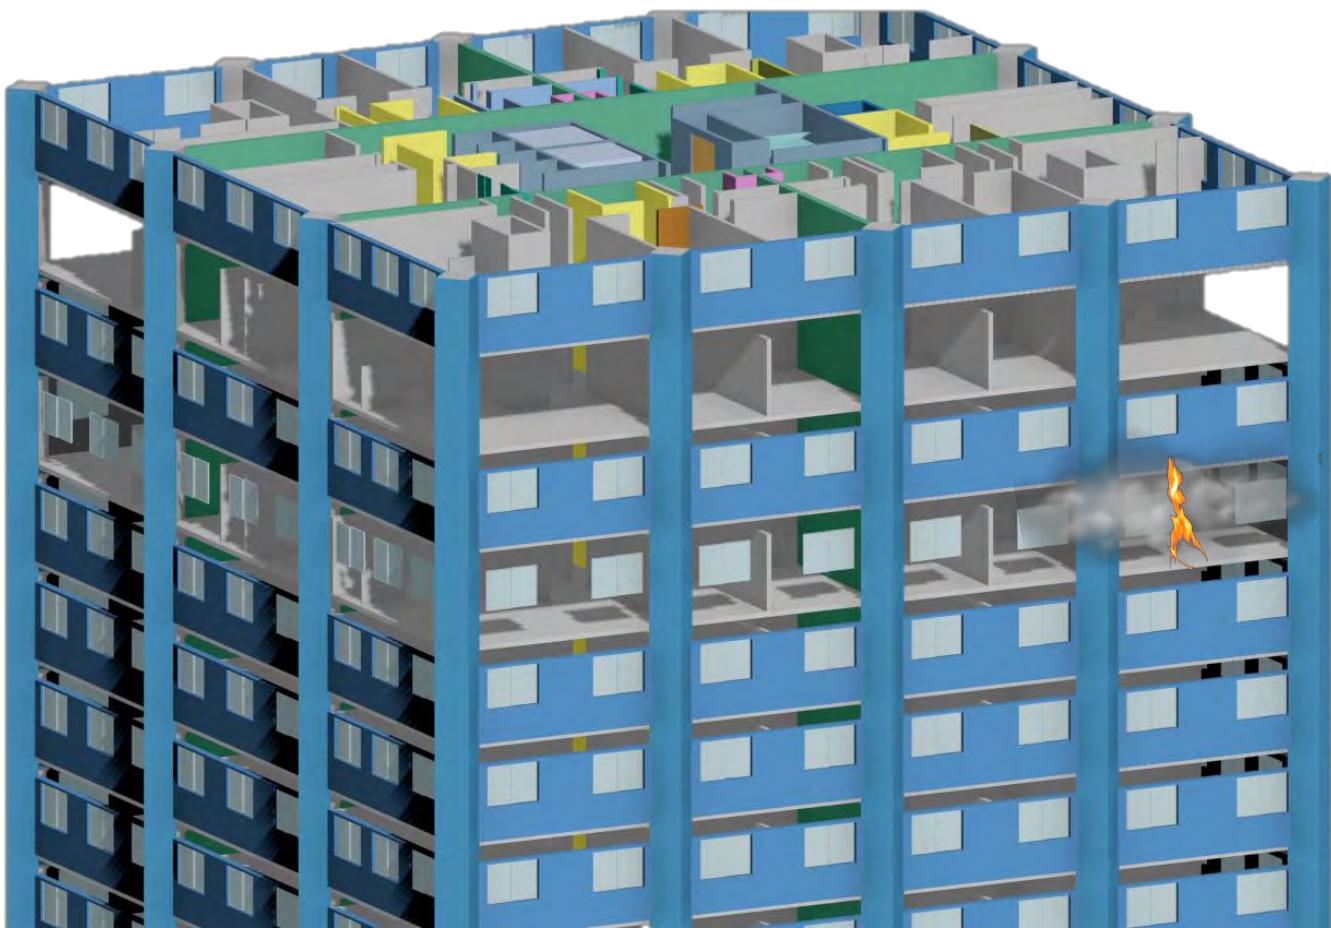
## Ignition (0-5 min)

The detectors activate at 60 °C and the alarms activate. Evacuation commences.

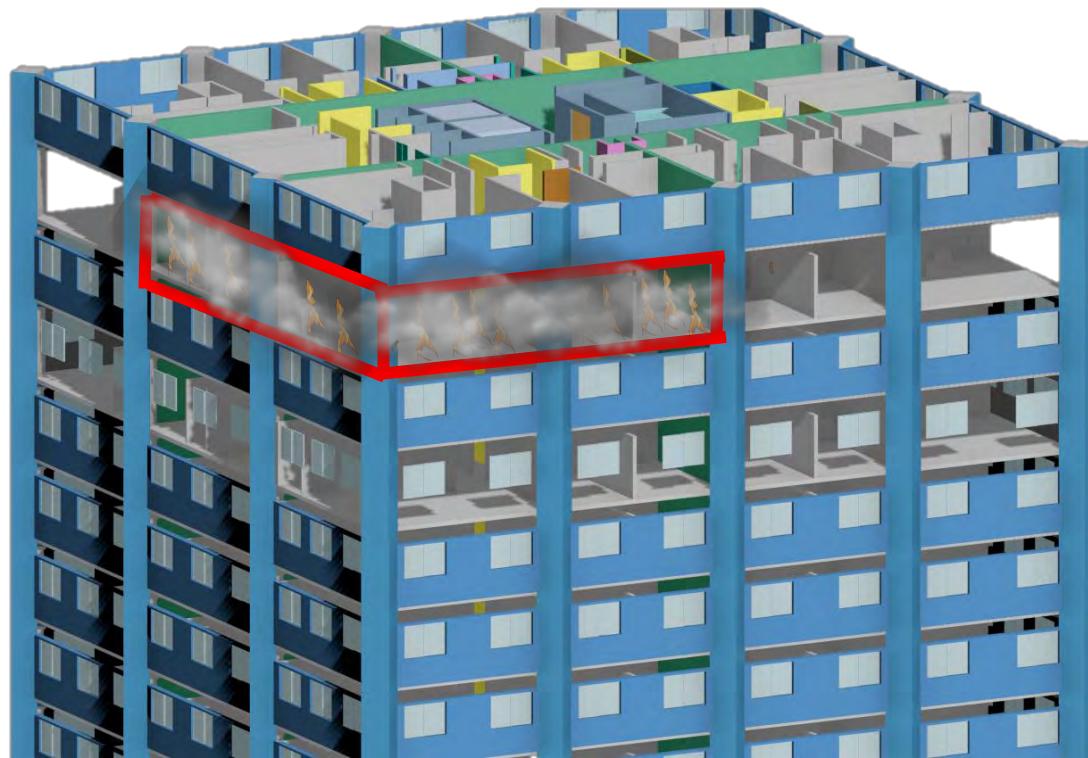
#### Rapid Fire Spread

Cladding system contributes to flame spread resulting in risk of multiple simultaneous secondary fires

#### Restricted Fire Spread

Cladding system does not contribute to flame spread. Risk of secondary fires limited
