# The role of Passive F Protection

Dr Gabrielle Peck, BSc (Hons), Ph.D., MRSC,  
Technical Director

# Smoke toxicity is the leading cause of death in fire.

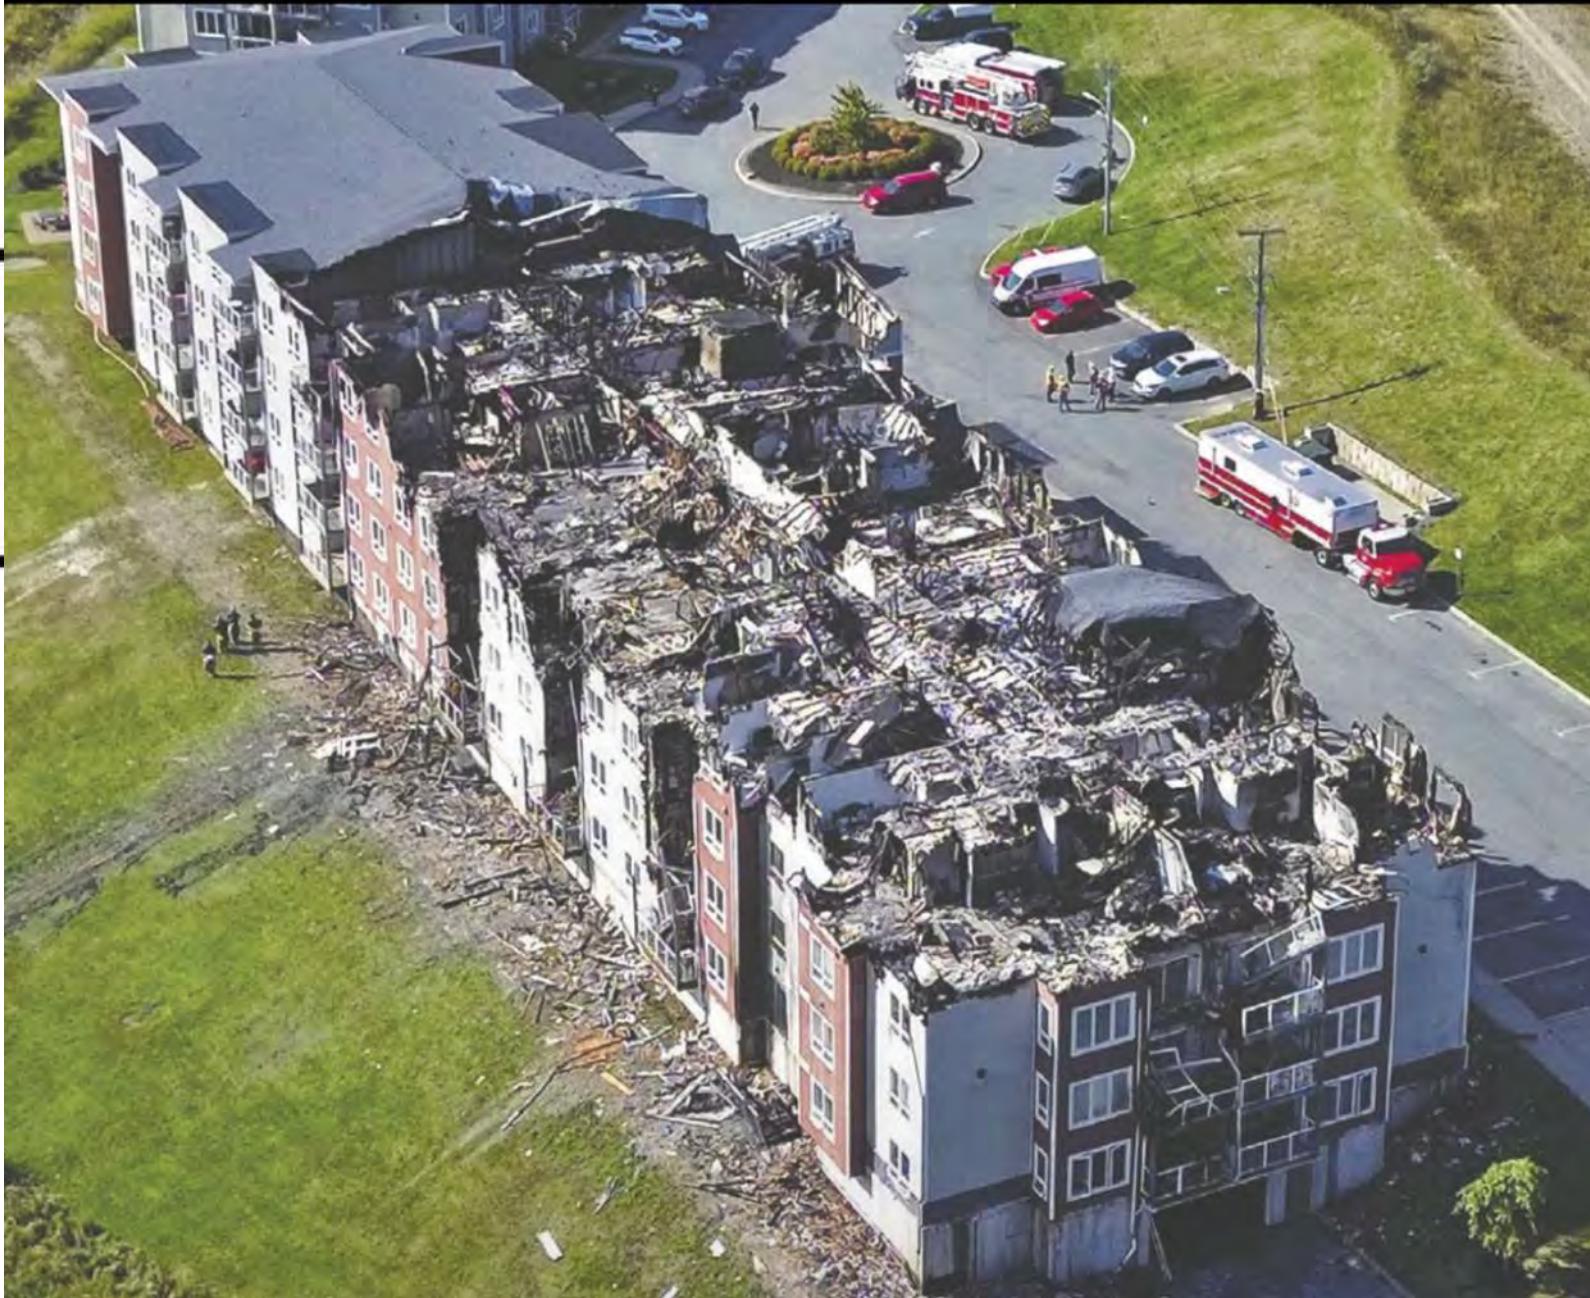
These buildings will have services that will disrupt compartmentation:

- Plumbing pipes through the floor and walls
- Electric cables through walls, floors, ceilings etc..

**How do we maintain compartmentation when the wall has holes in for services?**

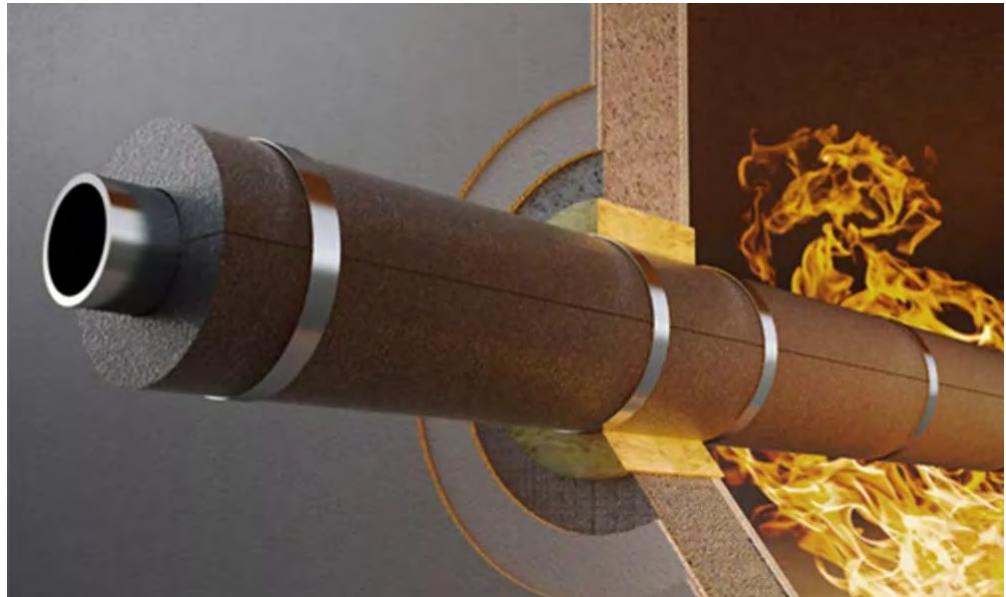
# F- rating

- This certifies a firestop's **ability to block flame passage**.
- **This is defined as the Time (in hours) a system prevents flame passage to the unexposed side.**
- Requirements: **Field installs must mirror lab test set up** (e.g., exact fill depth);
- **A 2-hour F means  $\geq 2$  hours before breakthrough.**
- Chosen to match barrier rating (e.g., 2-hr wall

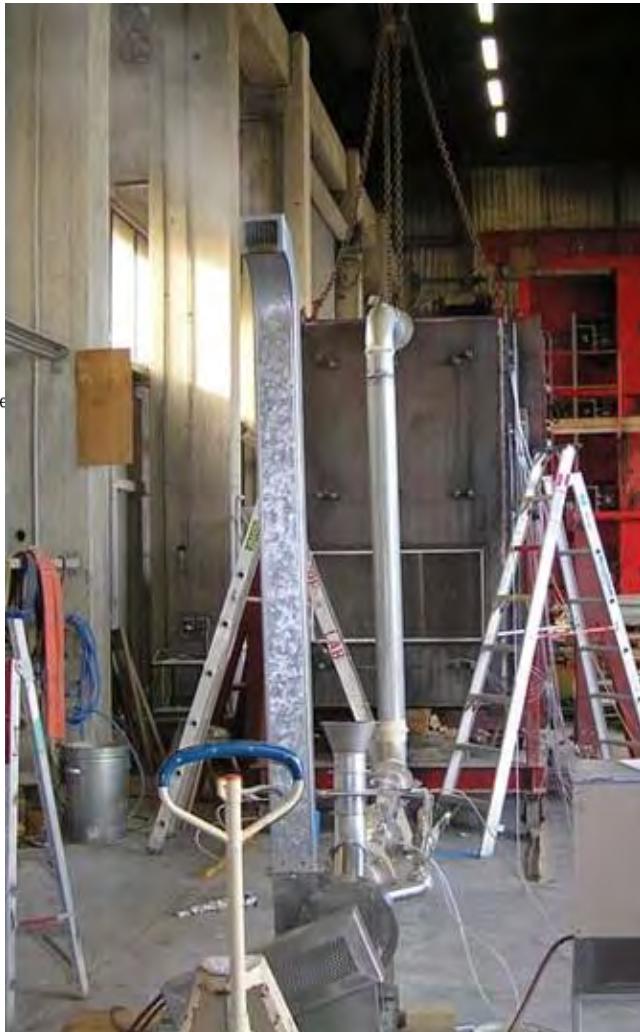
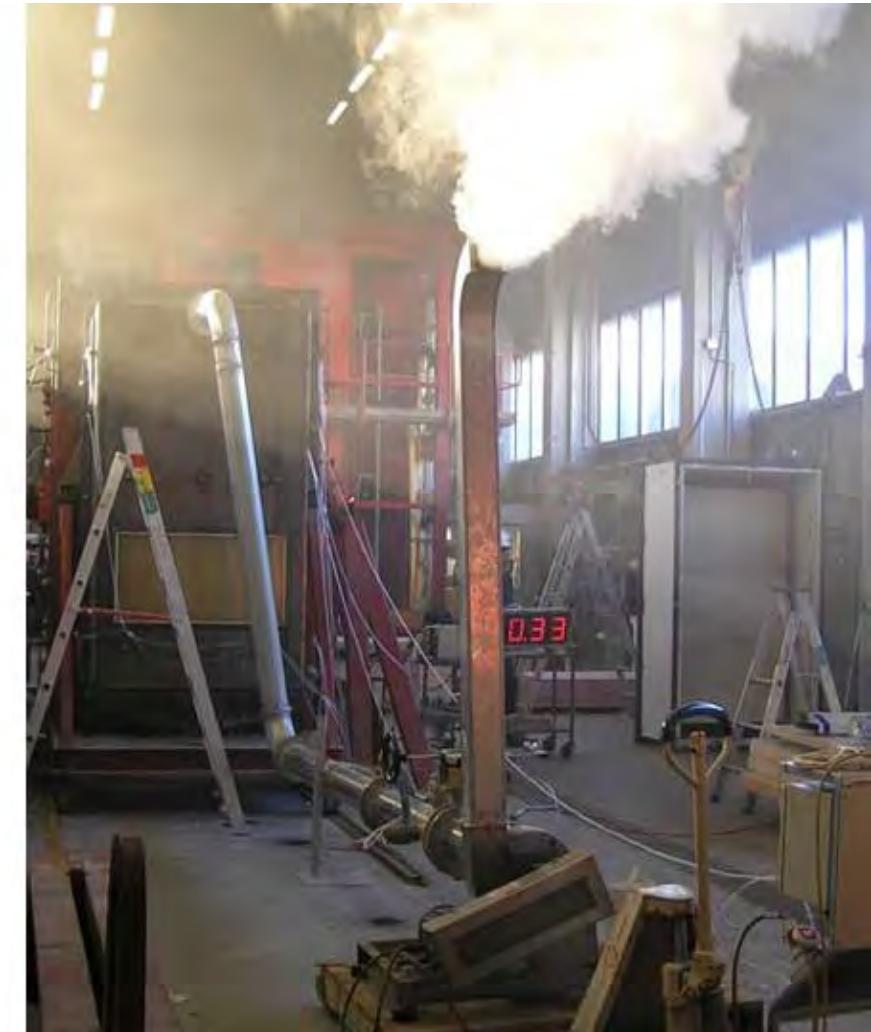
# L-Rating

- L-Rating: Air leakage rates for smoke seal assess how much smoke will pass through the system.
- It is determined post-fire via blower door test; required for smoke barriers (NFPA 105).
- L-Rating measures air/smoke leakage
- Even F/T-rated systems leak if unsealed—L ensures tenable air for escape.
- Steps:
  - (1) Fire test first
  - (2) Cool, seal chamber
  - (3) Apply pressure, measure flow.
- UL 1479 Annex
- E/ASTM E814 Annex A

- L-Rating: Air leakage rates for smoke seal

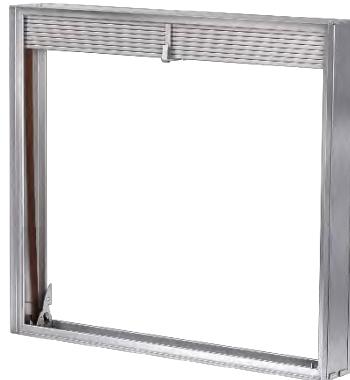
Curtain Fire Damper

“A device, installed in an air distribution system, designed to close automatically upon detection of heat, to interrupt migratory airflow, and to **restrict the passage of flame**.” (NFPA 80) –IBC 2024 Section 717

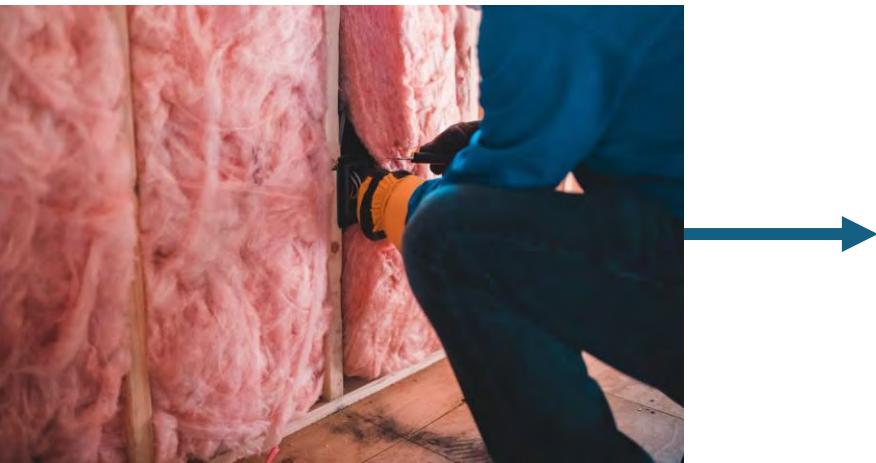
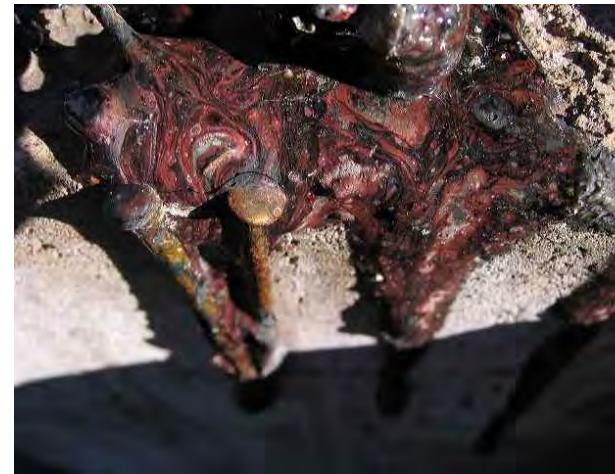
# C-AJ-1291: During a fire, with fibreglass

- **Substitute Fiberglass for Mineral Wool**
- Replace mineral wool with E-glass fiberglass insulation (**melting**  $\sim 800^{\circ}\text{C}$  or  $1472^{\circ}\text{F}$ ).
- It softens at approximately  $600^{\circ}\text{C}$  ( $1112^{\circ}\text{F}$ ) and melts into a viscous flow at  $\sim 800^{\circ}\text{C}$  ( $1472^{\circ}\text{F}$ ).
- **fiberglass does not char**; it undergoes melting and viscous deformation under fire exposure.

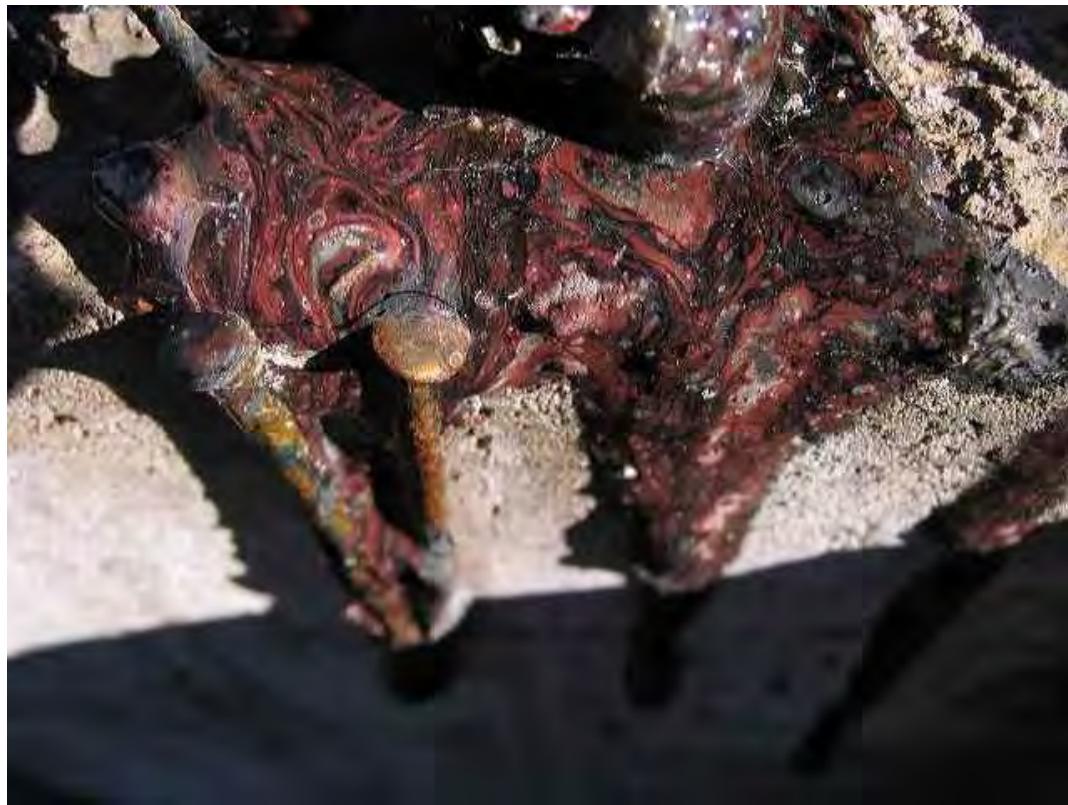
# C-AJ-1291: Substitute rockwool with fibreglass

- Material selection must match what has been tested.
  - Thermal/chemical profiles for penetrant-substrate vary;
  - fiberglass is unsuitable for this firestop application.

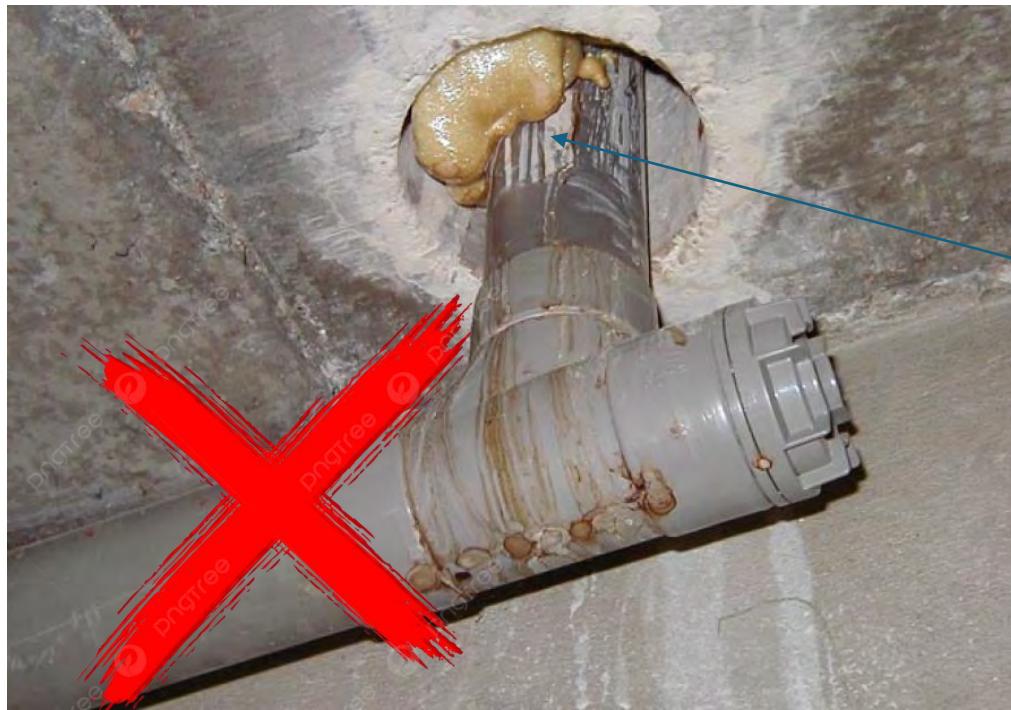
**Combustible foam-  
this will not  
protect the  
penetration.**

**This will generate  
Hydrogen Cyanide on  
burning. This will**

**HCN causes rapid  
incapacitation & death on  
inhalation**

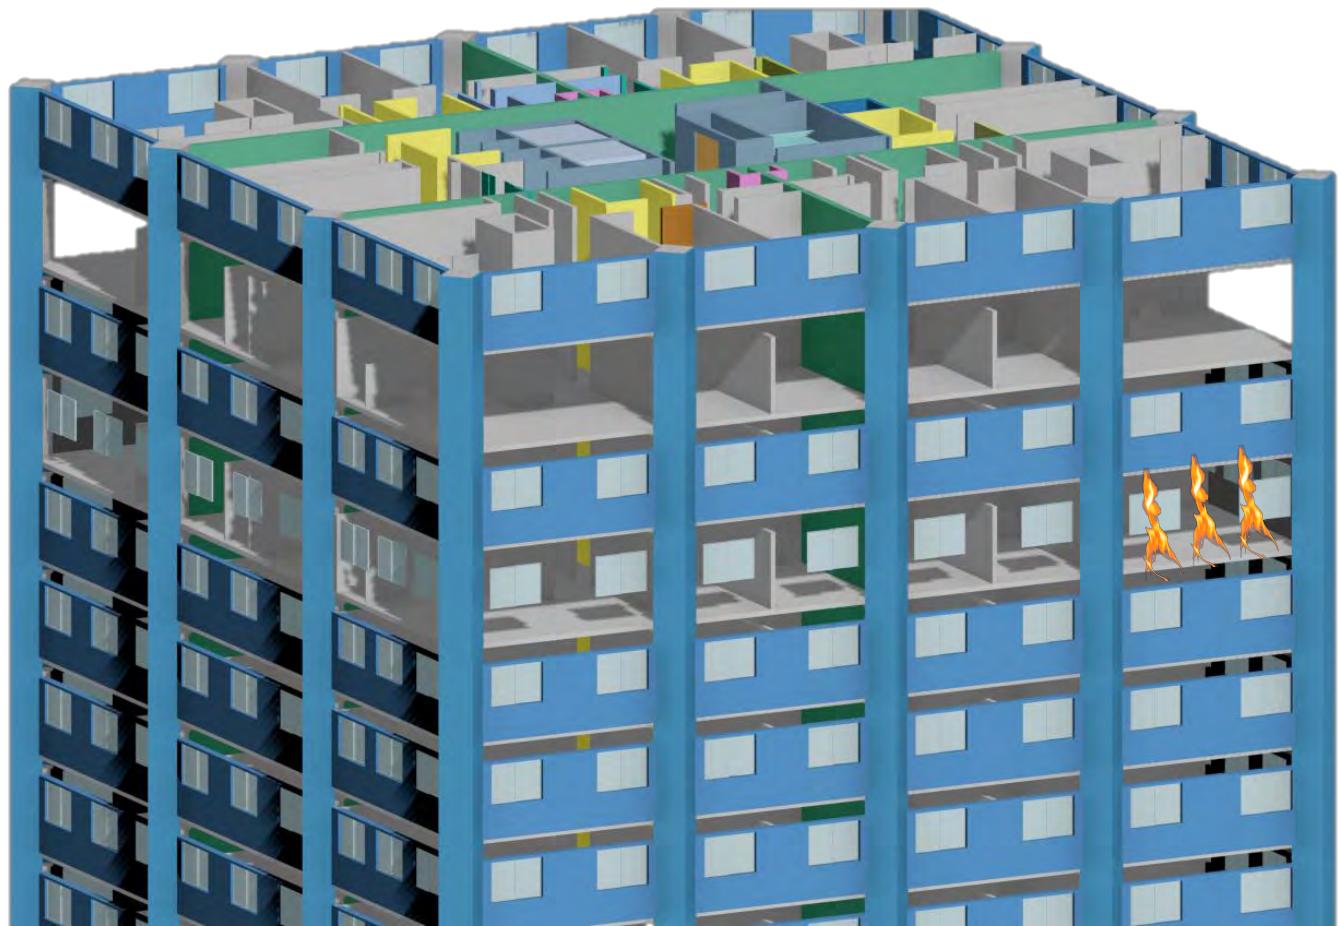
# Substitutions

**Substitutions like fiberglass batt are common** because it is a cheaper alternative.

**This substitution WILL FAIL IN A REAL FIRE.**

**Only use what is specified in the listed system or EJ.**

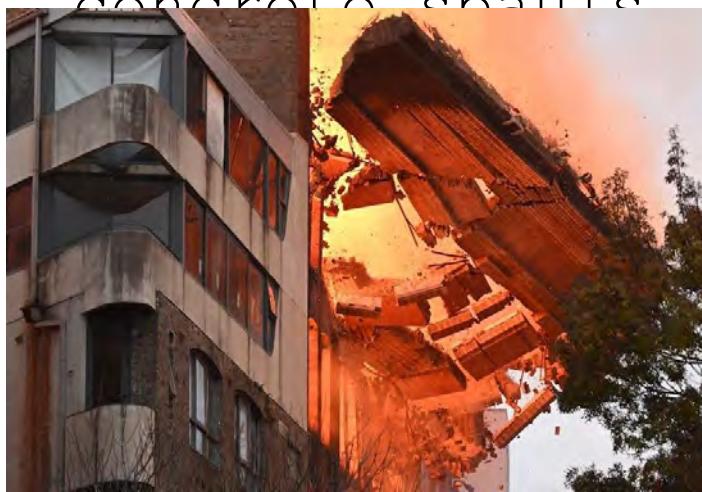
When exposed to high temperatures, the concrete's temperature will rise. As it rises, the **water within the concrete structure will start to evaporate** and leave the structure. This causes the concrete to begin losing its structural integrity. On extreme heating-concrete spalls.

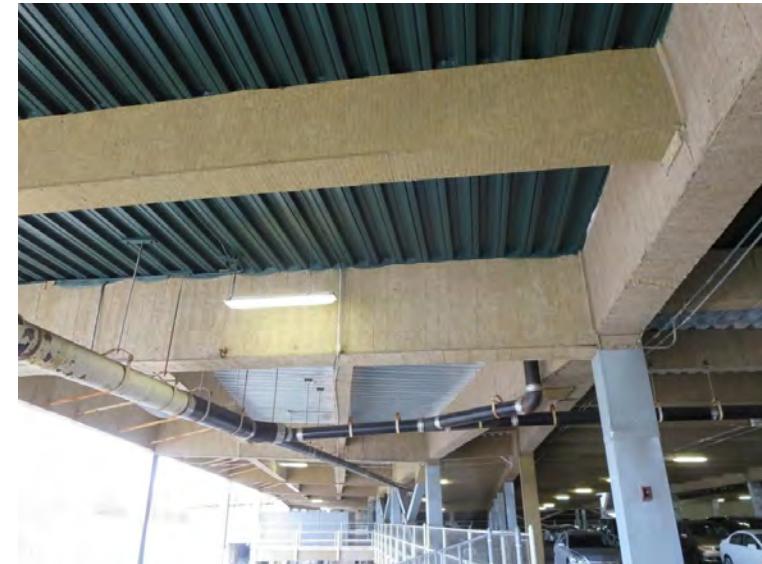
# Types of protection

- **Spray-Applied Fire-Resistive Materials (SFRM)**
- **Intumescent Coatings**
- **Board Systems**
- **Outcome:** Ensures structural stability, limits temperature rise.

Everything has limitations.  
Protection delays the point of failure.

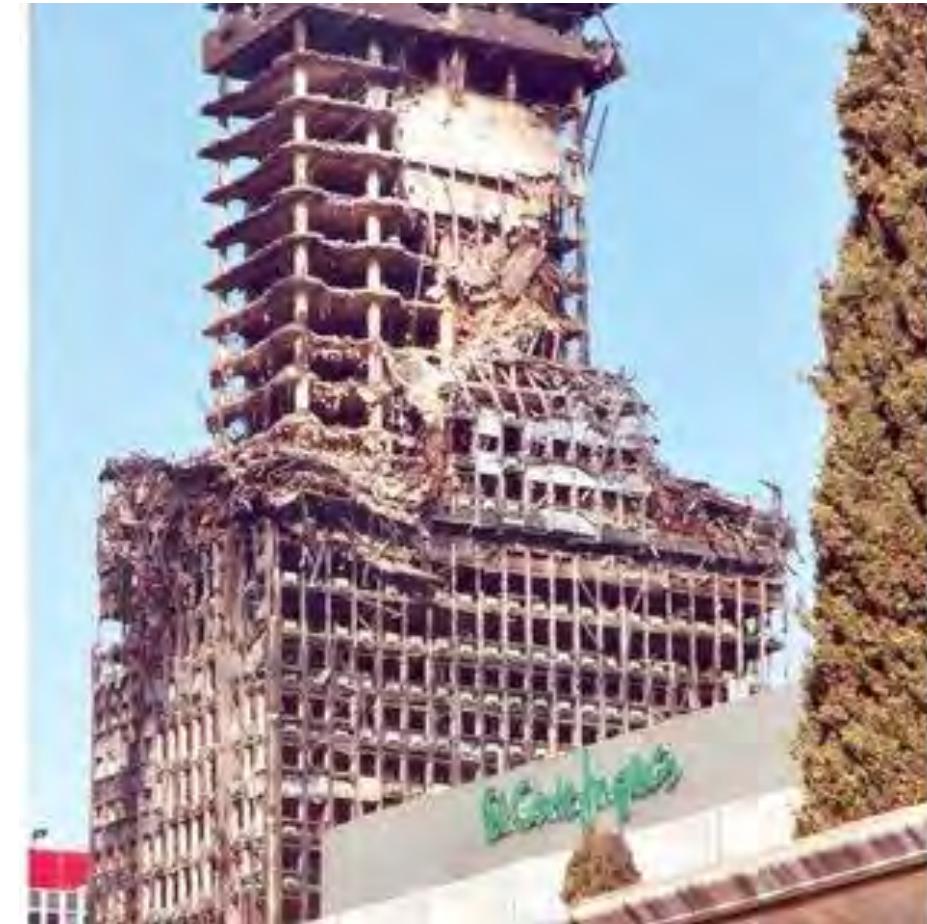
- This triggered progressive collapses.
- 1<sup>st</sup> east face of the 21st floor at 3hrs into the fire
- 2<sup>nd</sup> upper sections around floors 20-25 shortly after
- 3<sup>rd</sup> south mid-sections of 17-20 appx 1 hour after that
- Debris from these falls thought to have cracked the 17th-floor transfer slab, aiding downward fire spread.
- Aluminum used in the curtain wall melted, "fire drops" propelled downward spread

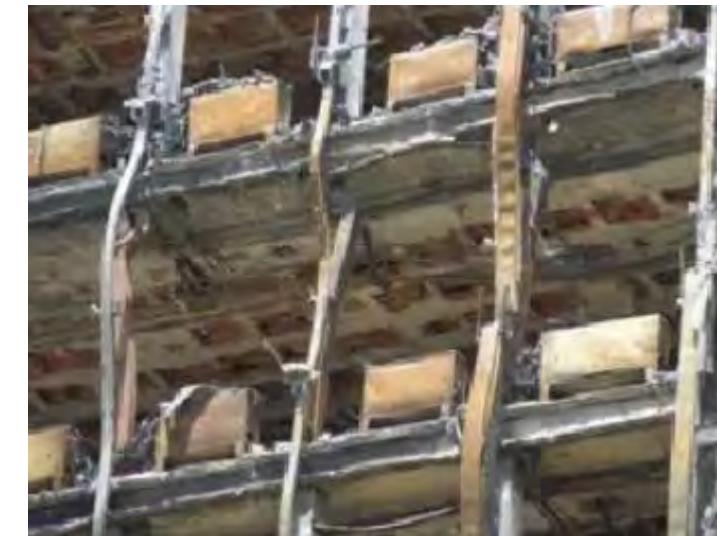
**Buckling at floor 9**

Fire protection system	At time of construction (1970s Spanish code)	At time of fire (under refurbishment)
Compartmentation	X	Under construction, <b>but not fully compartmentalised</b>
firestopping between cladding & Structure	X	Under construction
Protection of steel	X	17 <sup>th</sup> floor + above: NO 18 <sup>th</sup> floor, part complete 4-15 <sup>th</sup> floor: Complete (except 9 and 15)
Sprinkler system	X	Being retrofitted
Fire alarm system	YES	YES

- Below the 17th floor, **protected steel held**, but unprotected spots (e.g., 9th floor south/west sides) buckled
- The concrete core and internal columns redistributed loads, preventing further failure.

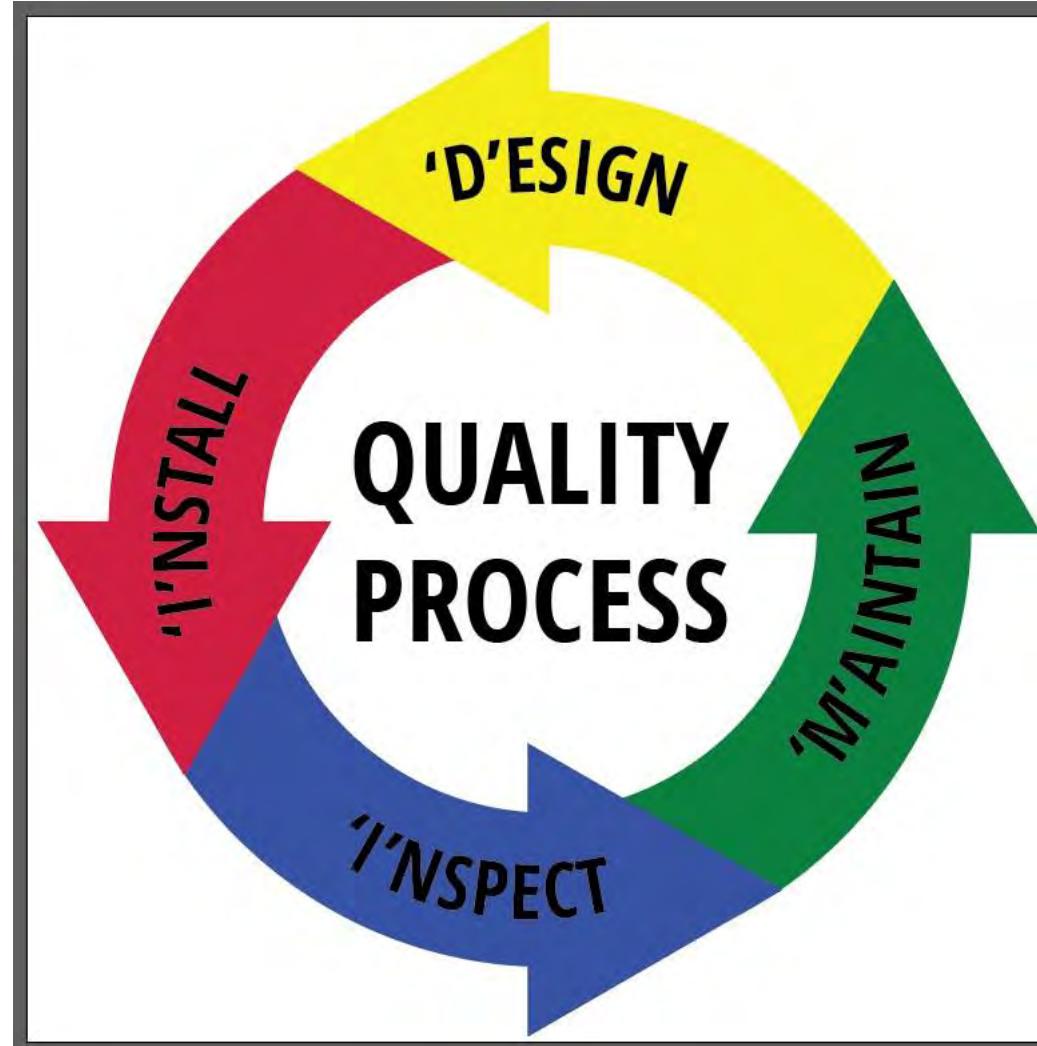
## DIIM Model

Maintaining a chain of  
accountability &  
responsibility  
is imperative for fire
