CONSTRUCTION WITHOUT OVERSIGHT

Douglas H. Evans, P.E., FSFPE
DHE FPE LLC
Las Vegas, NV

In 2008, Clark County Building Department instituted a rigorous inspections program to uncover unreported building code violations in the existing resorts on the world-famous Las Vegas Strip. The violations discovered were primarily due to substantial work conducted without permits or inspections and inadequate or improper maintenance. An overview of the various types of violations and their extent will be discussed.

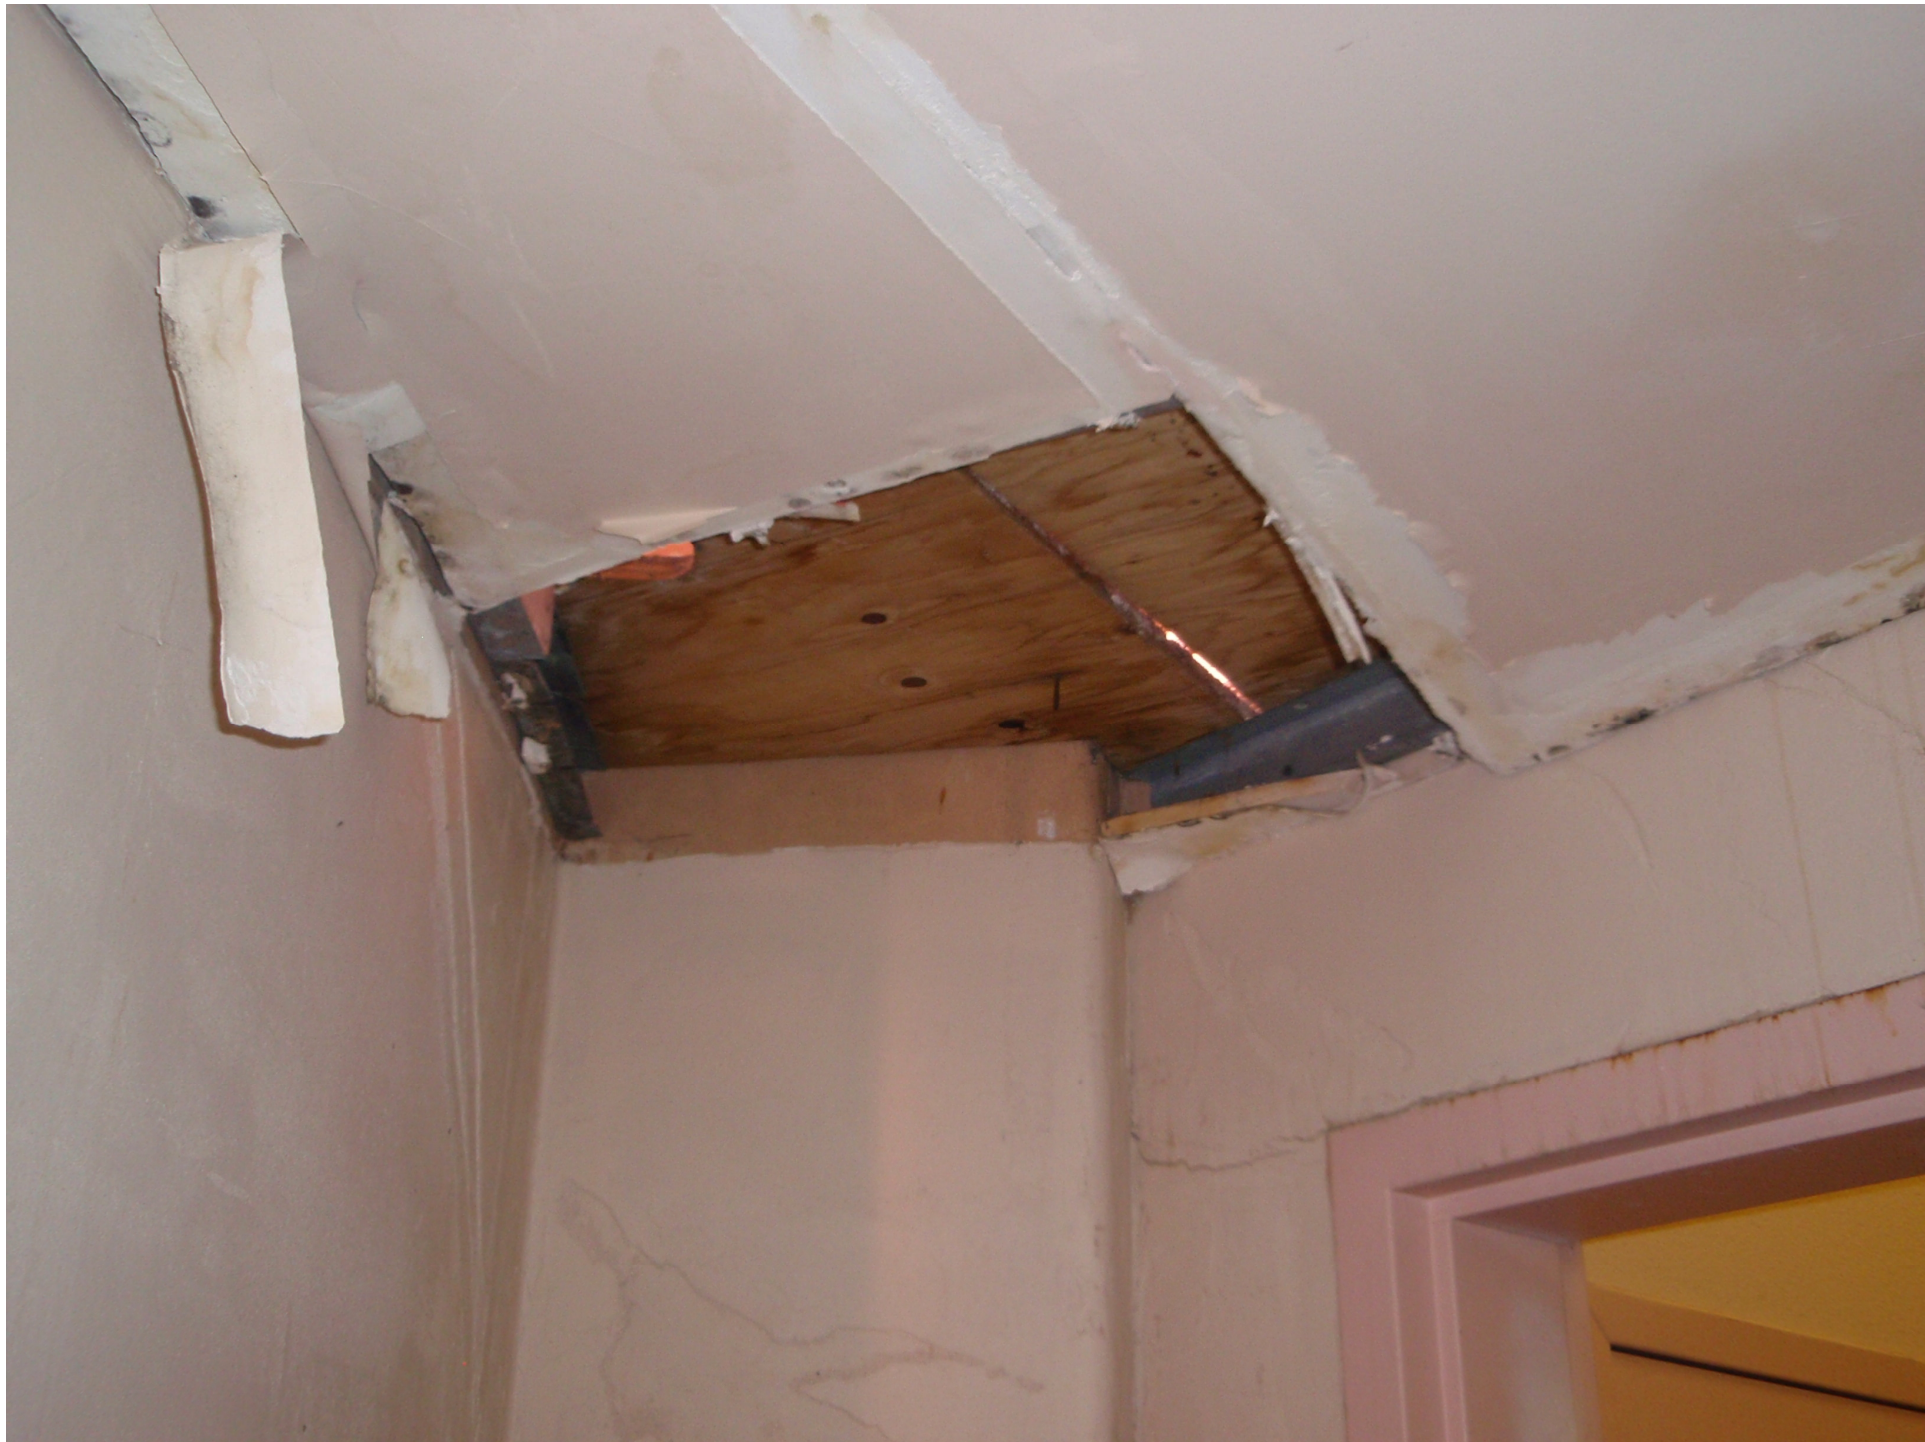
Wood room constructed for comm
equipment w/o permits. Basement
HK storage area.
